BUFFALO & ERIE COUNTY BOTANICAL GARDENS
 GROW HOUSE

ASBESTOS CONTAINING MATERIALS LOCATION PLAN
 GROUND FLOOR AND ROOF PLAN

**Asbestos Containing Materials and Hazardous
Materials Inspection Report**

6
7
8
9

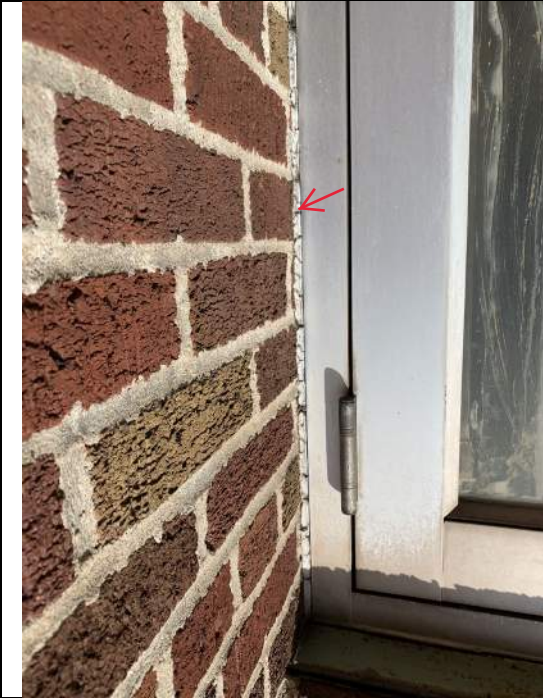
Caulk around Double doors, White – Asbestos Containing Material

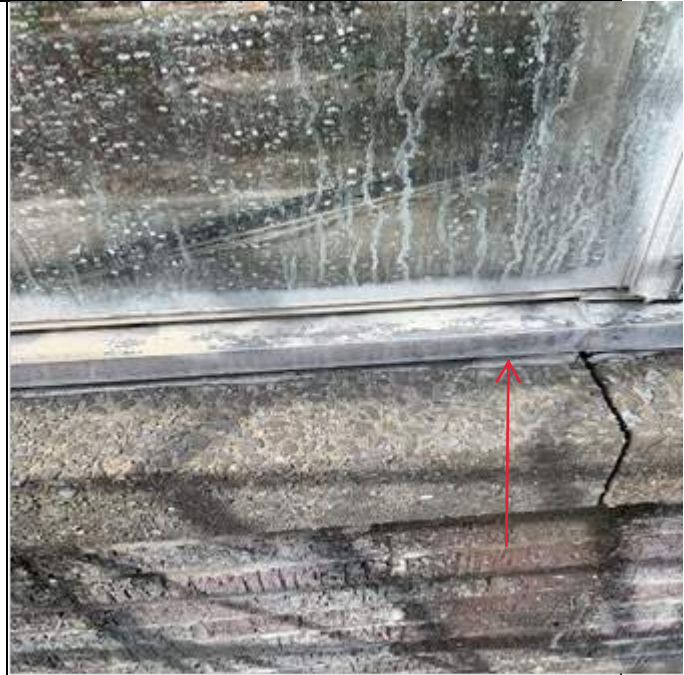
Caulk, Gray, Greenhouse 1 and 2, between Glass and Concrete –Asbestos Containing Material

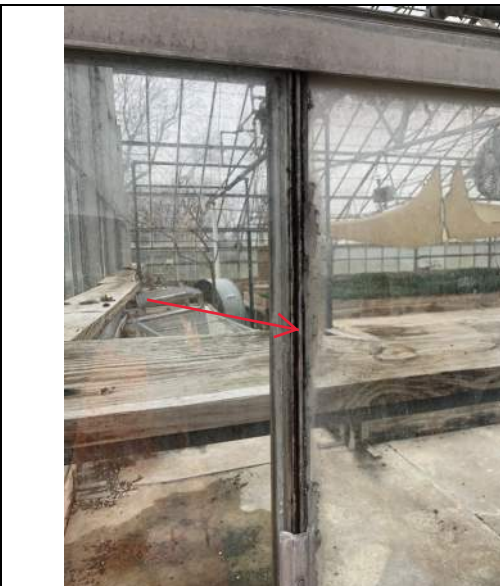
Caulking for Glass, Under Metal Trim - Asbestos Containing Material

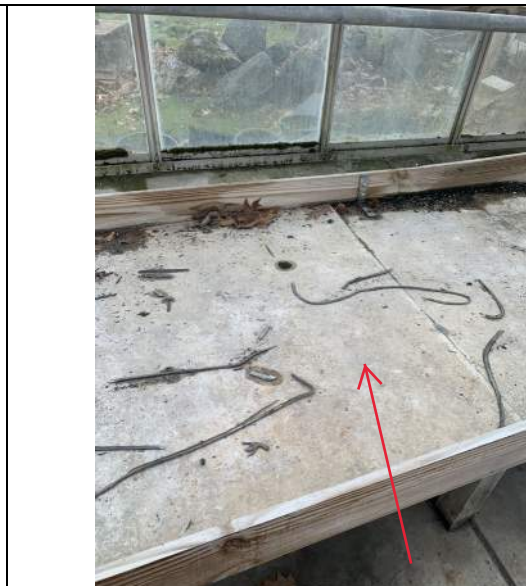
Tabletop Surface Slabs - Asbestos Containing Material

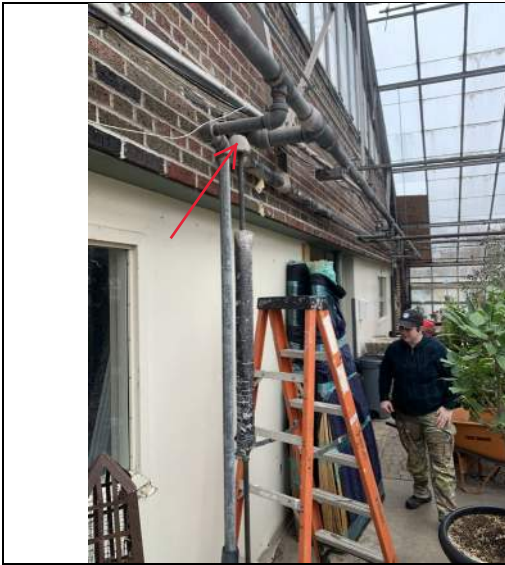
**Mudded Joint Fitting associated with 504 -
Asbestos Containing Material**

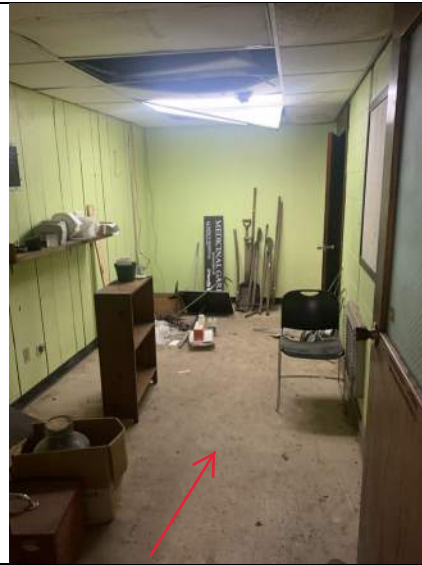
**12x12" Floor Tile, Gray –
Asbestos Containing Material**

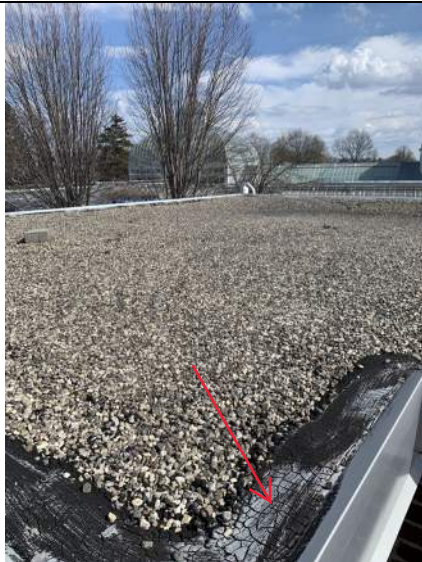
**Silver Seal, Silver - Asbestos Containing
Material**

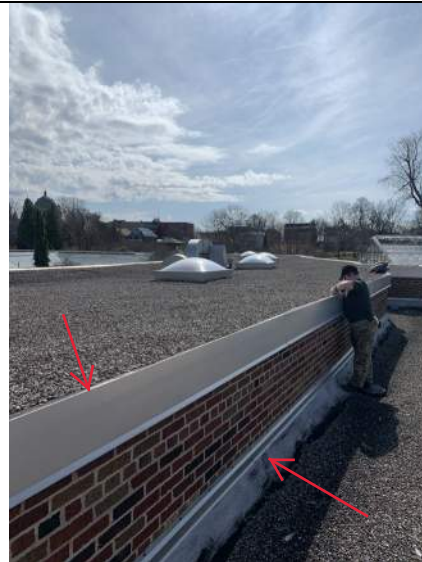
**Silver Seal, Silver - Asbestos Containing
Material**

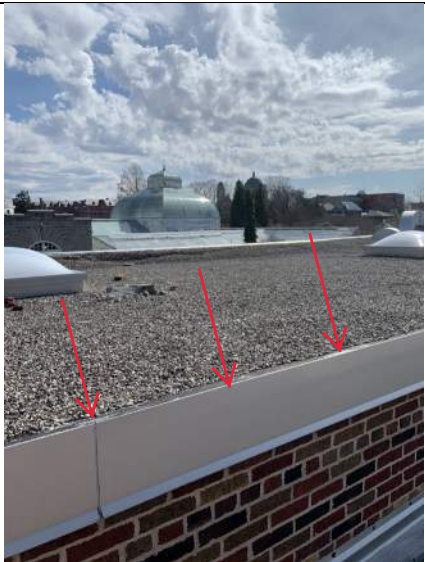
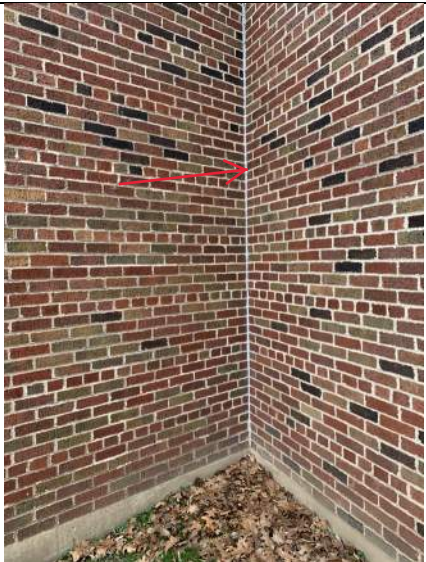
<p>Caulk, Parapet Wall, Black,- Asbestos Containing Material</p>	<p>Caulk, Expansion Joint Non-Asbestos Containing Material</p>

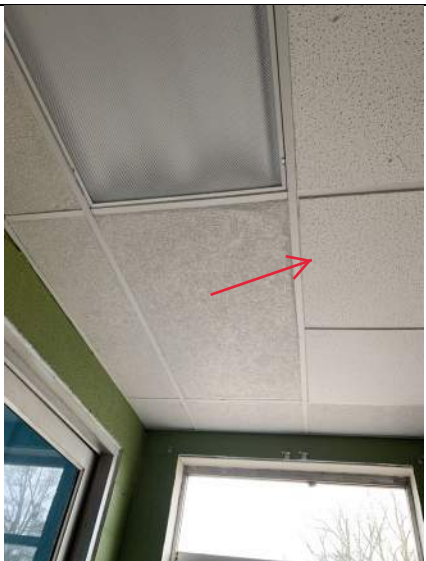
<p>Waterproof Membrane under ceramic floor tile, Assumed Asbestos Containing Material</p>	<p>2x4 Ceiling Tile, Non-Asbestos Containing Material</p>

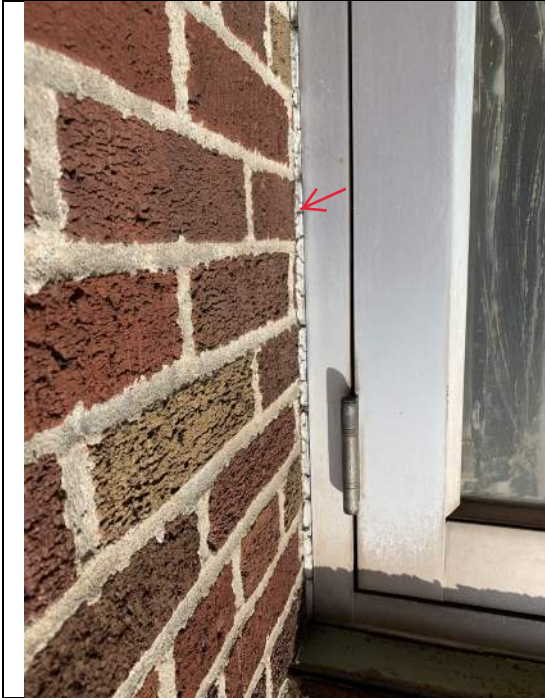
Caulk around Double doors, White – Asbestos Containing Material

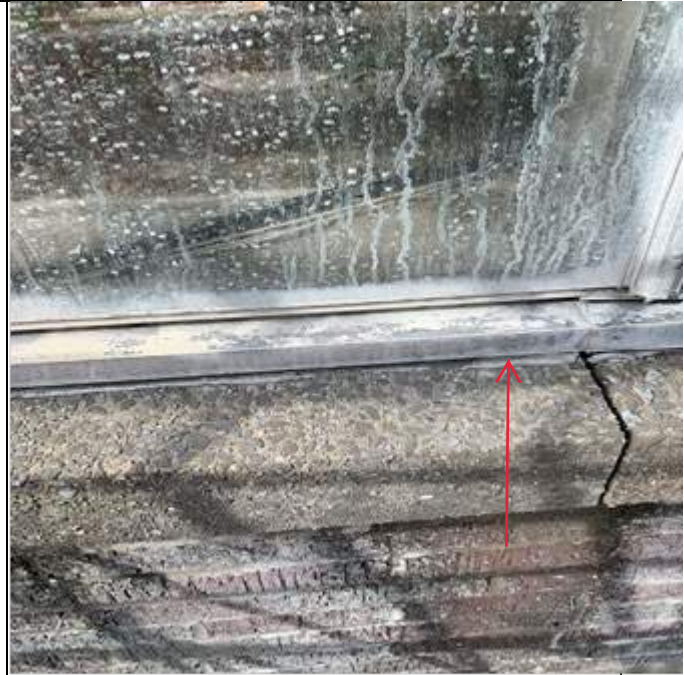
Caulk, Gray, Greenhouse 1 and 2, between Glass and Concrete –Asbestos Containing Material

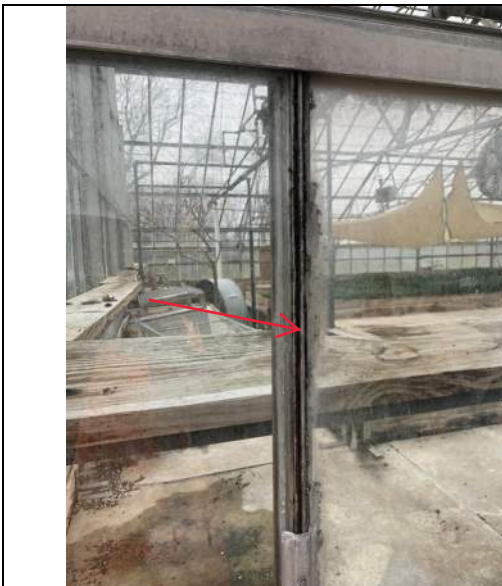
Caulking for Glass, Under Metal Trim - Asbestos Containing Material

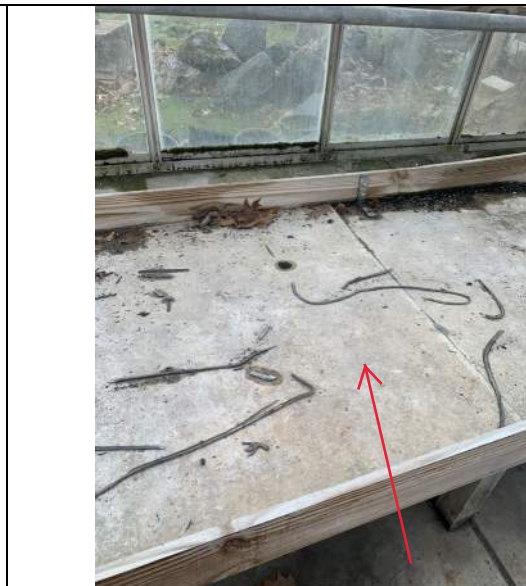
Tabletop Surface Slabs - Asbestos Containing Material

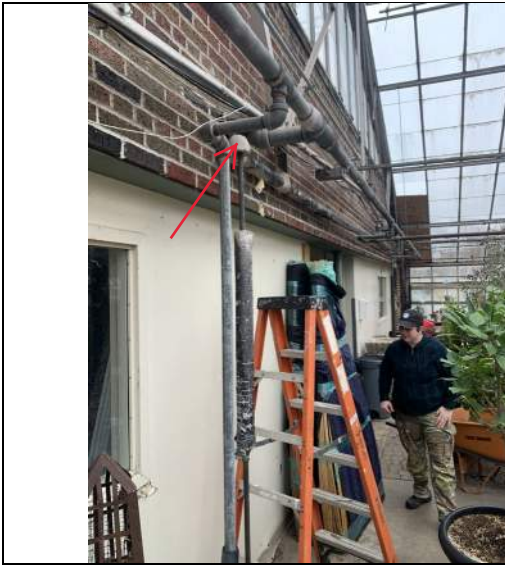
**Mudded Joint Fitting associated with 504 -
Asbestos Containing Material**

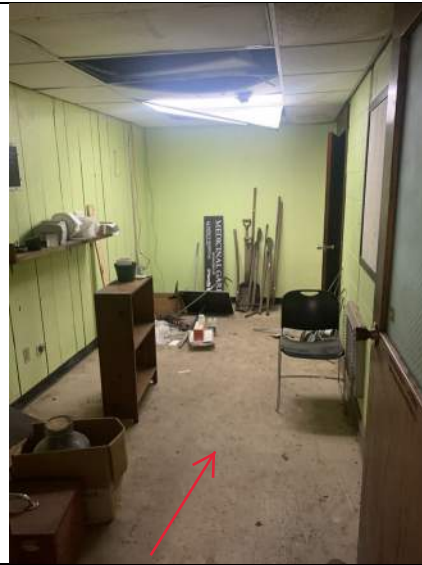
**12x12" Floor Tile, Gray –
Asbestos Containing Material**

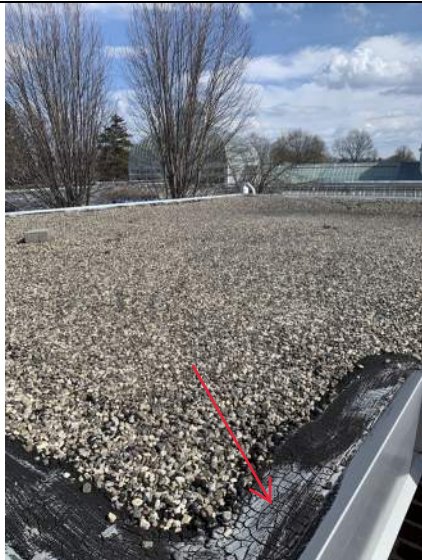
**Silver Seal, Silver - Asbestos Containing
Material**

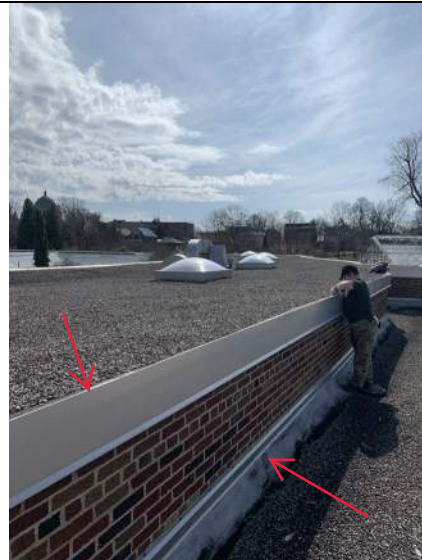
**Silver Seal, Silver - Asbestos Containing
Material**

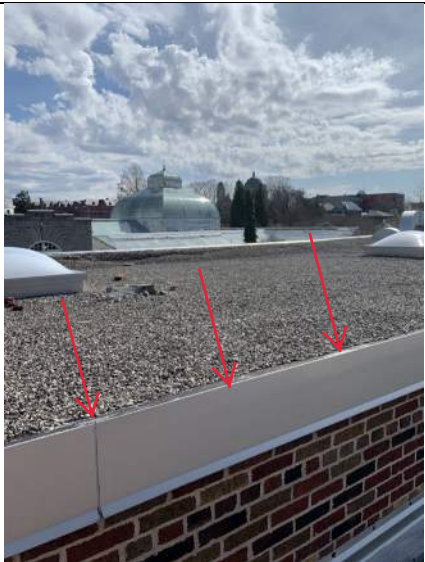
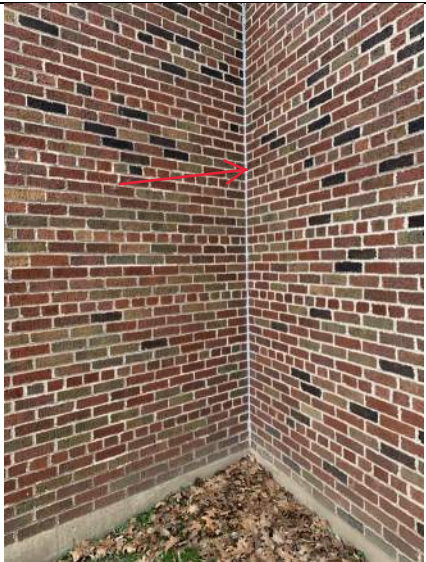
<p>Caulk, Parapet Wall, Black,- Asbestos Containing Material</p>	<p>Caulk, Expansion Joint Non-Asbestos Containing Material</p>

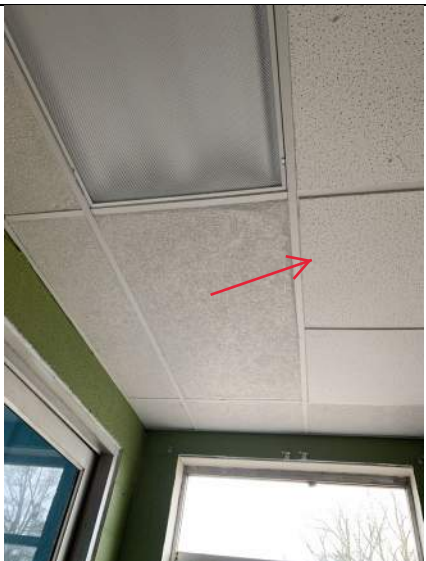
<p>Waterproof Membrane under ceramic floor tile, Assumed Asbestos Containing Material</p>	<p>2x4 Ceiling Tile, Non-Asbestos Containing Material</p>
