ADDENDUM NO. 001 05.16.2024

Project No. 429.11
Buffalo Convention Center Ballroom Renovations

Prepared for: Erie County

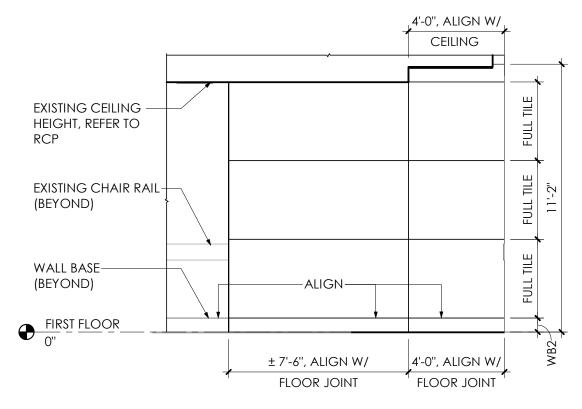
LFT2 INSTALLATION ELEVATION, TYP

ALTERNATE 4: LFT2 - PORCELAIN TILE, LARGE FORMAT MANUFACTURER: CROSSVILLE STYLE: PORCELAIN TILE PANEL COLOR: CALCE BIANCO SIZE: 1000 M X 3000 M X 3MM THICK (39.37 IN X 118.11 IN X .118 IN THICK) NOTE: LOCATIONS INCLUDE COLUMN ENCLOSURES AS NOTED, REFER TO FINISH PLAN FOR EXTENTS. WRAP ALL EXPOSED SURFACES AND ALIGN VERTICAL GROUT LINES WITH FLOOR

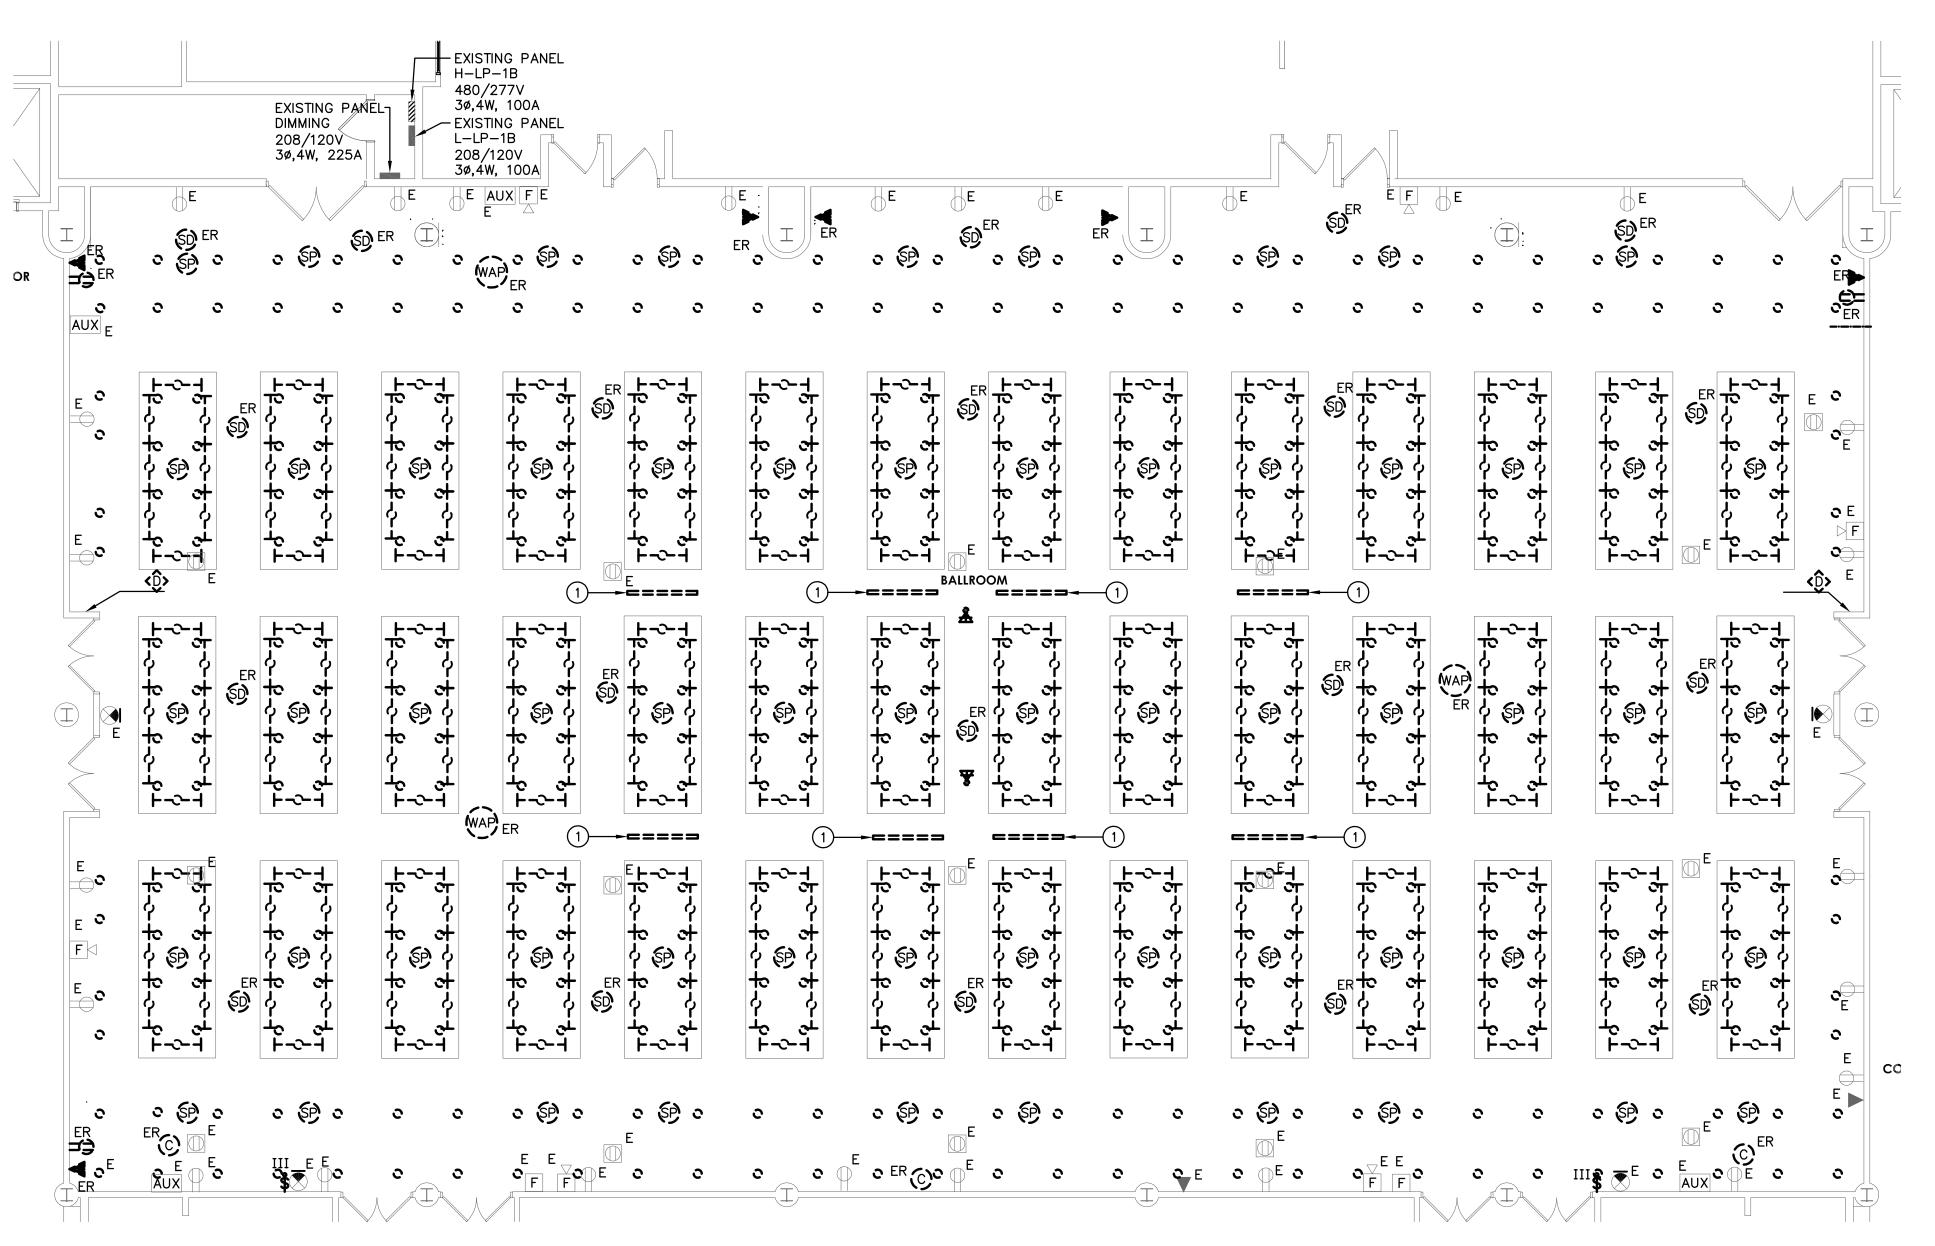
\ENLARGED BALLROOM ELECTRICAL DEMOLITION PLAN

- DISCONNECT AND REMOVE EXISTING SPEAKER. CONTRACTOR SHALL REMOVE EXISTING WIRING AND CONDUIT BACK TO SOURCE AS REQUIRED.
- CONTRACTOR SHALL DISCONNECT, REMOVE AND RELOCATE EXISTING SMOKE DETECTOR FOR CEILING REPLACEMENT. CONTRACTOR SHALL TEMPORARILY SUPPORT SMOKE DETECTOR DURING CEILING REPLACEMENT AND REINSTALL ONCE NEW CEILING WORK IS COMPLETE

- CONTRACTOR SHALL DISCONNECT & REMOVE EXISTING CAMERA AND STORE DURING CEILING REPLACEMENT. CONTRACTOR SHALL RE-INSTALL CAMERA IN EXISTING LOCATION AFTER CEILING REPLACEMENT HAS BEEN COMPLETE.

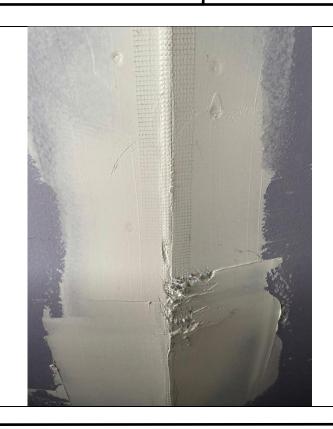
2nd Floor Front Storage Room

Drywall and joint compound tested negative for asbestos

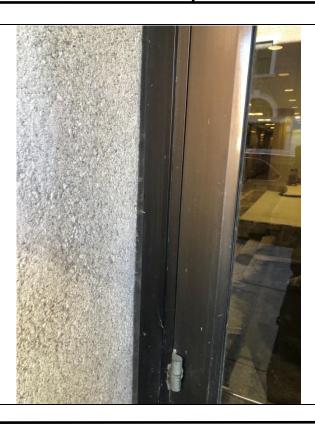
Front entrance

Vestibule entrance door casing tested negative for lead-based paint; black door caulk tested negative for asbestos

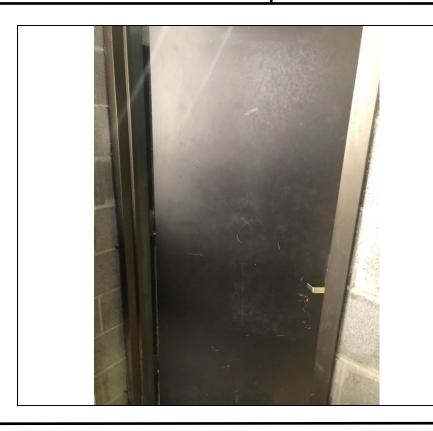
2nd Floor Front Storage Room

Door and casing tested negative for lead-based paint

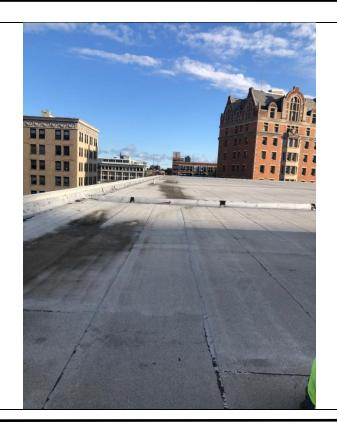
Roof

Roofing all tested negative for asbestos

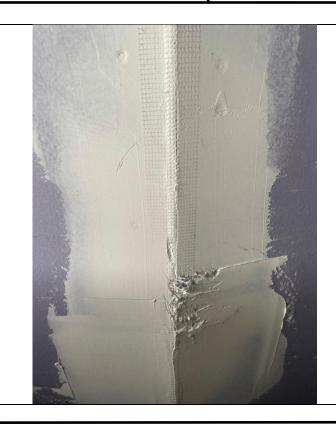
2nd Floor Front Storage Room

Drywall and joint compound tested negative for asbestos

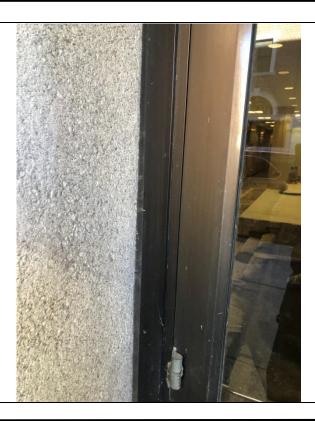
Front entrance

Vestibule entrance door casing tested negative for lead-based paint; black door caulk tested negative for asbestos

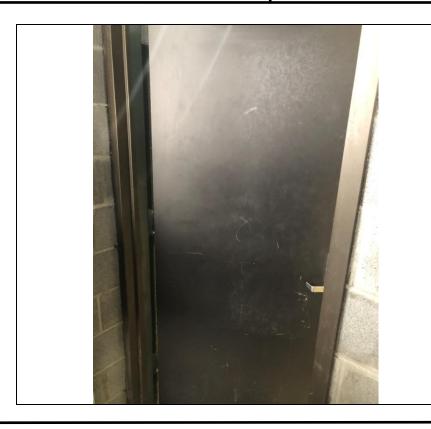
2nd Floor Front Storage Room

Door and casing tested negative for lead-based paint

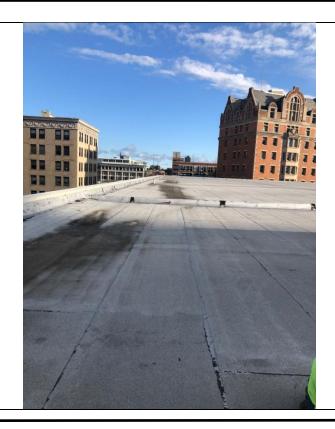
Roof

Roofing all tested negative for asbestos
