New Buffalo Bills Stadium Erie County, New York

Ecological Review

September 2022

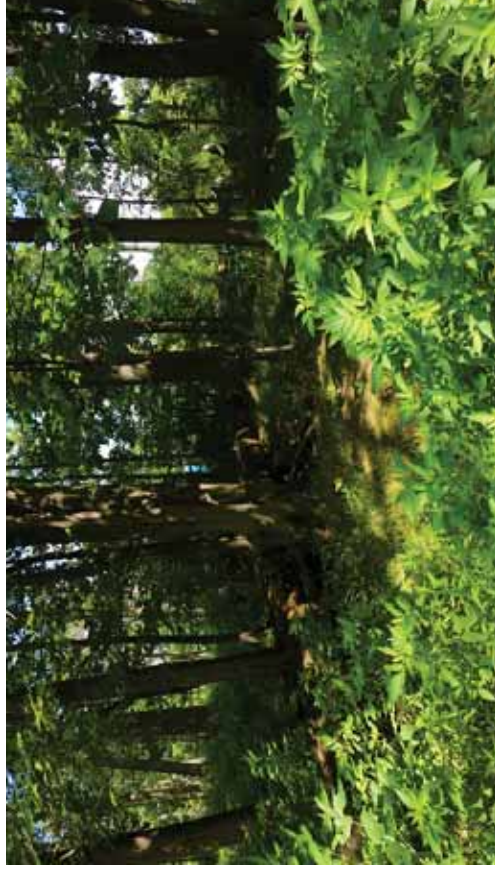
Photo 1

Datapoint 1, Wetland 1, facing north. Emergent marsh meets forested wetland.

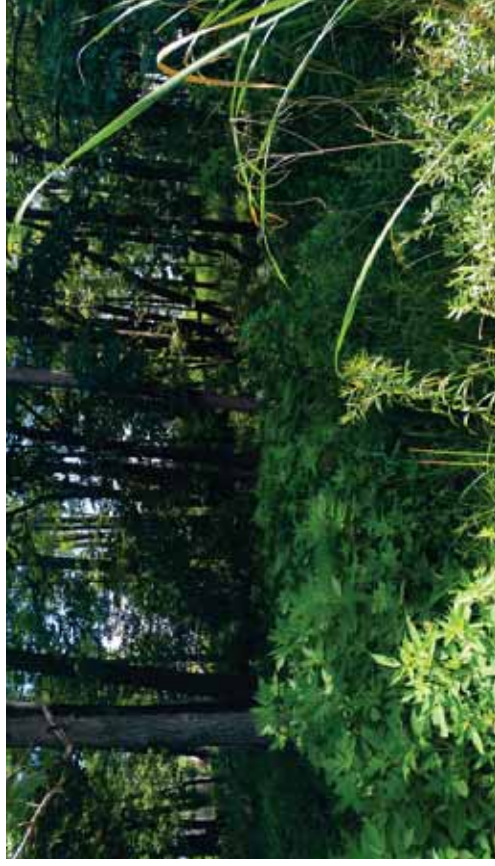
Photo 2

Datapoint 1, Wetland 1, facing east. Edge of emergent marsh and forested wetland.

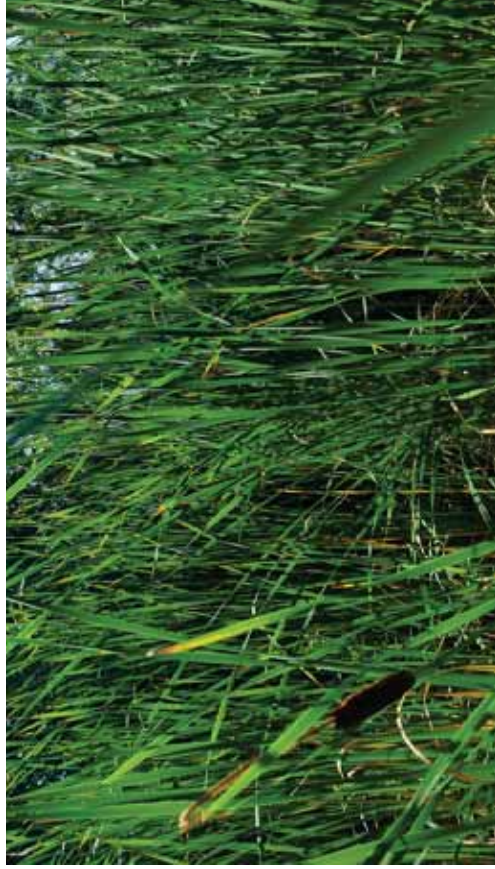
Photo 3

Datapoint 1, Wetland 1, facing south. Emergent marsh dominated by cattail and purple loosestrife.

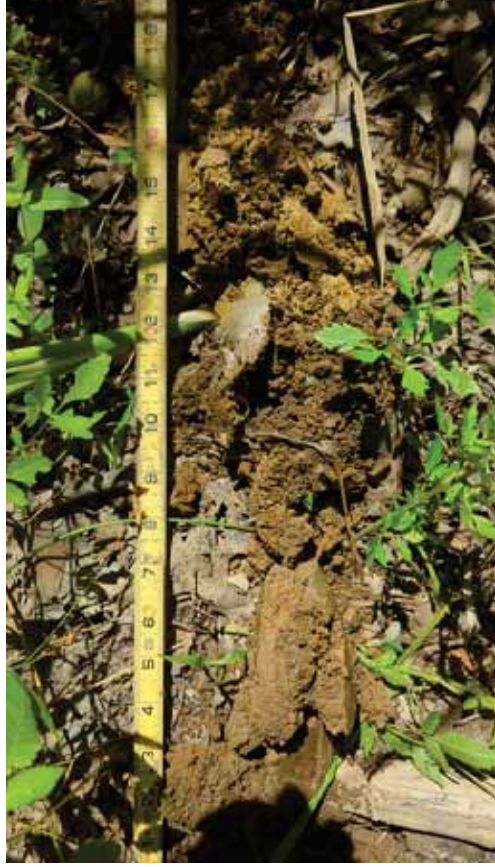
Photo 5

Datapoint 1, Wetland 1, soils. Note the abundant redox.

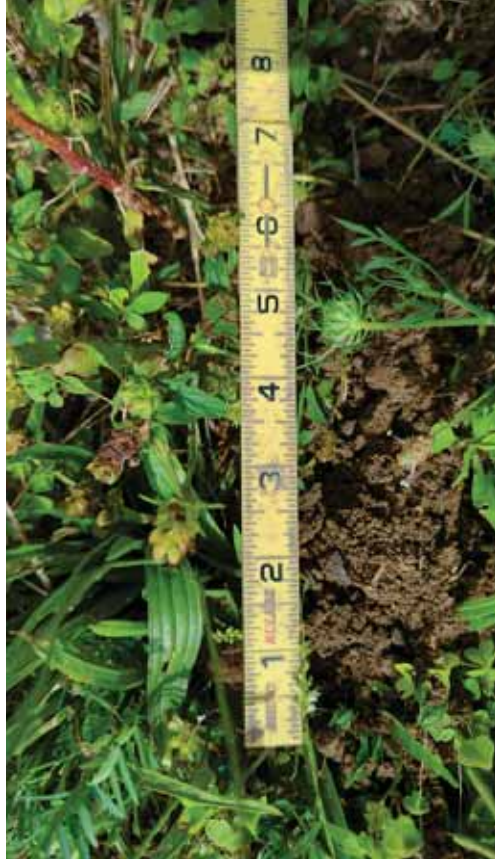
Photo 10

Datapoint 2, Upland, soils. Light colored, single shade with a dry and crumbly texture.

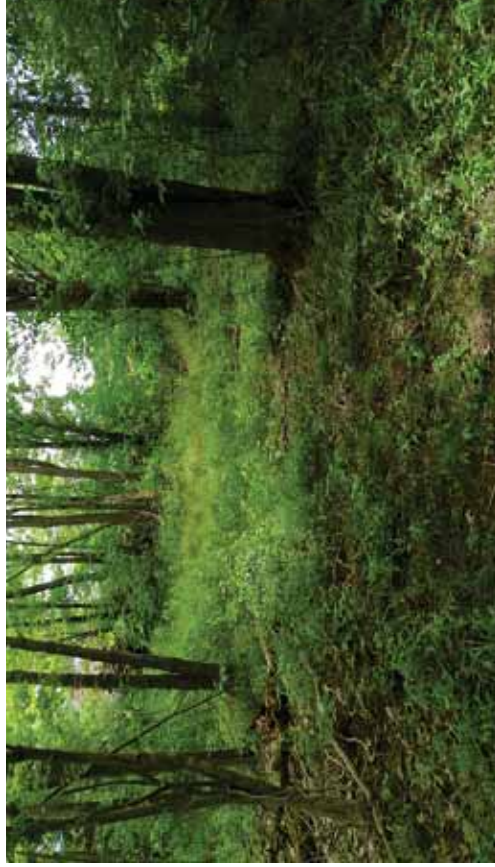
Photo 11

Waypoint 7, Wetland 1, facing northeast. Mix of FACW and FAC plants within the understory.

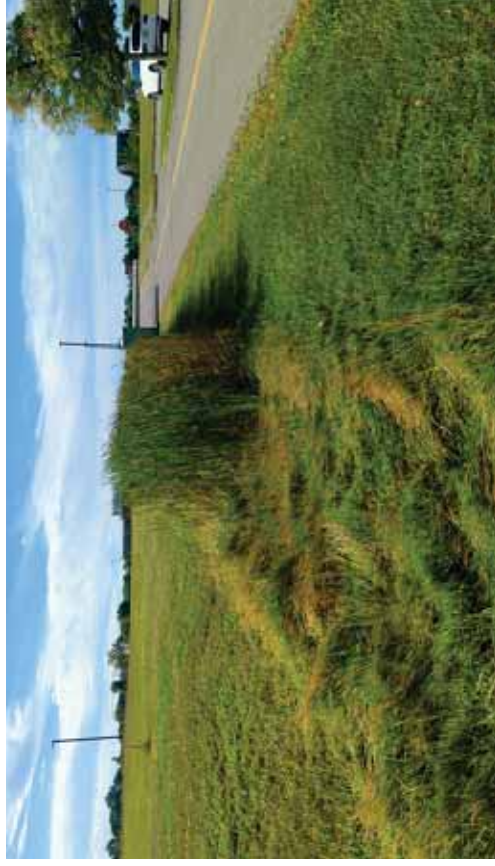
Photo 18

Waypoint 34, Drainage 1, facing southeast (upstream). Dense cattails are present surrounding the culvert pipe at Community Campus Drive.

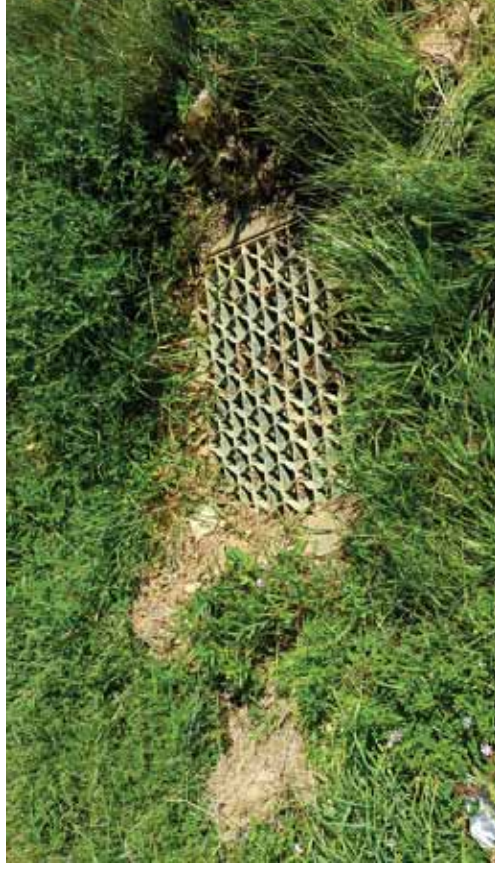
Photo 21

Waypoint 45, Drainage 1, facing northwest (downstream). Stormwater grate that collects water from Drainage 1.

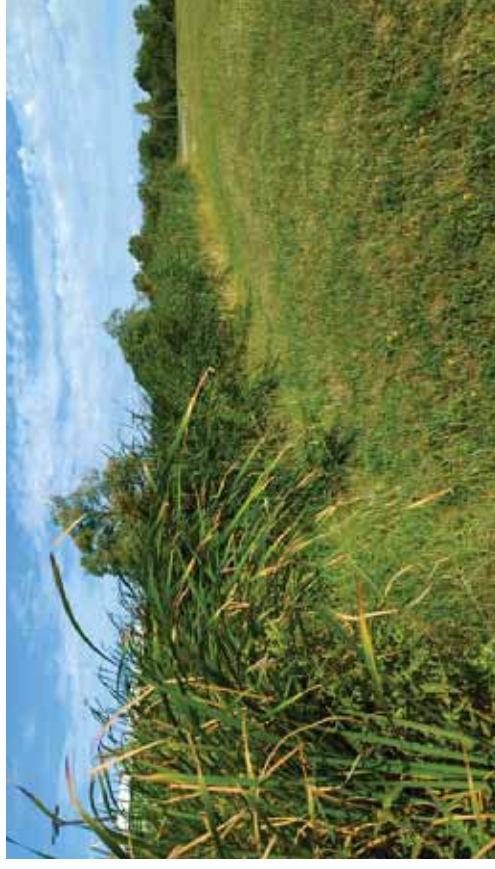
Photo 22

Waypoint 61, Drainage 1, facing northwest (downstream). Dense cattails are present surrounding the culvert pipe at Community Campus Drive.

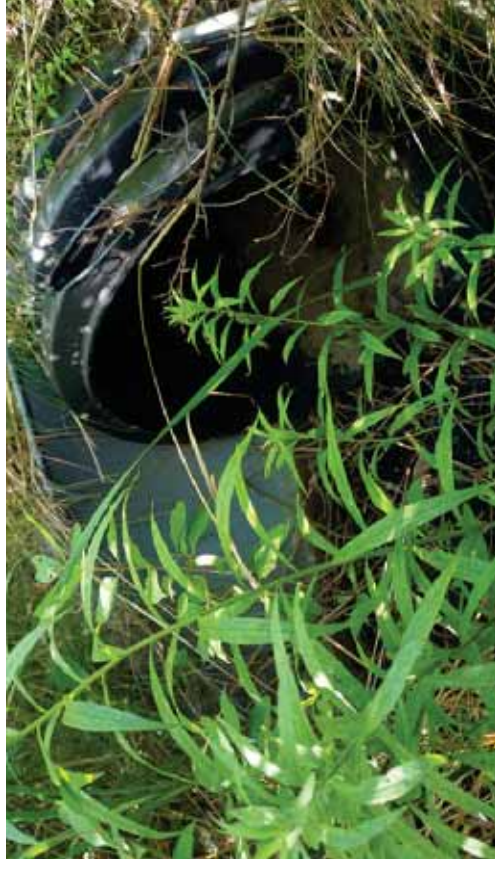
Photo 30

Waypoint 120, Drainage 2, facing south. Drainage flows into this culvert pipe toward Drainage 3.

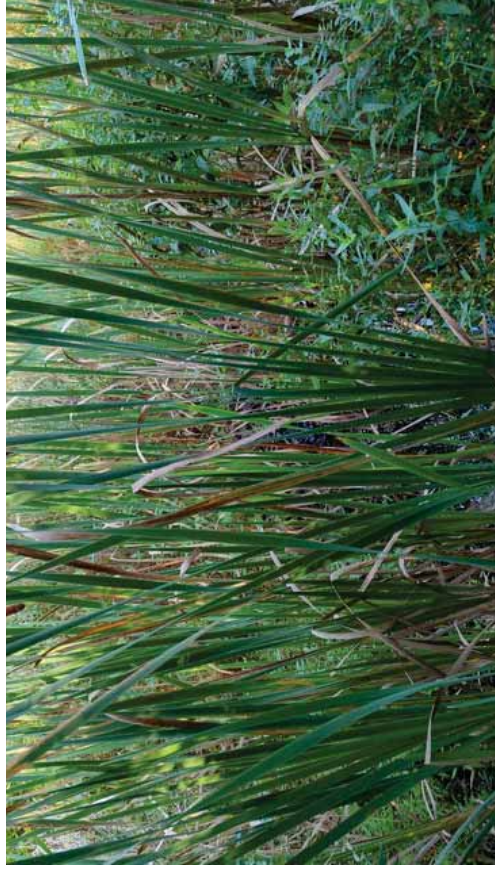
Photo 37

Waypoint 145, Wetland 2, facing northeast (upstream).
from culvert pipe. Narrow channel can be seen
containing water among the cattails.

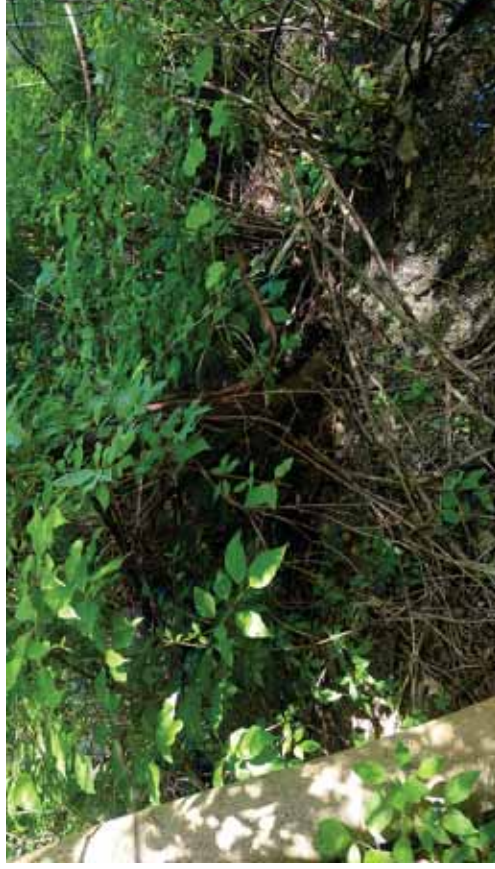
Photo 43

Waypoint 152, Drainage 3/Wetland 2, facing west (downstream). Significant rocky substrate in Drainage 3 just downstream of the Drainage 2 inlet.

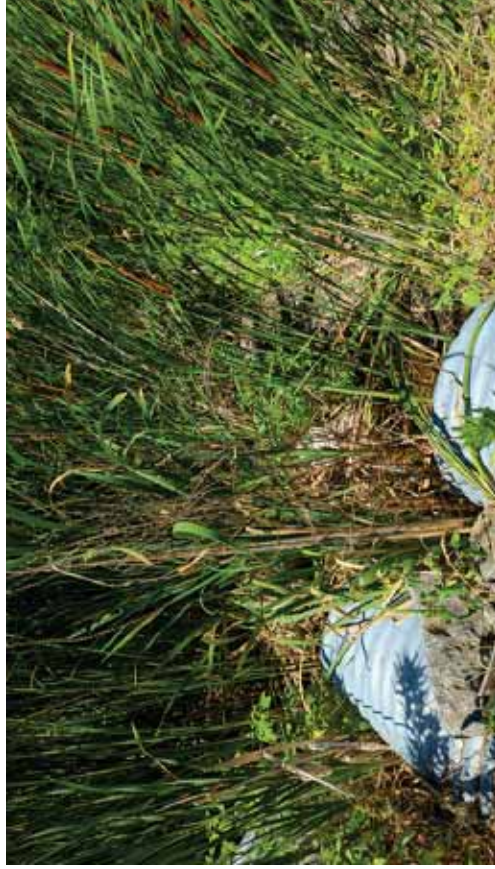
Photo 47

Waypoint 177, Stream 1, facing southwest
(downstream). Culverts outlet Stream from under Erie
College Drive.

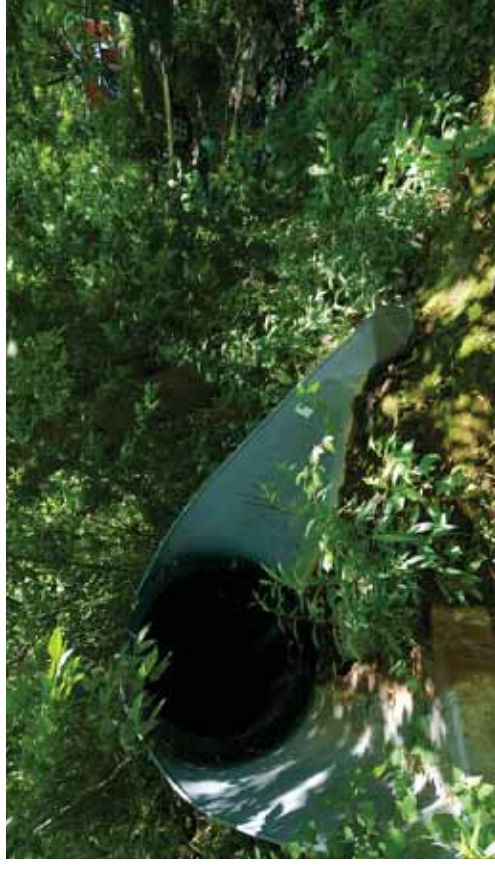
Photo 52

Waypoint 190, Stream 1, facing north. Outlet of Drainage 3 into Stream 1.

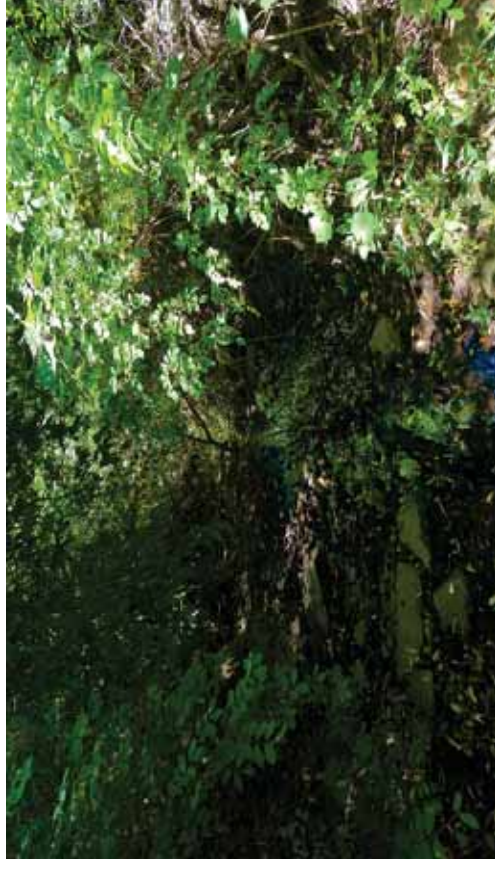
Photo 54

Waypoint 195, Stream 1, facing west (downstream).
Substrate is a mix of rock and muck.

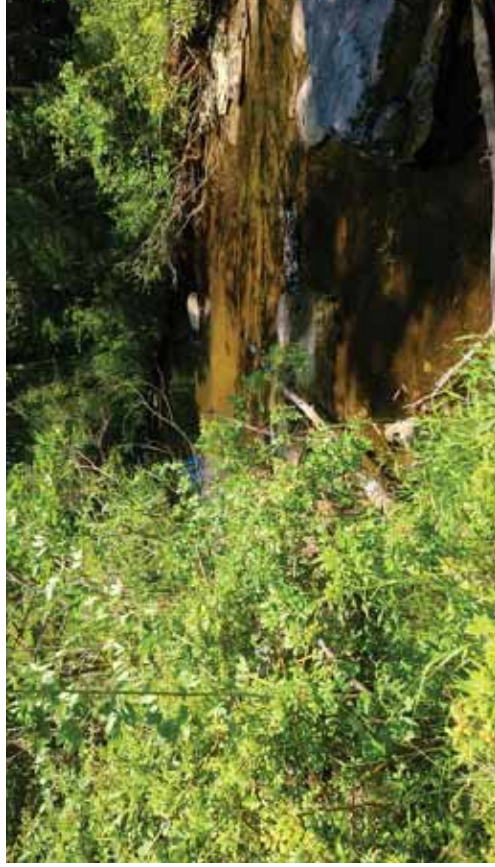
Photo 69

Waypoint 223, Stream 2, facing north (downstream).
Flow here includes water from stormwater outflow.

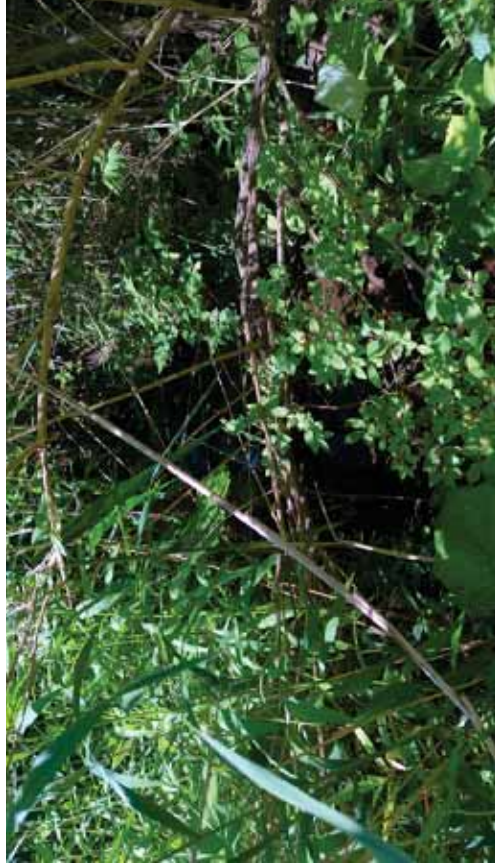
Photo 71

Waypoint 223, Stream 2, facing southwest. Looking
upstream at stormwater drainage.

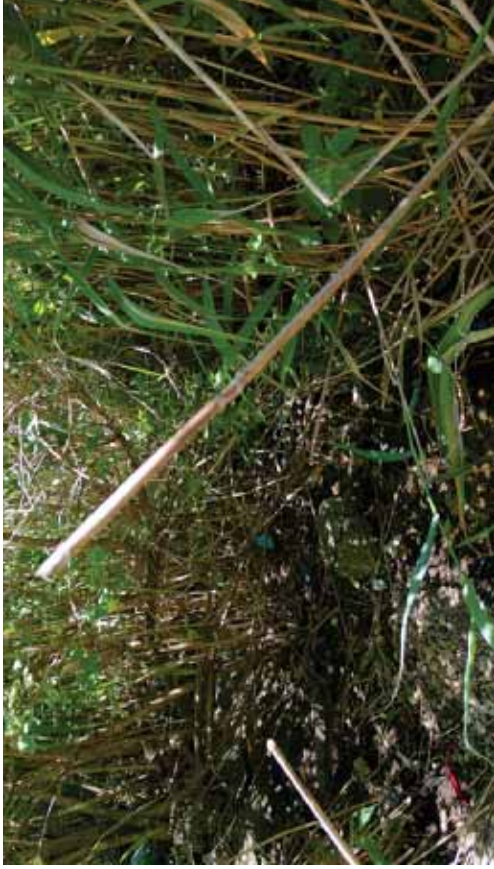
Photo 73

Waypoint 225, Stream 2, facing northeast. Stormwater drainage facing downstream toward Stream 2.
