BUFFALO & ERIE COUNTY BOTANICAL GARDENS
 GROW HOUSE

ASBESTOS CONTAINING MATERIALS LOCATION PLAN
 GROUND FLOOR AND ROOF PLAN

**Asbestos Containing Materials and Hazardous
Materials Inspection Report**

6
7
8
9

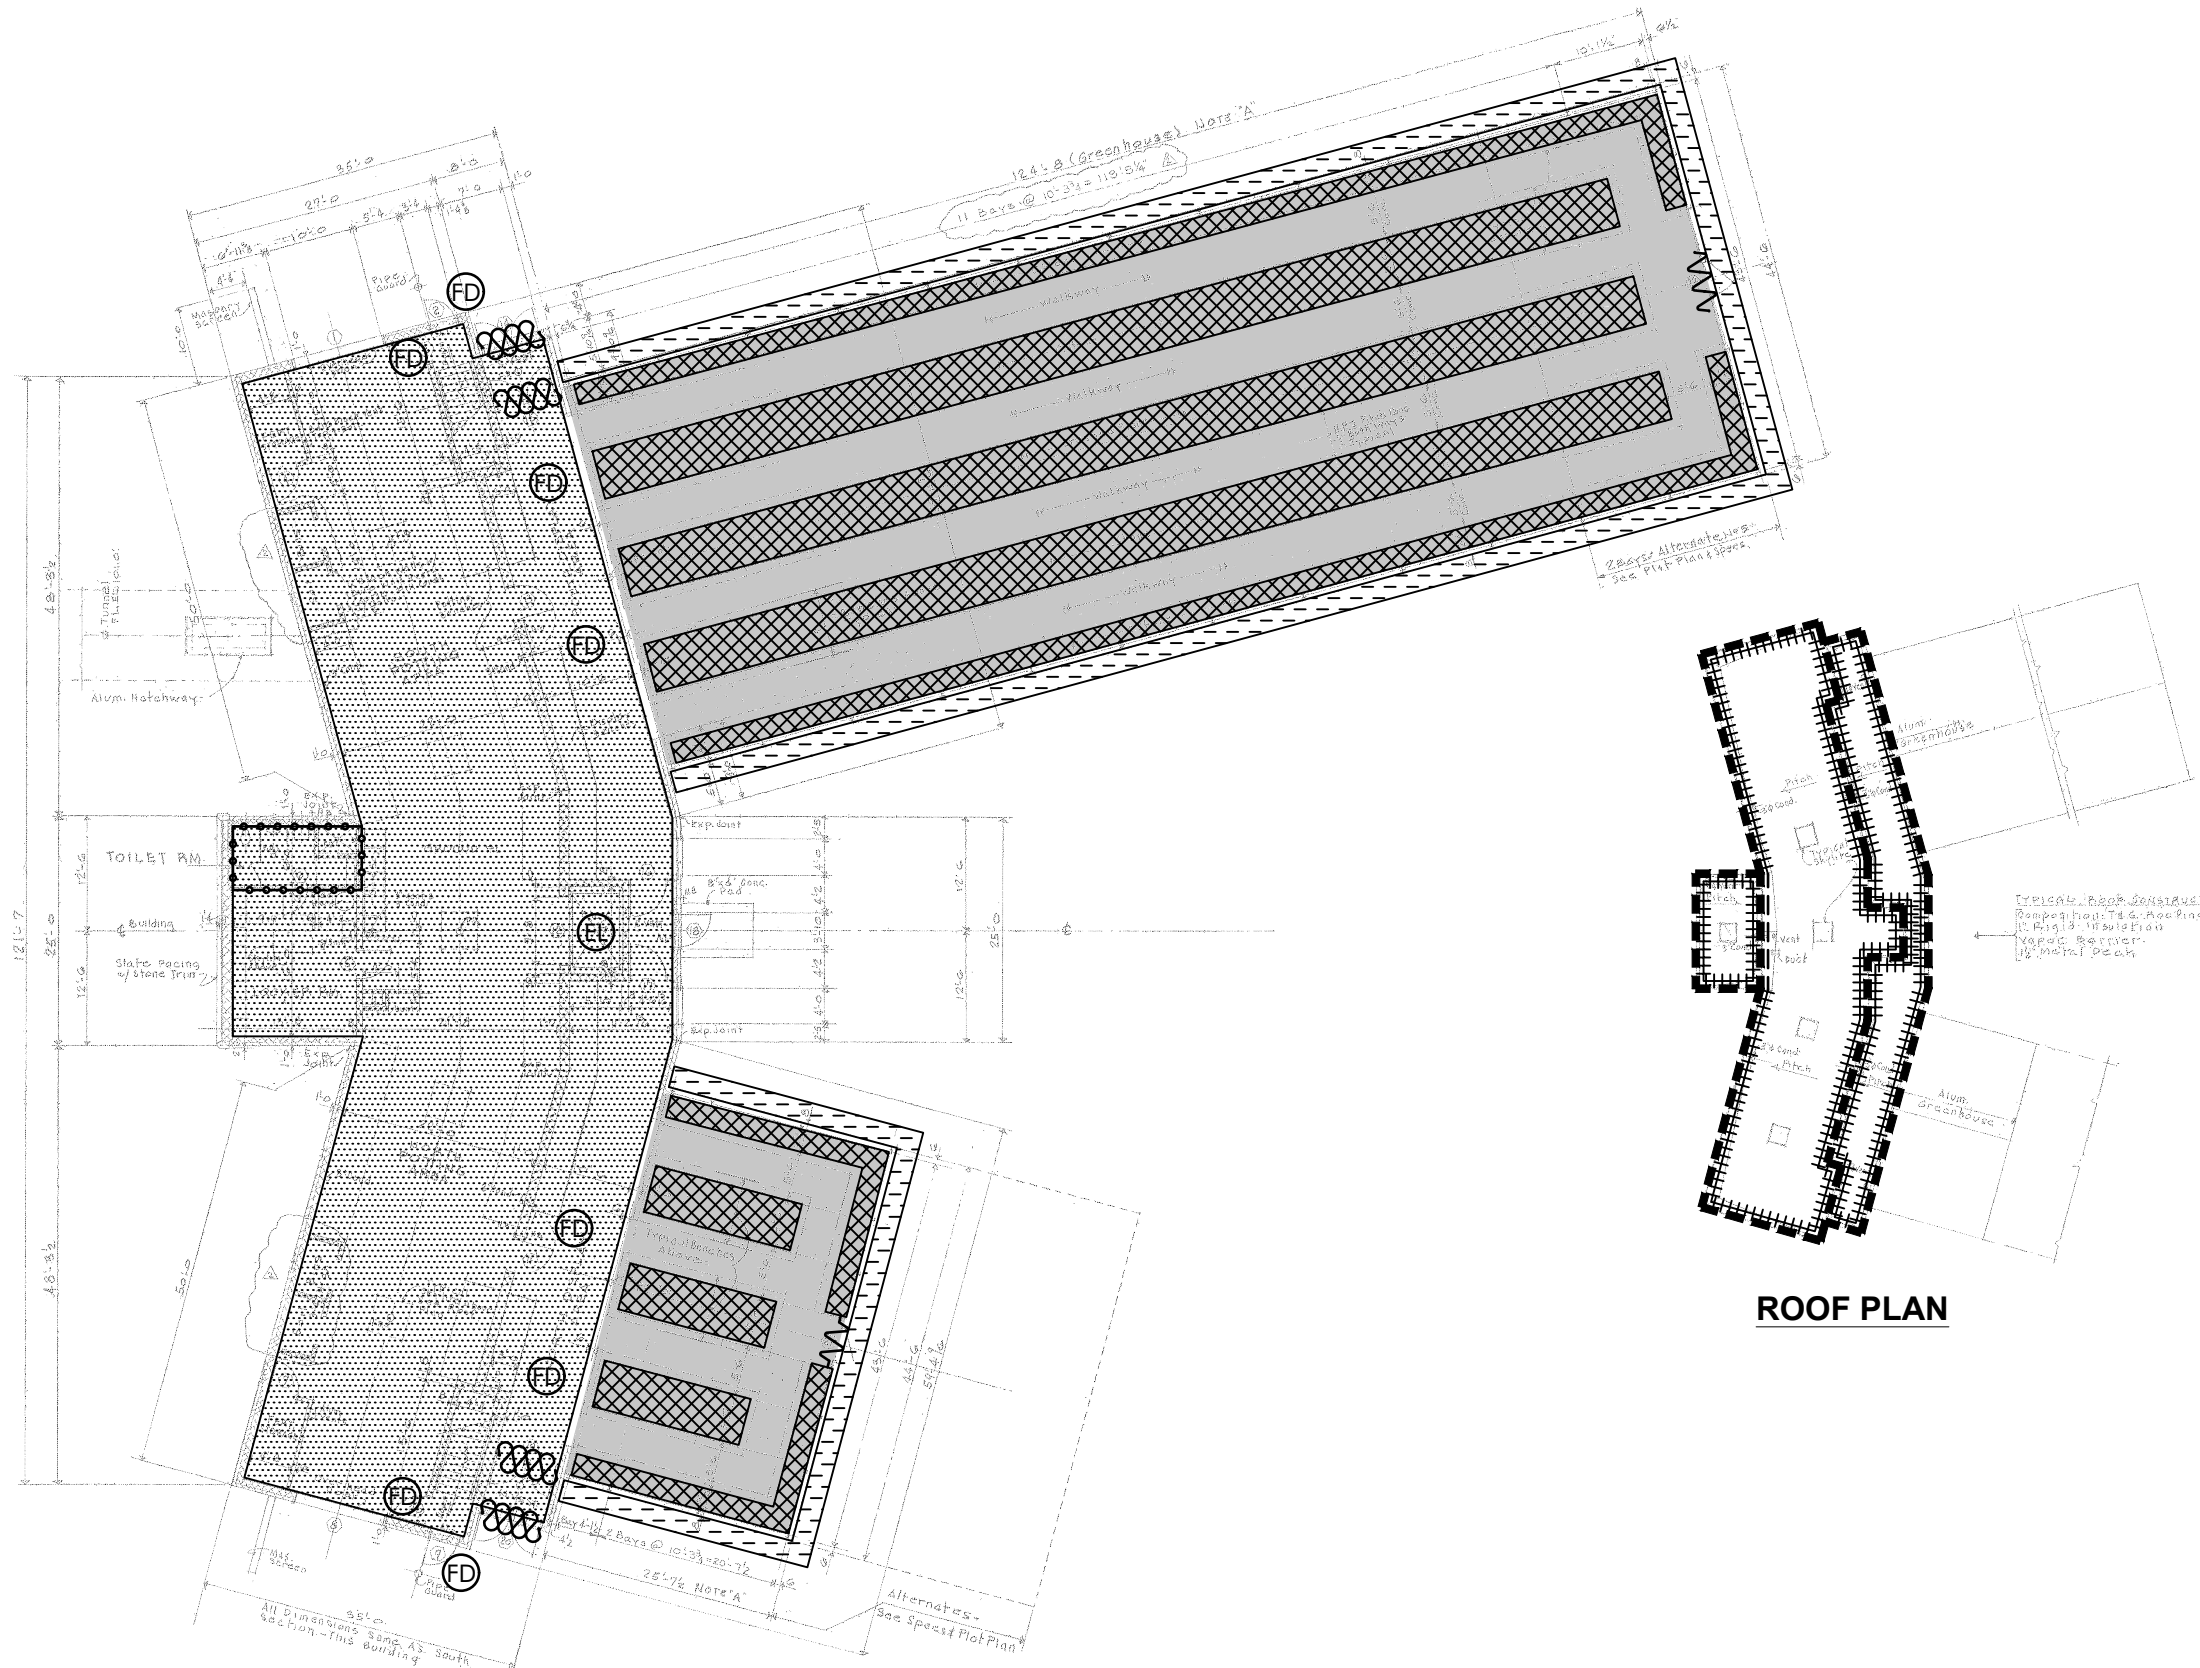
ACM-1

- CAULK, GRAY, DOUBLE DOORS (10 SF)
- CAULK, GRAY, BETWEEN GLASS AND CONCRETE (5 SF)
- CAULK, GRAY, AROUND MAN DOOR (3 SF)
- CAULK, GRAY, AROUND GLASS, UNDER METAL TRIM AND ASSOCIATED GLAZING (150 SF)
- TABLE TOP SURFACES (3,500 SF)
- MUD ELBOWS, JOINTS, AND HANGER FITTINGS (100 SF)
- SILVER SEAL AT ROOF FLASHING, SILVER (670 SF)
- CAULK, BLACK, PARAPET WALL PERIMETER (10 SF)
- FIRE DOOR (ASSUMED) (10 EACH)
- ELEVATOR BRAKES (ASSUMED) (1 PAIR)
- WATERPROOFING MEMBRANE (ASSUMED) (120 SF)

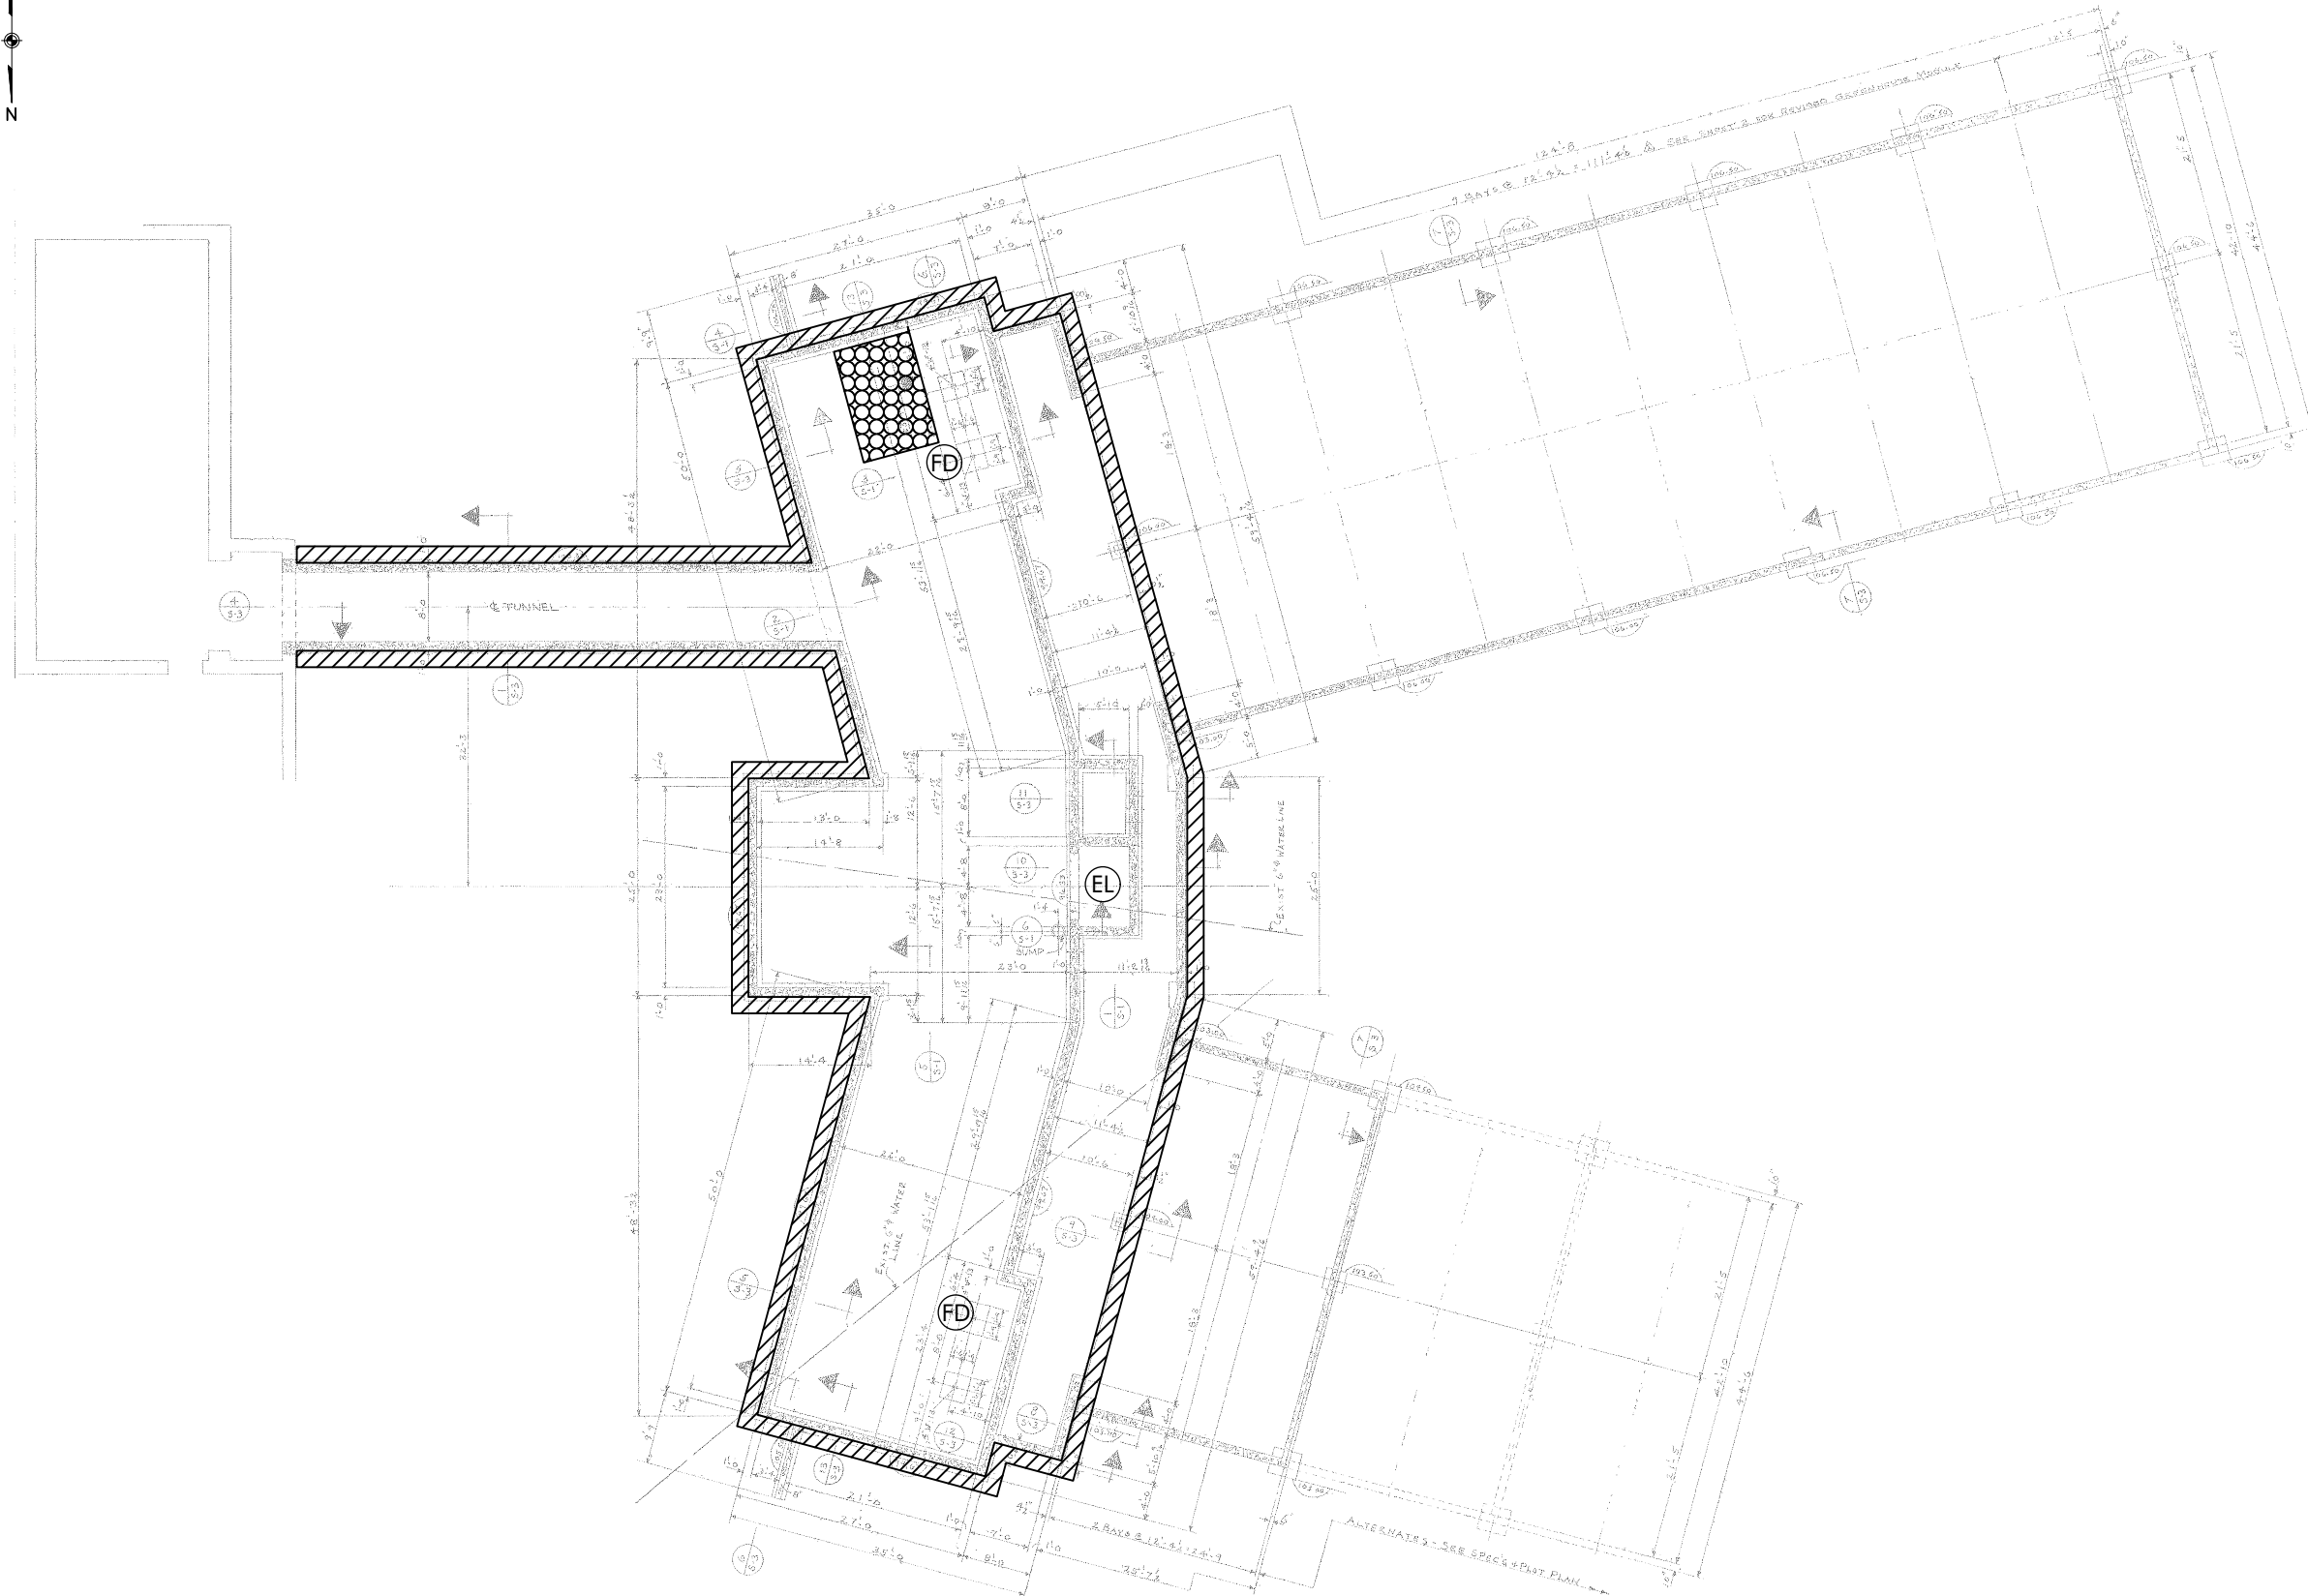
JOB TITLE AND LOCATION:	LIRO JOB NO.:
BUFFALO & ERIE COUNTY BOTANICAL GARDENS GROW HOUSE	22-095-0127
DRAWING TITLE:	SHEET OF
ASBESTOS CONTAINING MATERIALS LOCATION PLAN FOUNDATION PLAN	2 OF 2
	DRAWING NO.
	ACM-2

- MOISTURE BARRIER TAR ON FOUNDATION, BLACK (3,700 SF)
- FIRE DOOR (ASSUMED) (10 EACH)
- 12x12 FLOOR TILE, GRAY (100 SF)
- ELEVATOR BRAKES (ASSUMED) (1 PAIR)
