ADDENDUM No. 4
January 30, 2025

SUNY ECC NORTH CAMPUS KITTINGER HALL
CLASSROOM INFRASTRUCTURE PHASE 1 IMPROVEMENTS

Ashley McGraw Architects, D.P.C.
125 East Jefferson Street
Syracuse, New York 13202
Phone: (315) 425-1814

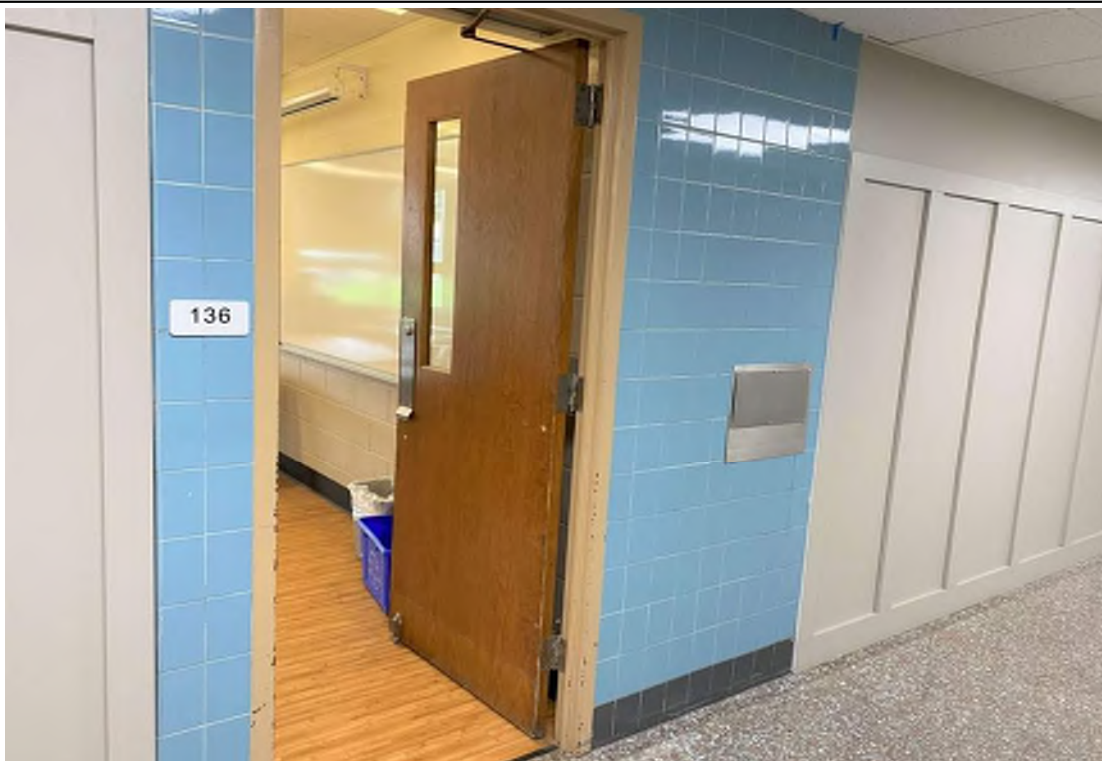
Photo #1 - View of the first floor corridor at Classroom 136. The thin set mastic associated with the blue ceramic wall tiles on the corridor walls has been determined to be an asbestos-containing material. Non-ACM terrazzo flooring is present in the corridors.
 Photo Date: 08/17/2023 Corridor and classroom suspended ceiling tiles have been determined to be non-ACM.

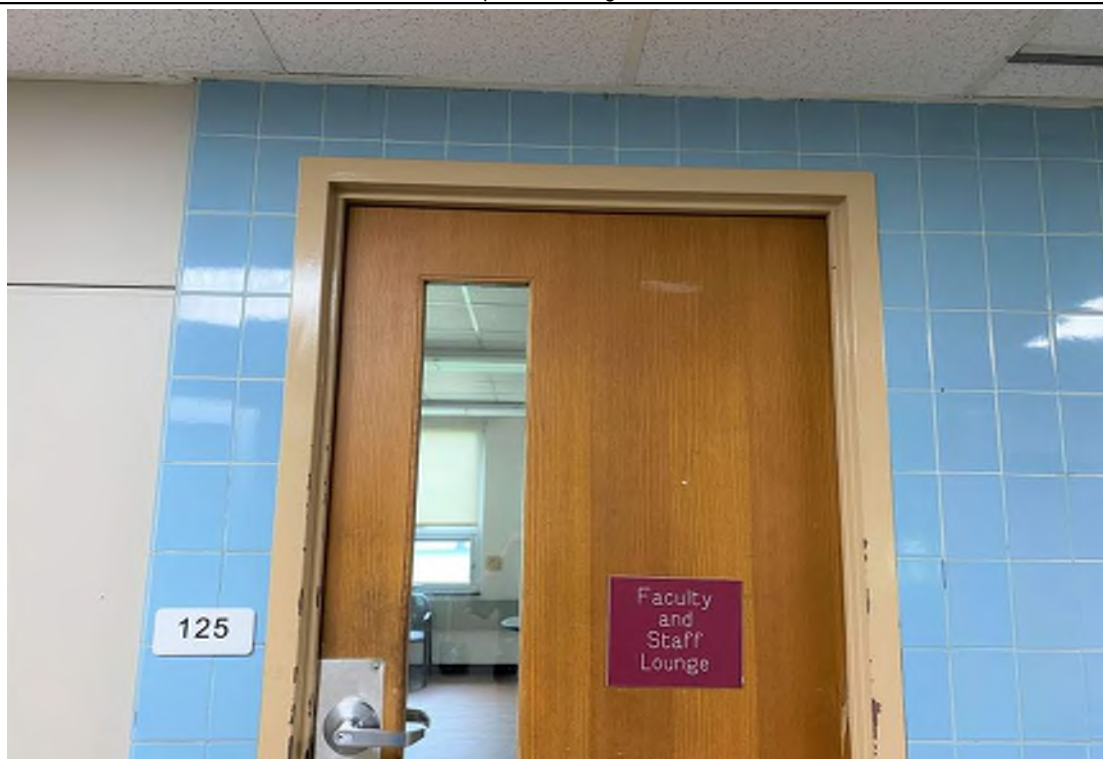
Photo #2 - View of the corridor wall and door to Room 125. The window glazing compound for the inset windows for the wood doors to classrooms and offices has been determined to be an asbestos-containing material.
 Photo Date: 08/17/2023

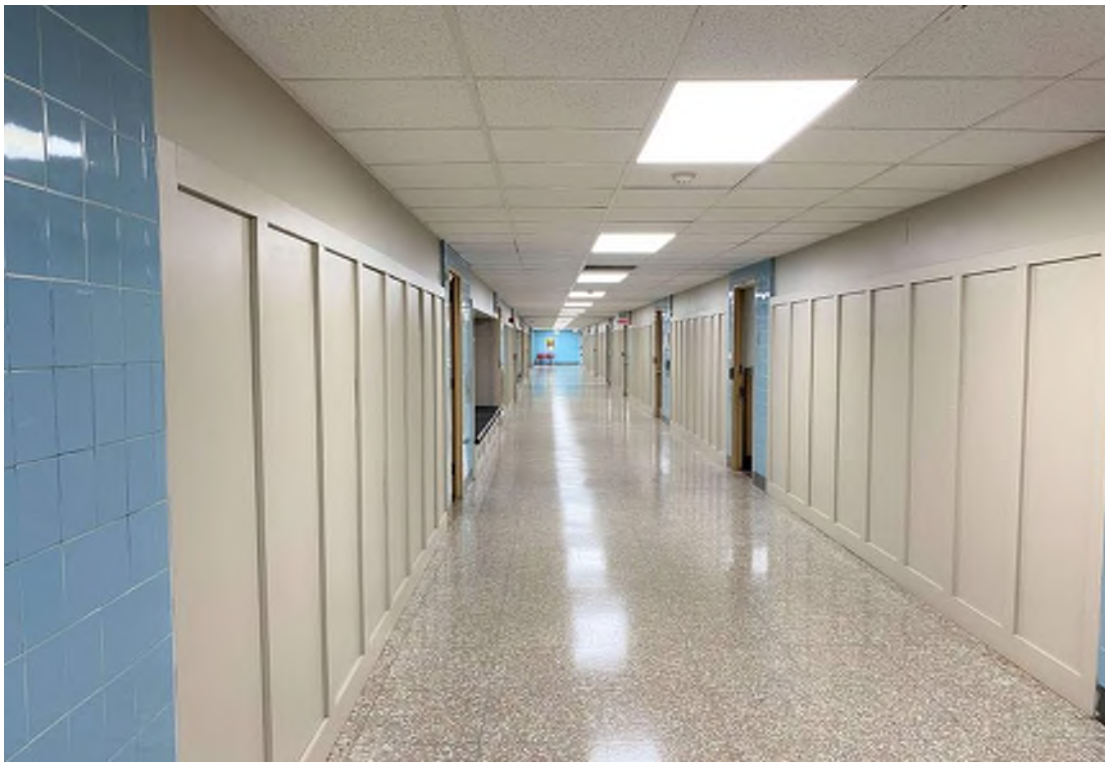
Photo #3 - View of plywood paneling and the corridor upper plaster walls on the second floor where lockers have been removed. Wall plaster in the building has been determined to be non-ACM. Blue ceramic wall tiles abutting doorways to classrooms has been determined to be an asbestos-containing material. Metal ash urns are set in blue ceramic wall tiles.
 Photo Date: 08/17/2023

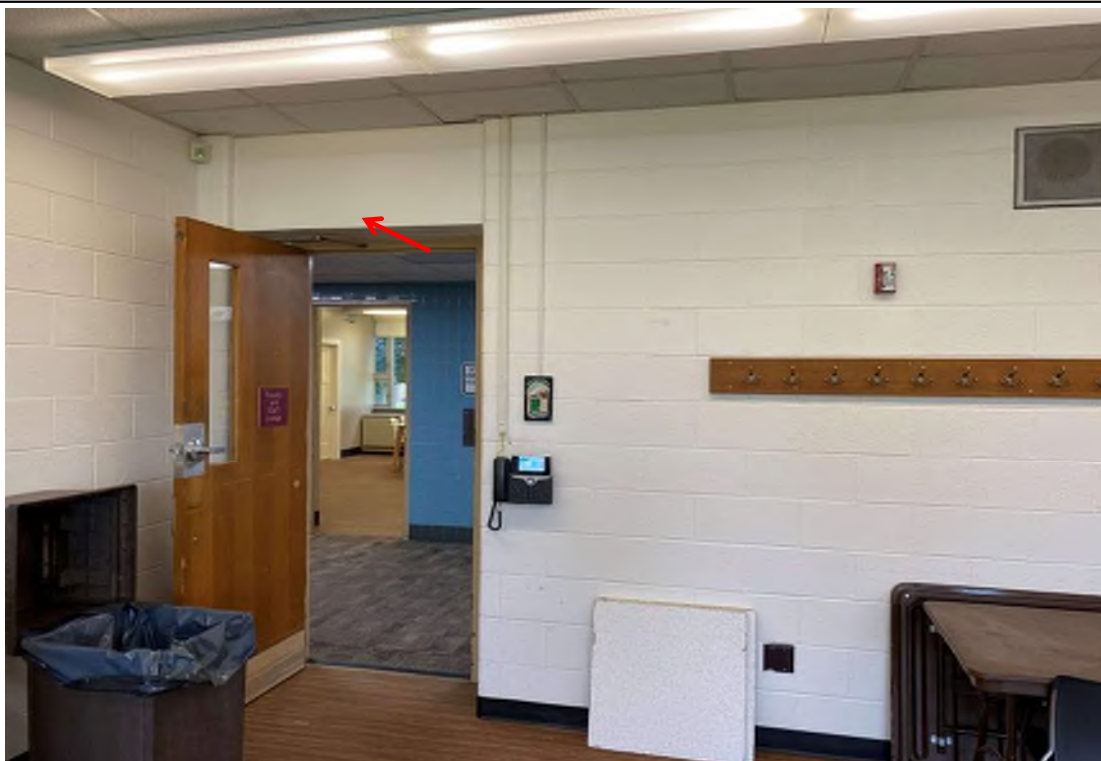
Photo #5 - View in Office 125 facing the corridor. The Paint on concrete masonry block walls was determined to be non-lead based paint. No caulk or sealant was observed along the steel door frames. Window glazing compound for the inset windows in the wood doors was determined to be an asbestos-containing material. Plaster above the door was determined to be non-ACM (arrow).
 Photo Date: 08/17/2023

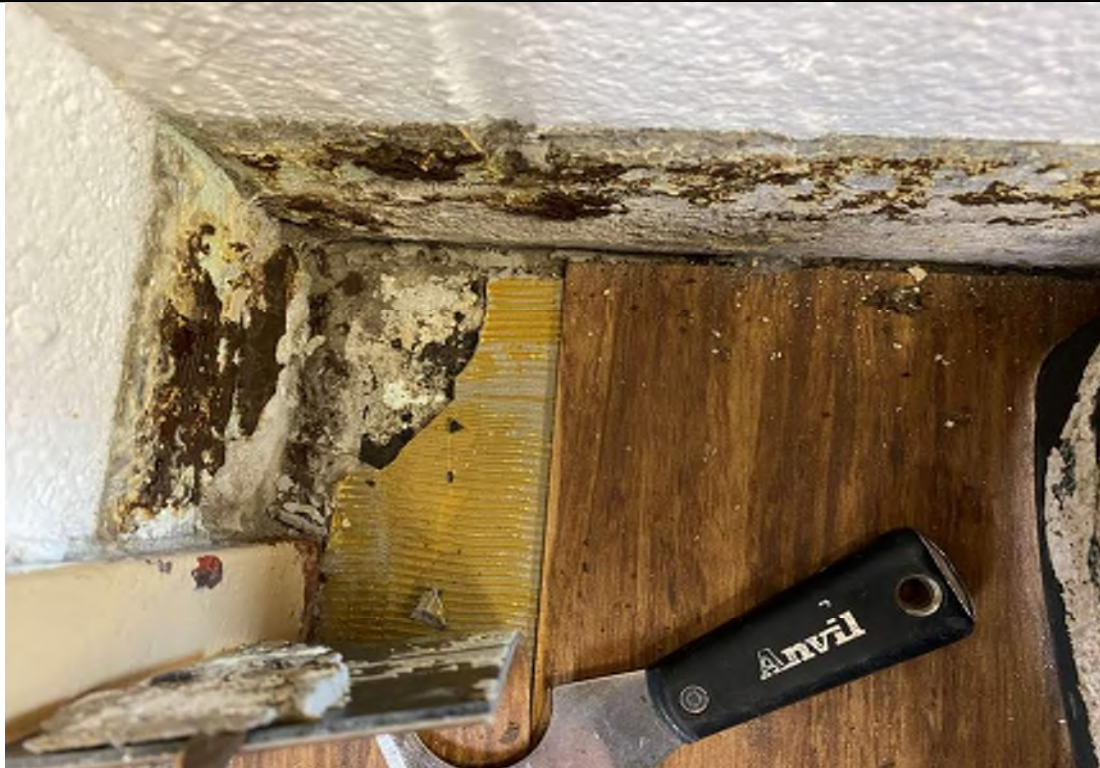
Photo #6 - View of non-ACM wood laminate-style sheet flooring on top of 9" asbestos-containing floor tiles in Room 125 by the door.
 Photo Date: 08/17/2023 All classrooms and offices in project limits have Asbestos-containing floor tiles beneath sheet flooring.

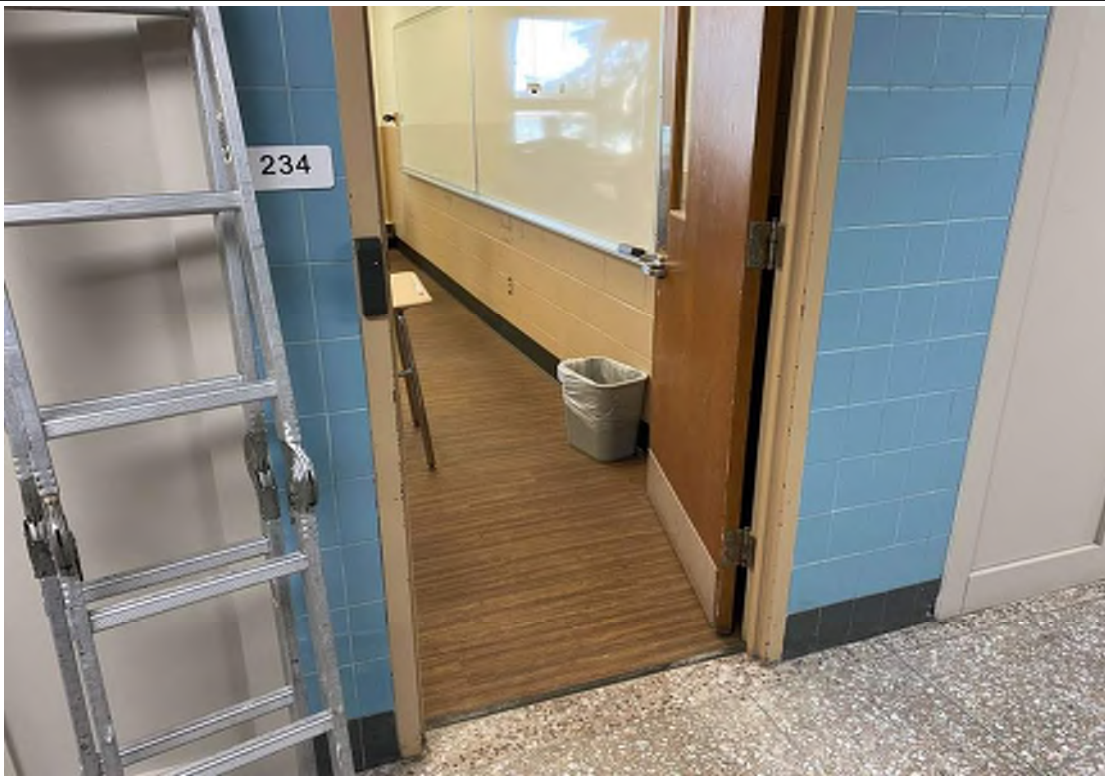
Photo #7 - View of the non-ACM sheet flooring on top of gray 9" asbestos-containing floor tiles in Classroom 234.
 Photo Date: 08/17/2023 Trace asbestos less than 1% was detected in the mastic behind vinyl cove base.

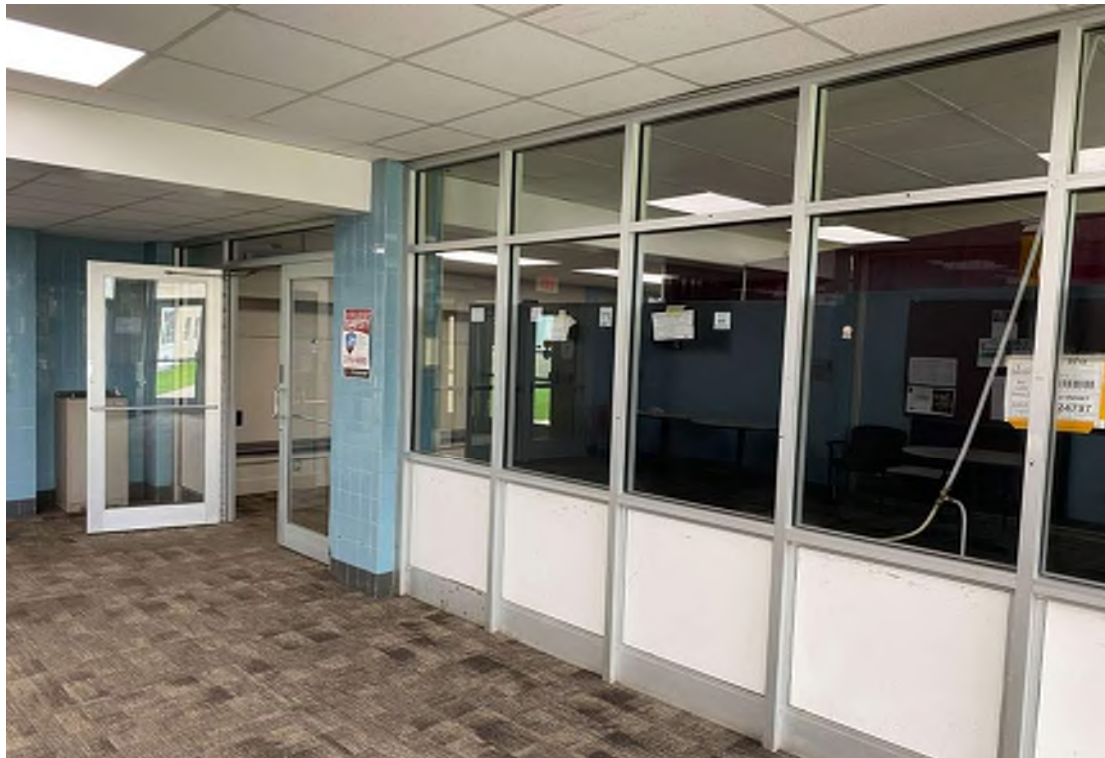
Photo #8 - View of the windows in Lobby 168 abutting Student Lounge 123 in the center area of the first floor corridor. The window frame caulk was determined to be non-ACM and non-PCB containing. Window glazing compound was determined to be non-ACM. Carpet adhesive on terrazzo and ceiling tiles were determined to be non-ACM.
 Photo Date: 08/17/2023

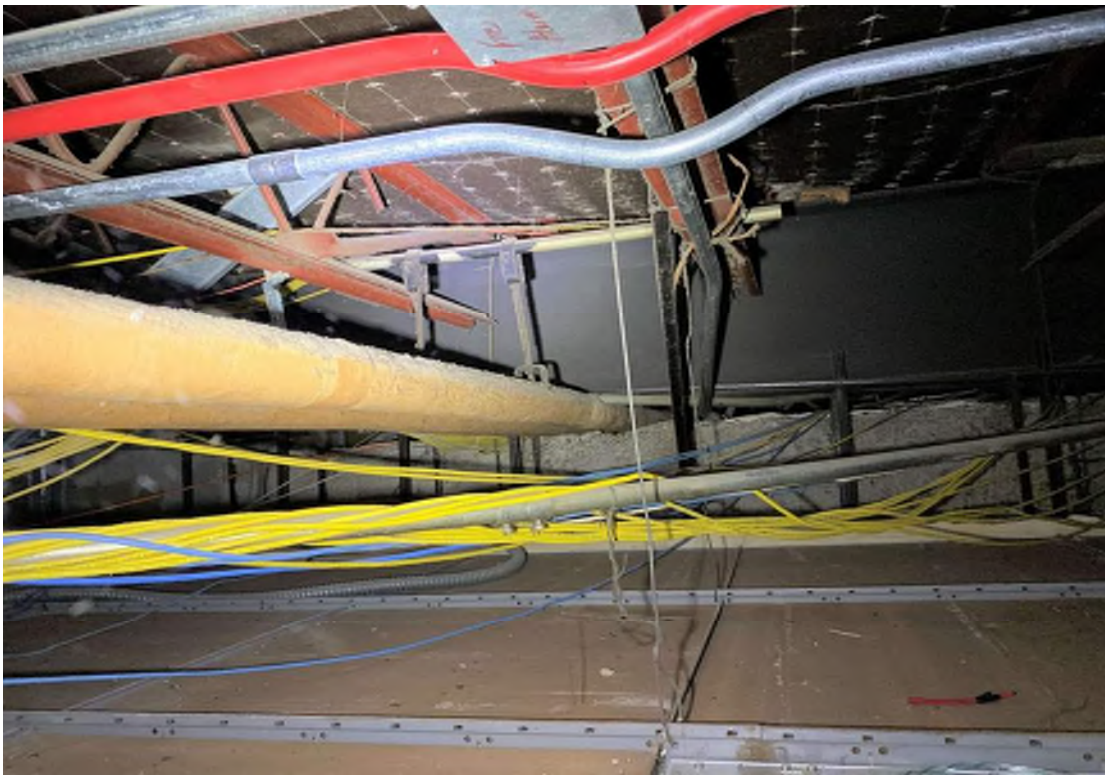
Photo #9 - View of fiberglass insulated piping above the suspended ceiling in Lobby 168. The paper with underlying black tar dabs on
 Photo Date: 08/17/2023 the fiberglass insulation was determined to be non-ACM. No mudded fittings were observed in this area.

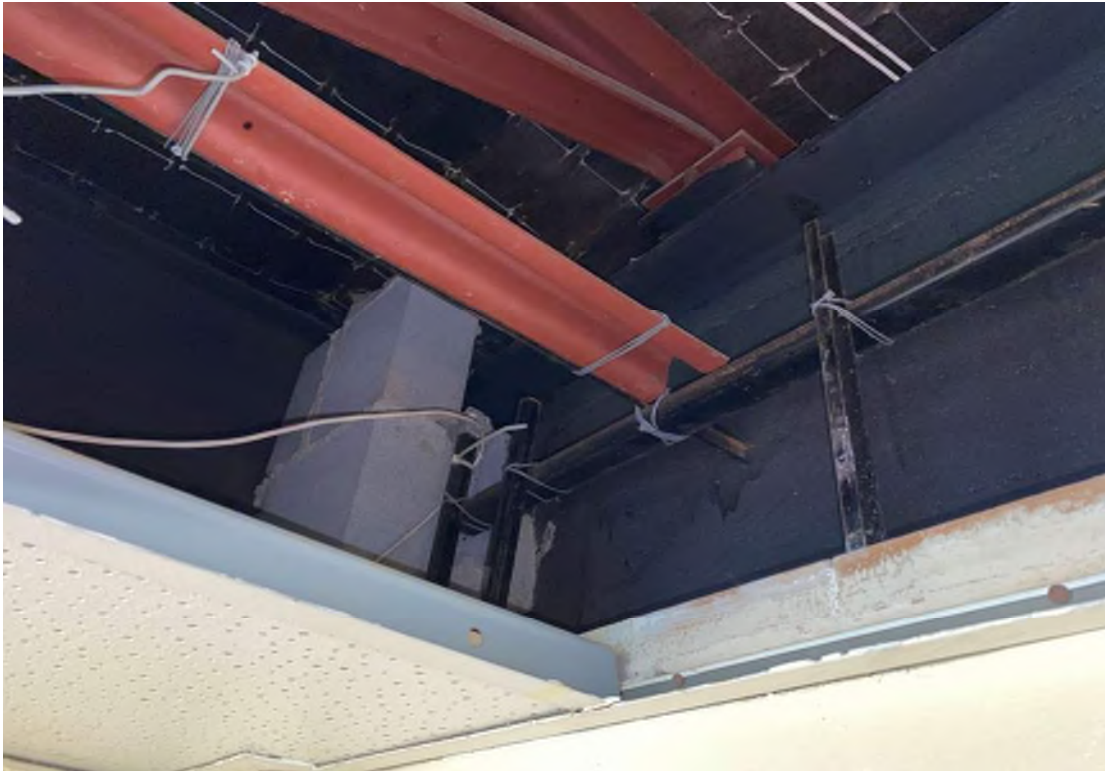
Photo #10 - View of the black structural steel beam above the HVAC vent in classroom 136. The black paint on the steel beams
 Photo Date: 08/17/2023 at the edges of corridor walls and above HVAC vents was determined to be lead-based paint.

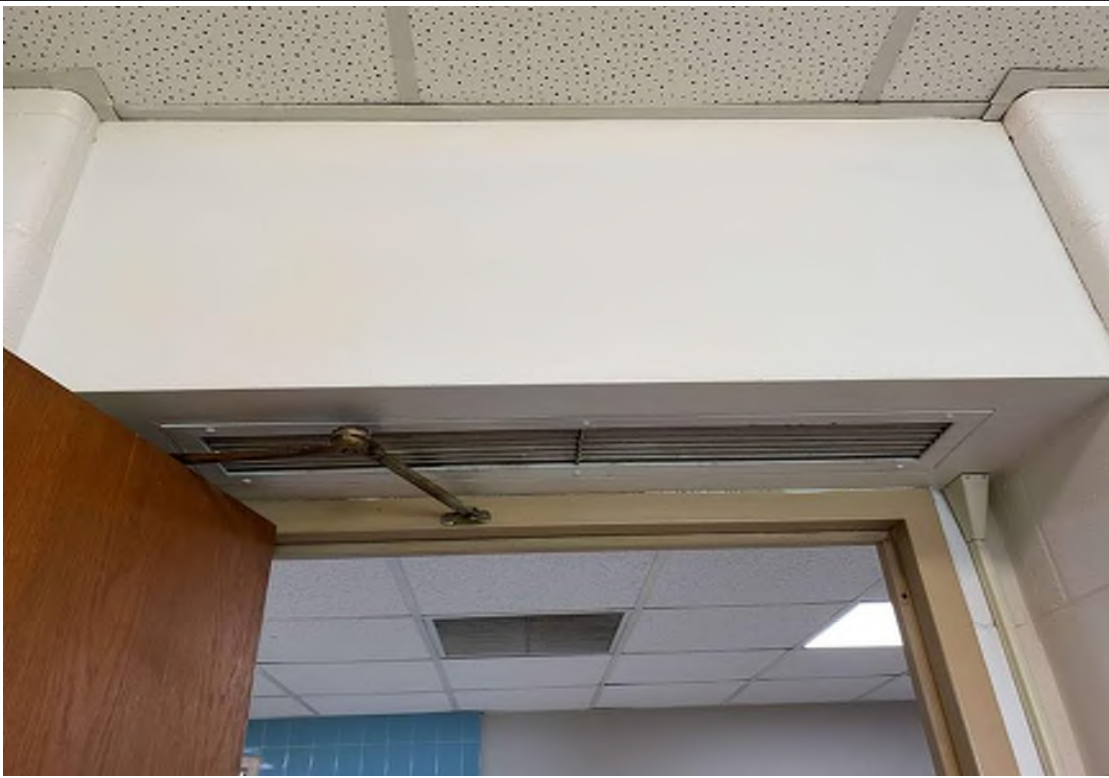
Photo #11 - View of the HVAC duct vent above the doorway in Classroom 234. No caulk or sealant was observed on the vent.
 Photo Date: 08/17/2023 The plaster was determined to be non-ACM. The ceiling tiles were also determined to be non-ACM.

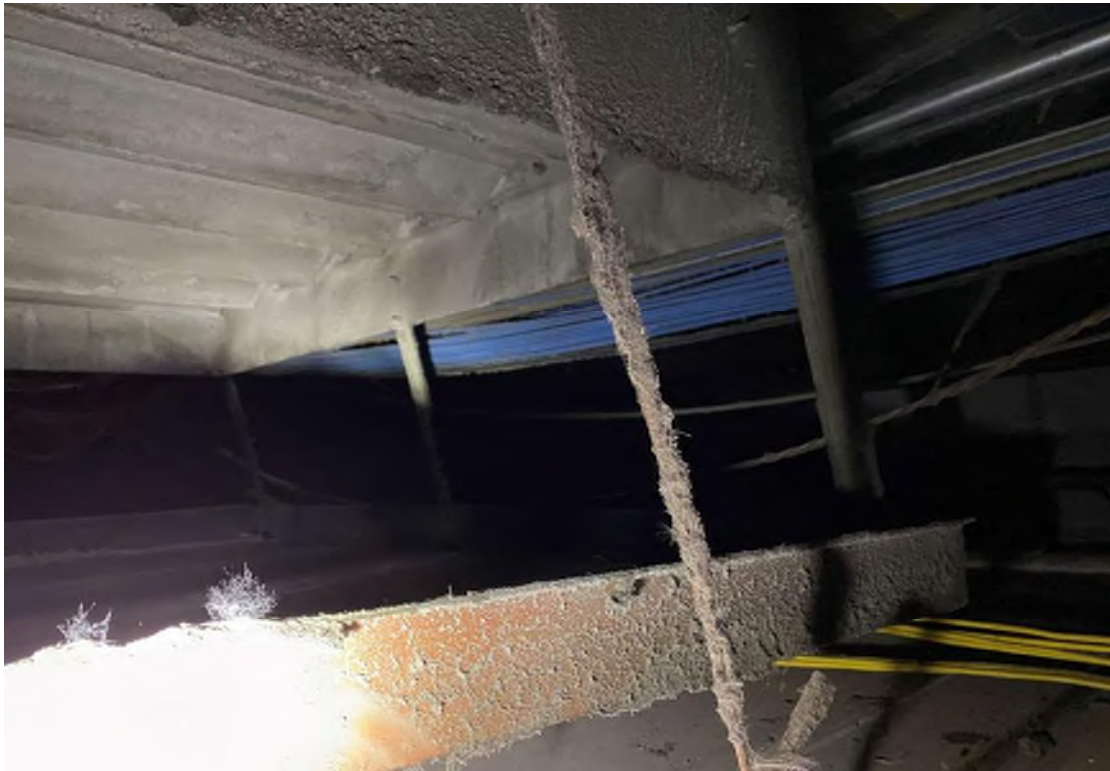
Photo #12 - View of large HVAC duct and the base of a roof top AHU above second floor corridor suspended ceiling tiles by Classroom 234.
 Photo Date: 08/18/2023 No insulation or suspect asbestos-containing stickpin mastic was observed on accessible corridor ducts.

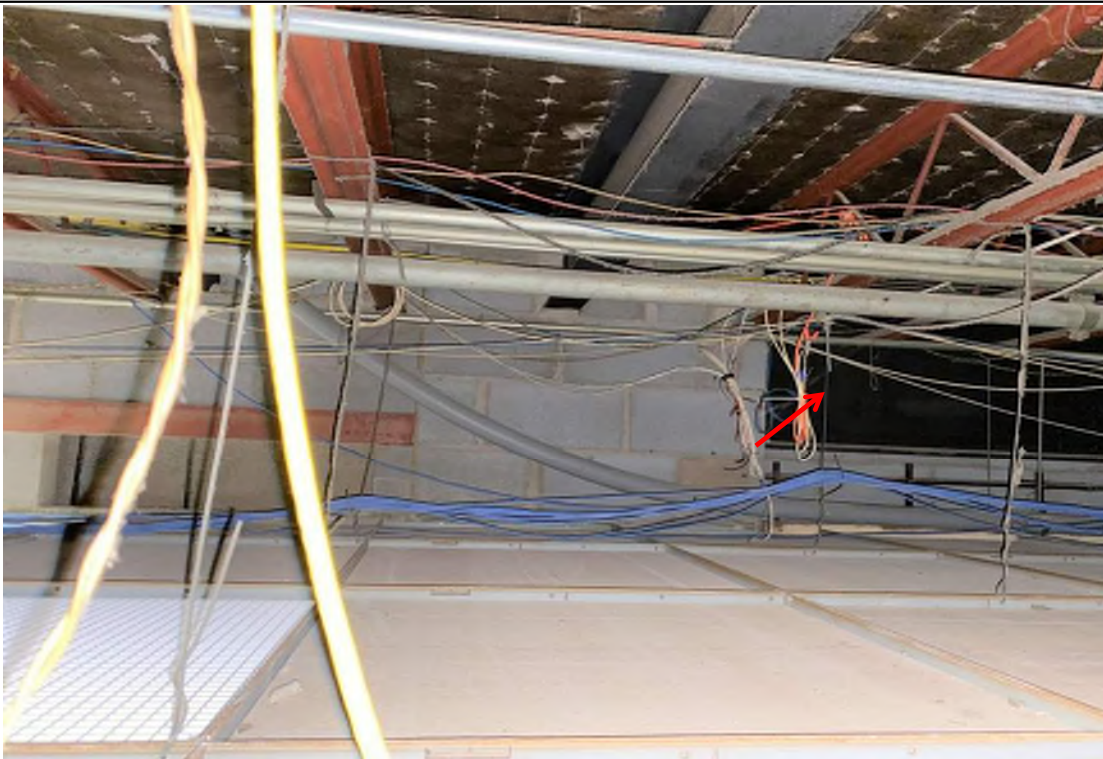
Photo #13 - View above the first floor corridor suspended ceiling tiles by Classroom 136. No spray-on fireproofing was observed on first floor or second floor decks above the suspended ceiling tiles. Paint on red girders was determined to be non-lead based paint. A steel beam with black lead-based paint above a doorway is visible in the concrete masonry block wall (Arrow).
 Photo Date: 08/17/2023

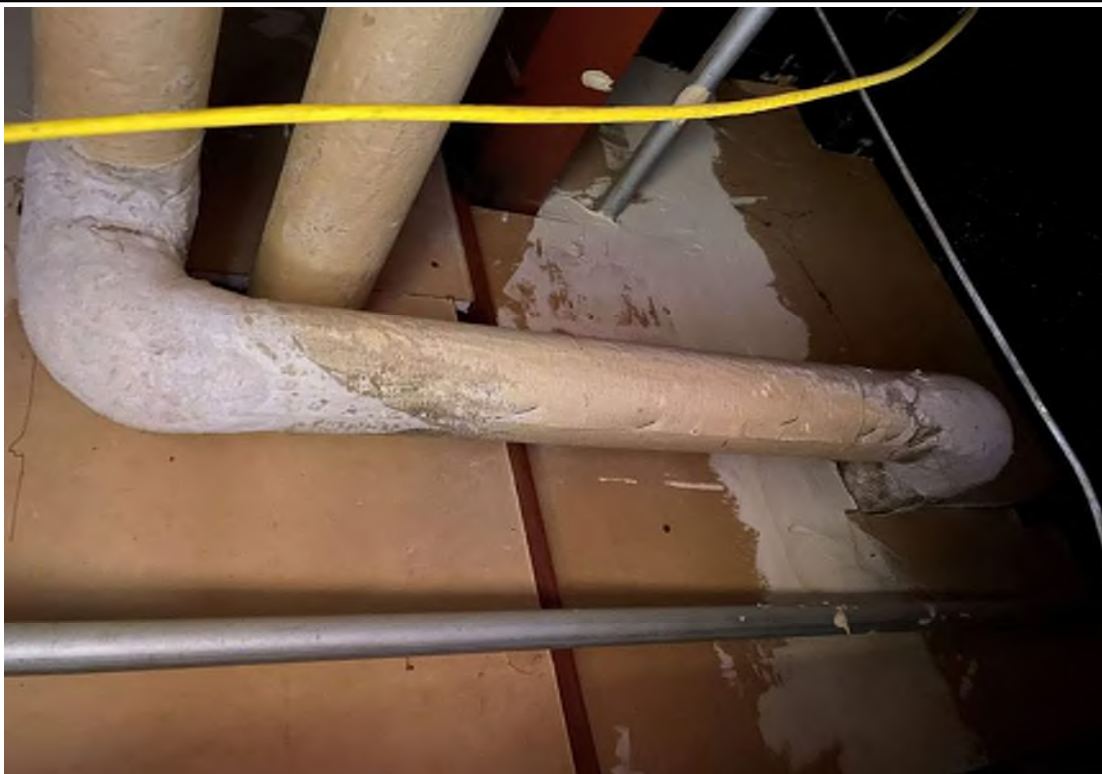
Photo #14 - View of mudded fittings on fiberglass pipe insulation above the suspended ceiling in Office 109, by the door to the corridor.
 Photo Date: 08/17/2023 The mudded fittings, paper jacket and tar in the jackets on fiberglass were determined to be non-asbestos.

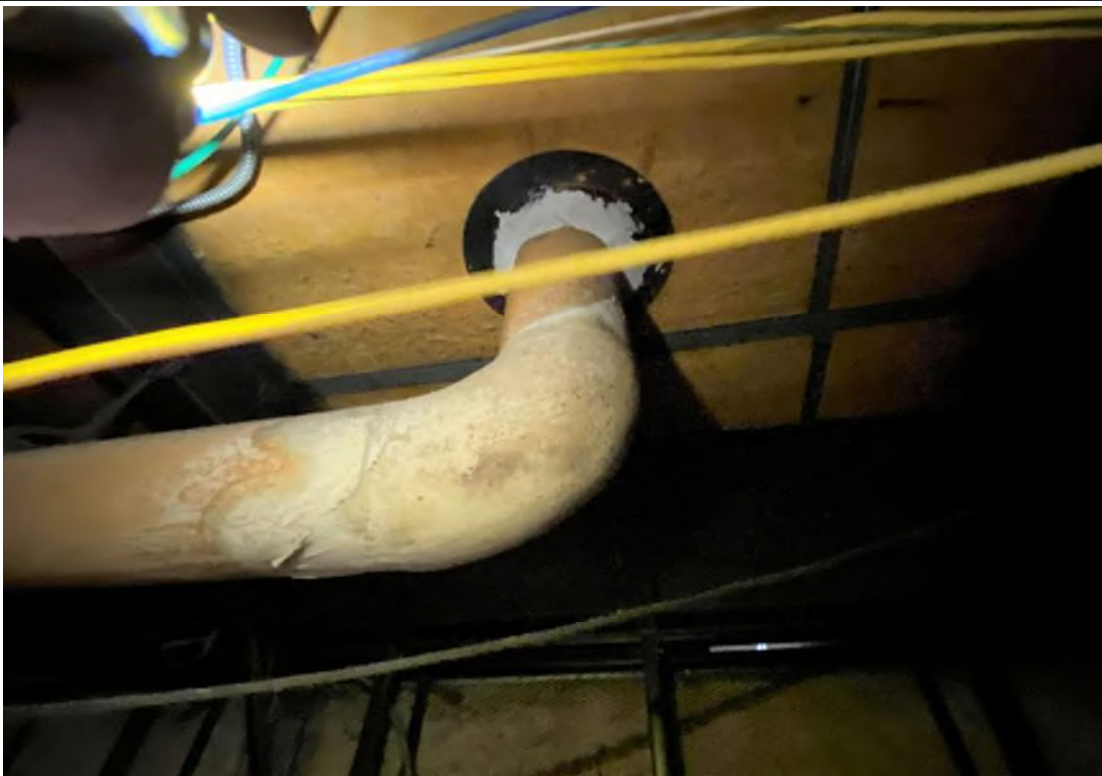
Photo #15 - View of a mudded insulation roof drain at the ceiling in the second floor corridor in front of Classroom 224.

The mudded elbow on the roof drain was determined to be non-asbestos.

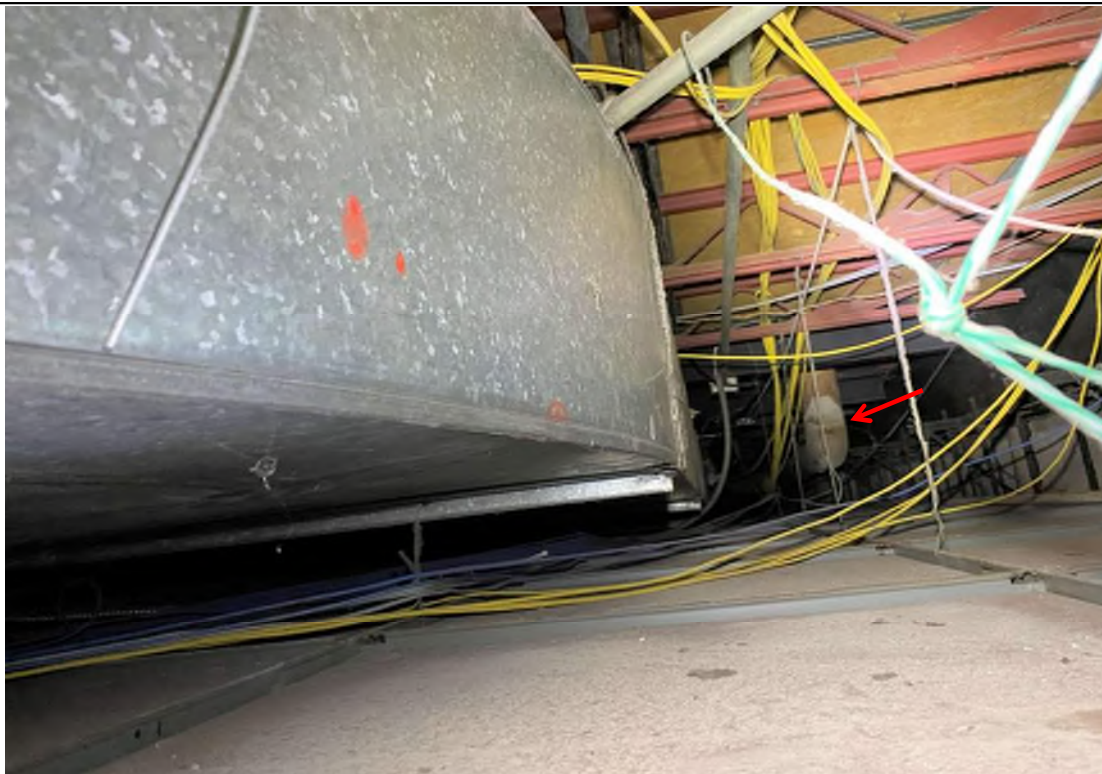
Photo #16 - View of a section of bare sheet metal HVAC duct above the second floor corridor suspended ceiling in front of Classroom 222.

No pin mastic or insulation was observed on the duct. A Non-ACM roof drain elbow is visible (Arrow).

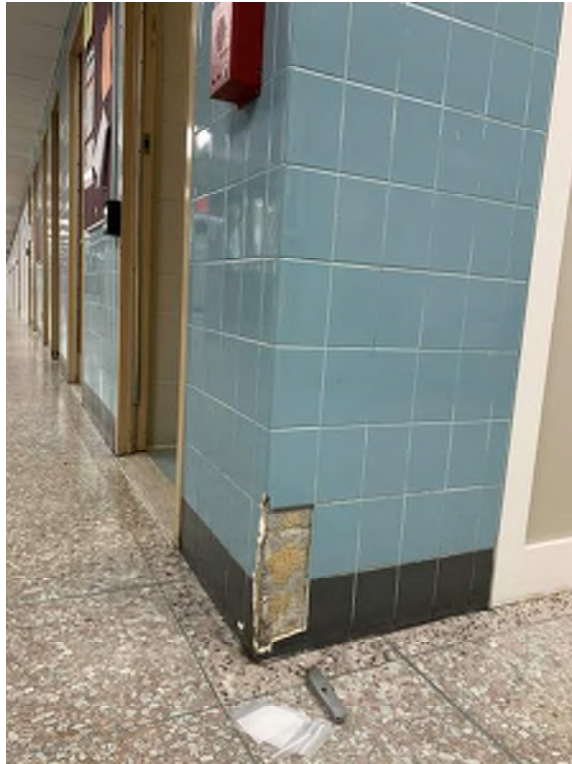
Photo #1: Kittinger Hall- HAN 123.2- 4" x 6" Ceramic Tile Mastic

HAN Number	Material Description	Comments
WALLS (100s)		
123.2	4" x 6" Ceramic Tile Mastic	Photo #1
PIPE INSULATION (400s)		
420	Mud Elbow on Domestic Line	Homogeneous to HAN 421
421	Mud Fitting on Fiberglass Insulation	Homogeneous to HAN 420

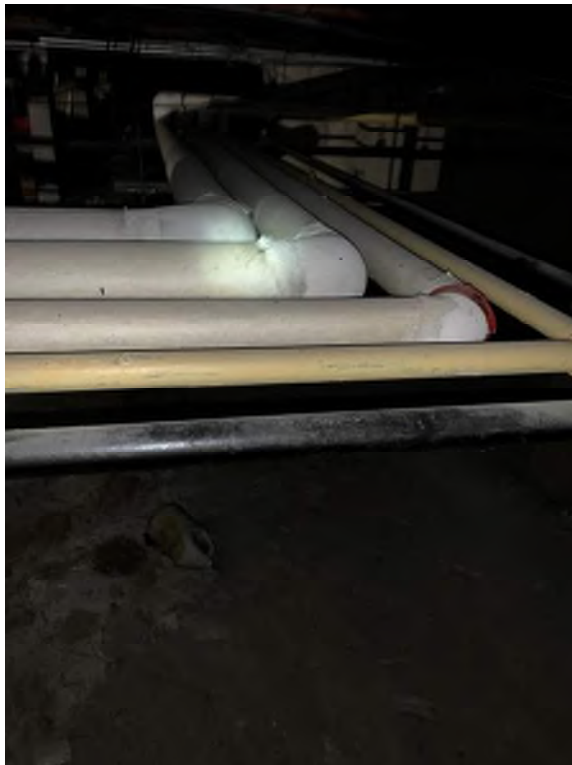
Photo #2: HAN 421- Kittinger Hall-Mud Fitting on Fiberglass Insulation
