BUFFALO CREEK SUB-WATERSHED SVAP MILEAGE 2021

BUFFALO CREEK

STREAM VISUAL ASSESSMENT PROTOCOL (SVAP) FOR REACH A & B

AVERAGE OVERALL SVAP RATING: **6.7**

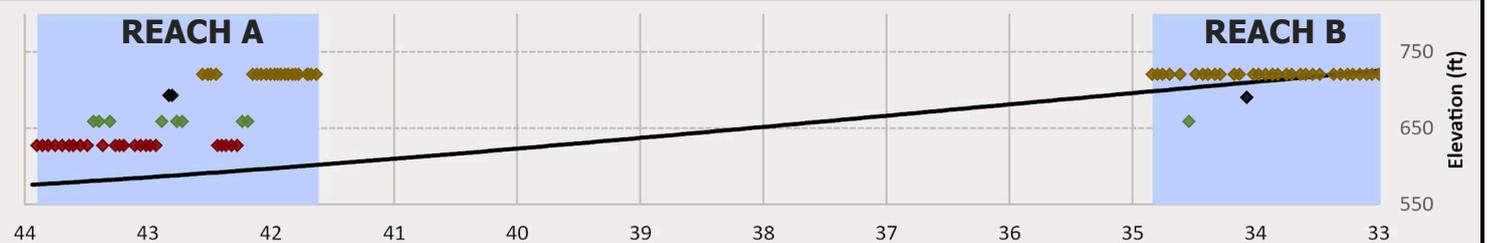
Elevation Profile

Substrate ◆ Bedrock/Concrete ◆ Boulder ◆ Cobble ◆ Gravel

← FLOW DIRECTION Creek Mile: Reach A (43.89 at Tailwater, 41.67 at Headwater); Reach B (34.78 at Tailwater, 33.48 at Headwater) FLOW DIRECTION →

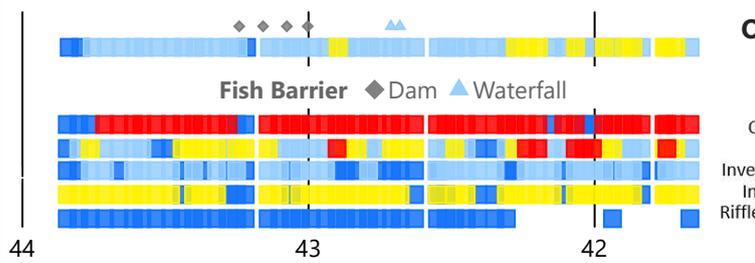
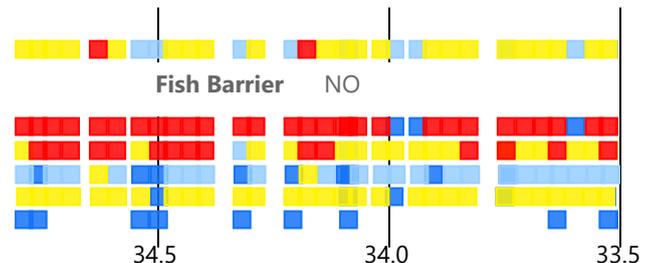
Note: Overall Score of Fish Habitat was calculated by averaging scores for the five variables shown below.

Canopy Cover Pools Invertebrate Habitat Instream Cover Riffle Embeddedness

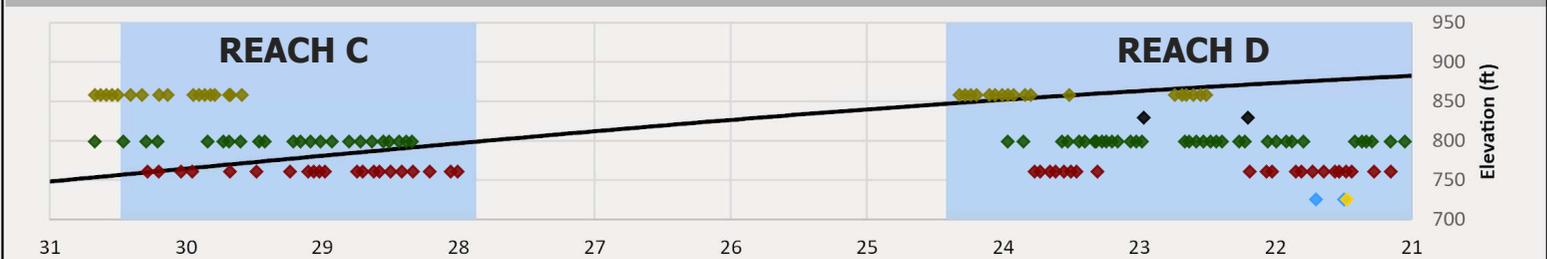
Elevation Profile

← FLOW DIRECTION Creek Mile (30.43 at Tailwater, 21.05 at Headwater) → FLOW DIRECTION

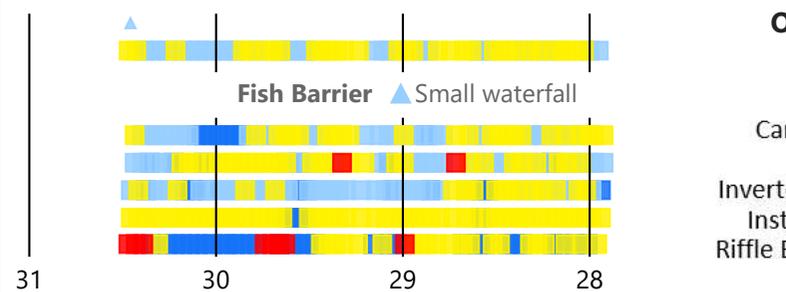
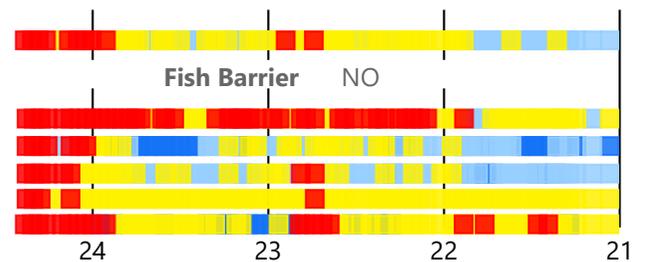
Note: Overall Score of Fish Habitat was calculated by averaging scores for the five variables shown below.

Canopy Cover Pools Invertebrate Habitat Instream Cover Riffle Embeddedness

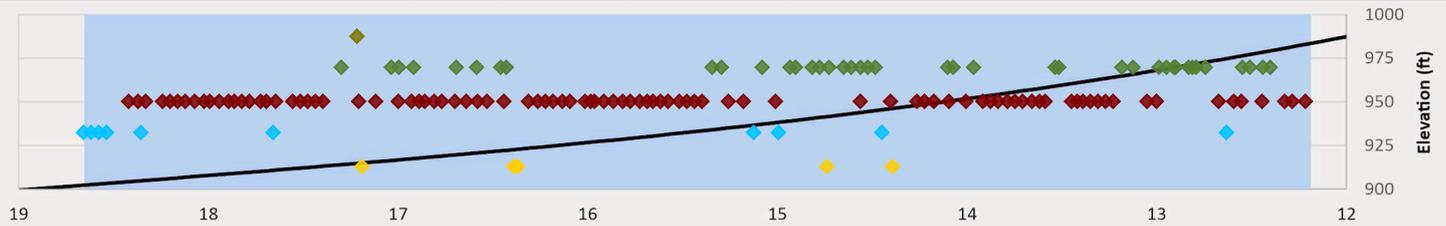
Elevation Profile

Substrate ◆ Bedrock/Concrete ◆ Cobble ◆ Gravel ◆ Sand ◆ Silt/Clay

← FLOW DIRECTION Creek Mile (18.62 at Tailwater, 12.22 at Headwater) FLOW DIRECTION →

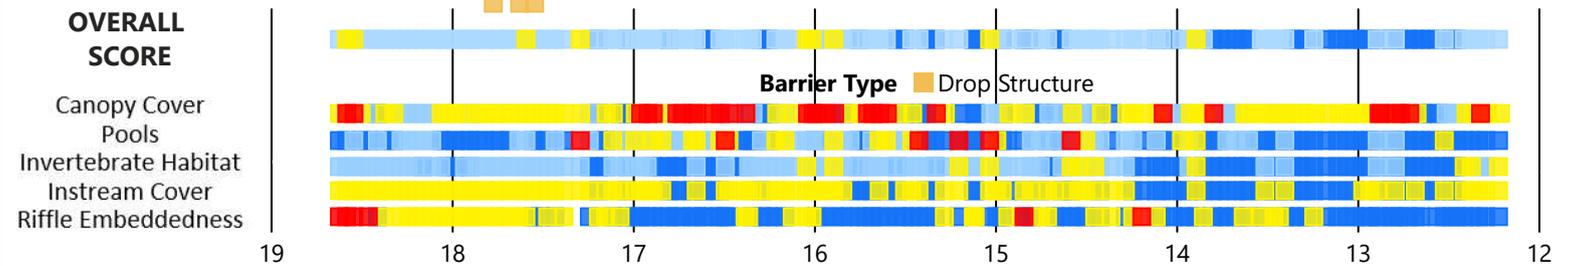
Score ■ Excellent ■ Good ■ Mediocre ■ Poor *Note: Overall Score of Fish Habitat was calculated by averaging scores for the five variables shown below.*

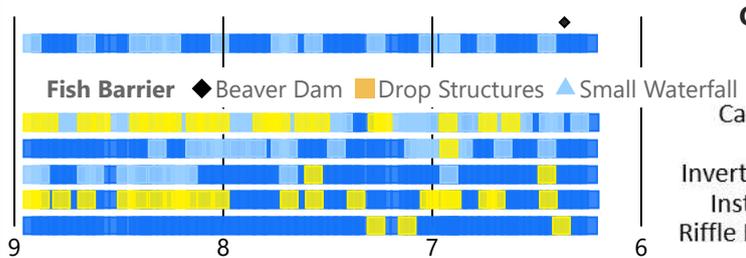
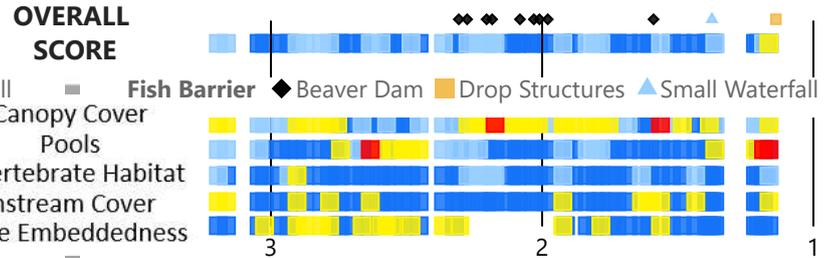
Fish Habitat Score Excellent Good Mediocre Poor

Note: Overall Score of Fish Habitat was calculated by averaging scores for the five variables shown below.

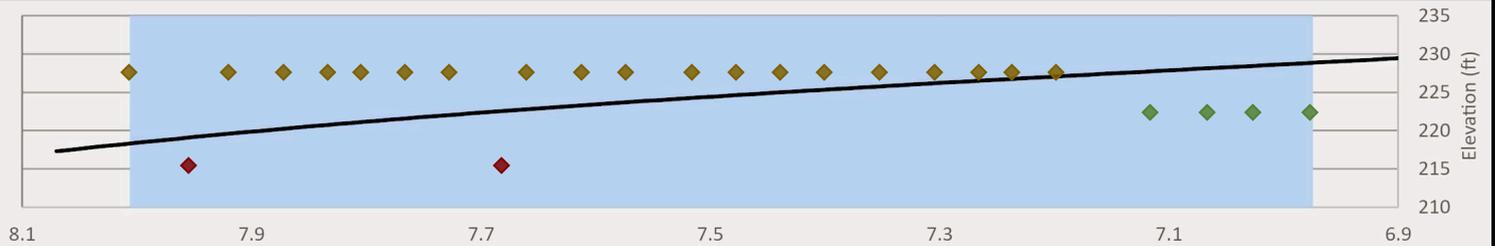
Elevation Profile

Substrate ◆ Bedrock/Concrete ◆ Cobble ◆ Gravel

← FLOW DIRECTION Creek Mile (8.00 at Tailwater, 6.98 at Headwater) FLOW DIRECTION →

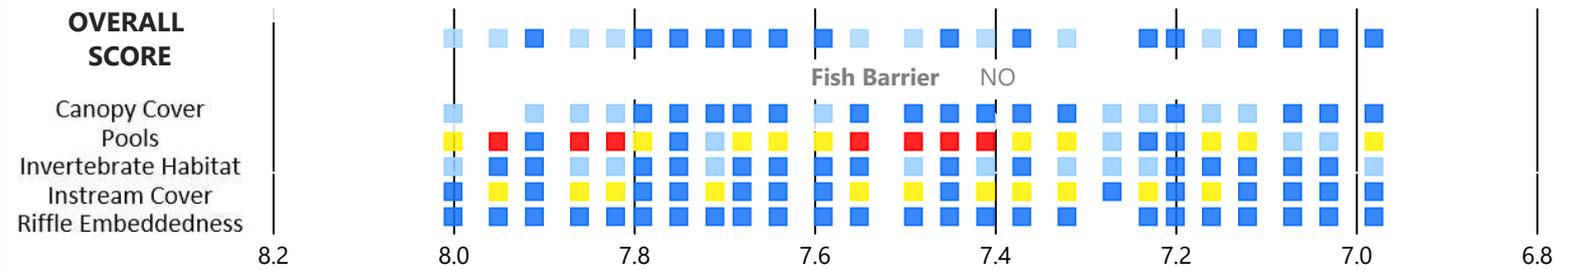
Note: Overall Score of Fish Habitat was calculated by averaging scores for the five variables shown below.

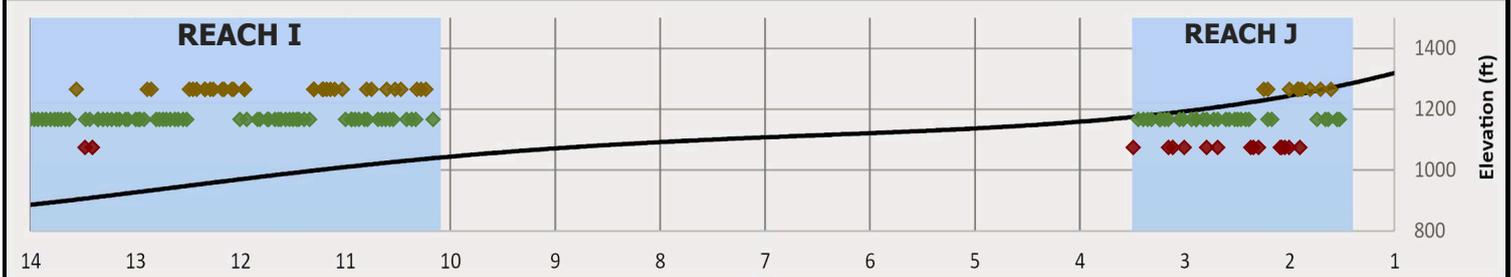
Elevation Profile Substrate ◆ Bedrock/Concrete ◆ Cobble ◆ Gravel

← **FLOW DIRECTION** Creek Mile: Reach I (14.00 at Tailwater, 10.15 at Headwater); Reach J (3.44 at Tailwater, 1.46 at Headwater) **FLOW DIRECTION** →

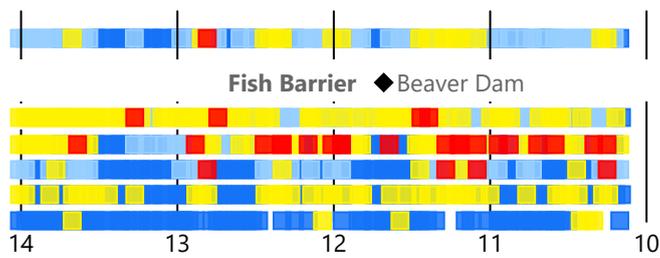
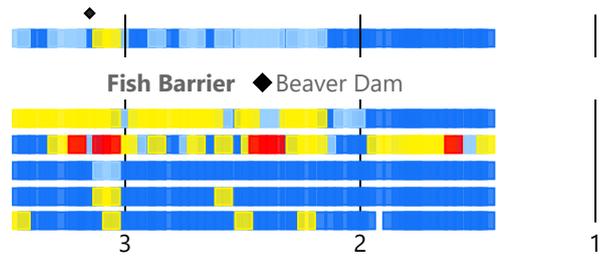
Fish Habitat Score Excellent Good Mediocre Poor

Overall Score of Fish Habitat was calculated by averaging scores for the five variables shown below.

Canopy Cover Pools Invertebrate Habitat Instream Cover Riffle Embeddedness

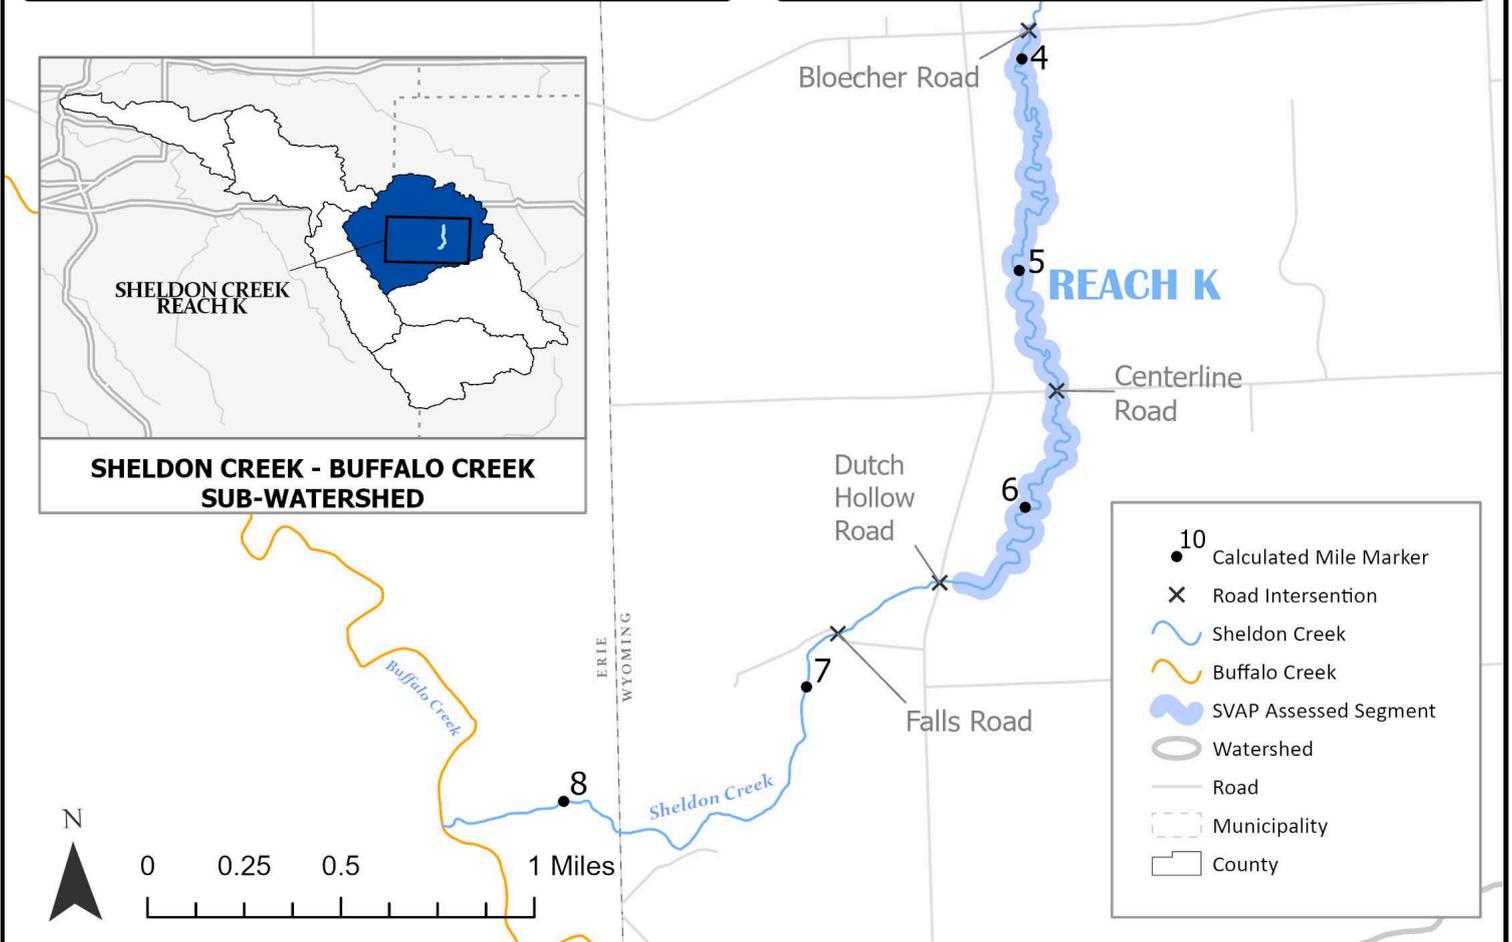
STREAM VISUAL ASSESSMENT PROTOCOL (SVAP) RESULTS FOR REACH K

AVERAGE OVERALL SVAP RATING: **8.1**

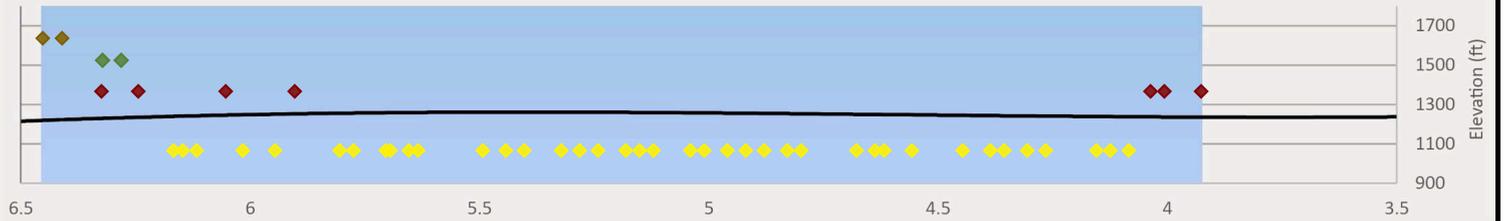
Elevation Profile

Substrate ◆ Bedrock/Concrete ◆ Cobble ◆ Gravel ◆ Silt/Clay

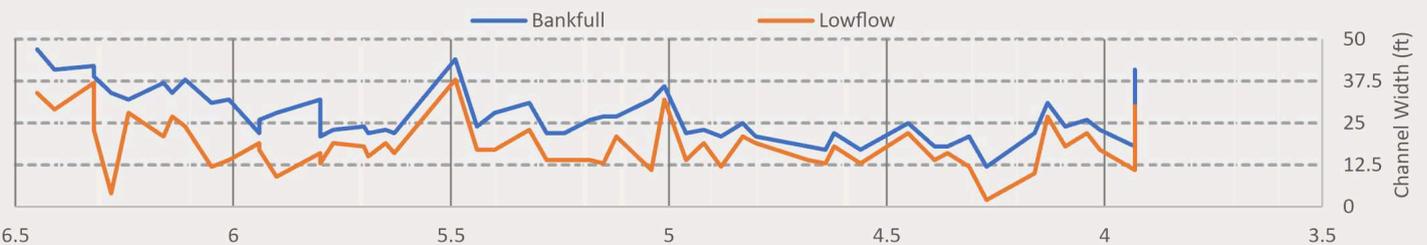
Channel Width

← FLOW DIRECTION
Creek Mile (6.45 at Tailwater, 3.93 at Headwater)
← FLOW DIRECTION

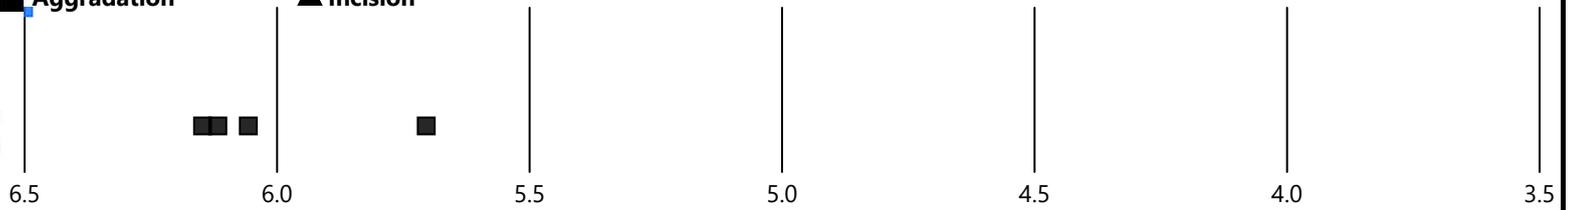
Aggradation/Incision

■ Aggradation

▲ Incision

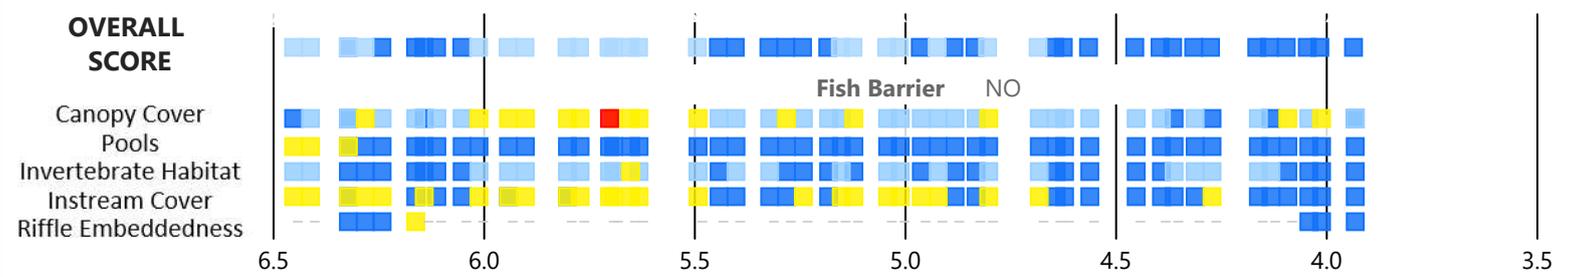
Fish Habitat

Score ■ Excellent ■ Good ■ Mediocre ■ Poor **Note:** Overall Score of Fish Habitat was calculated by averaging scores for the five variables shown below.

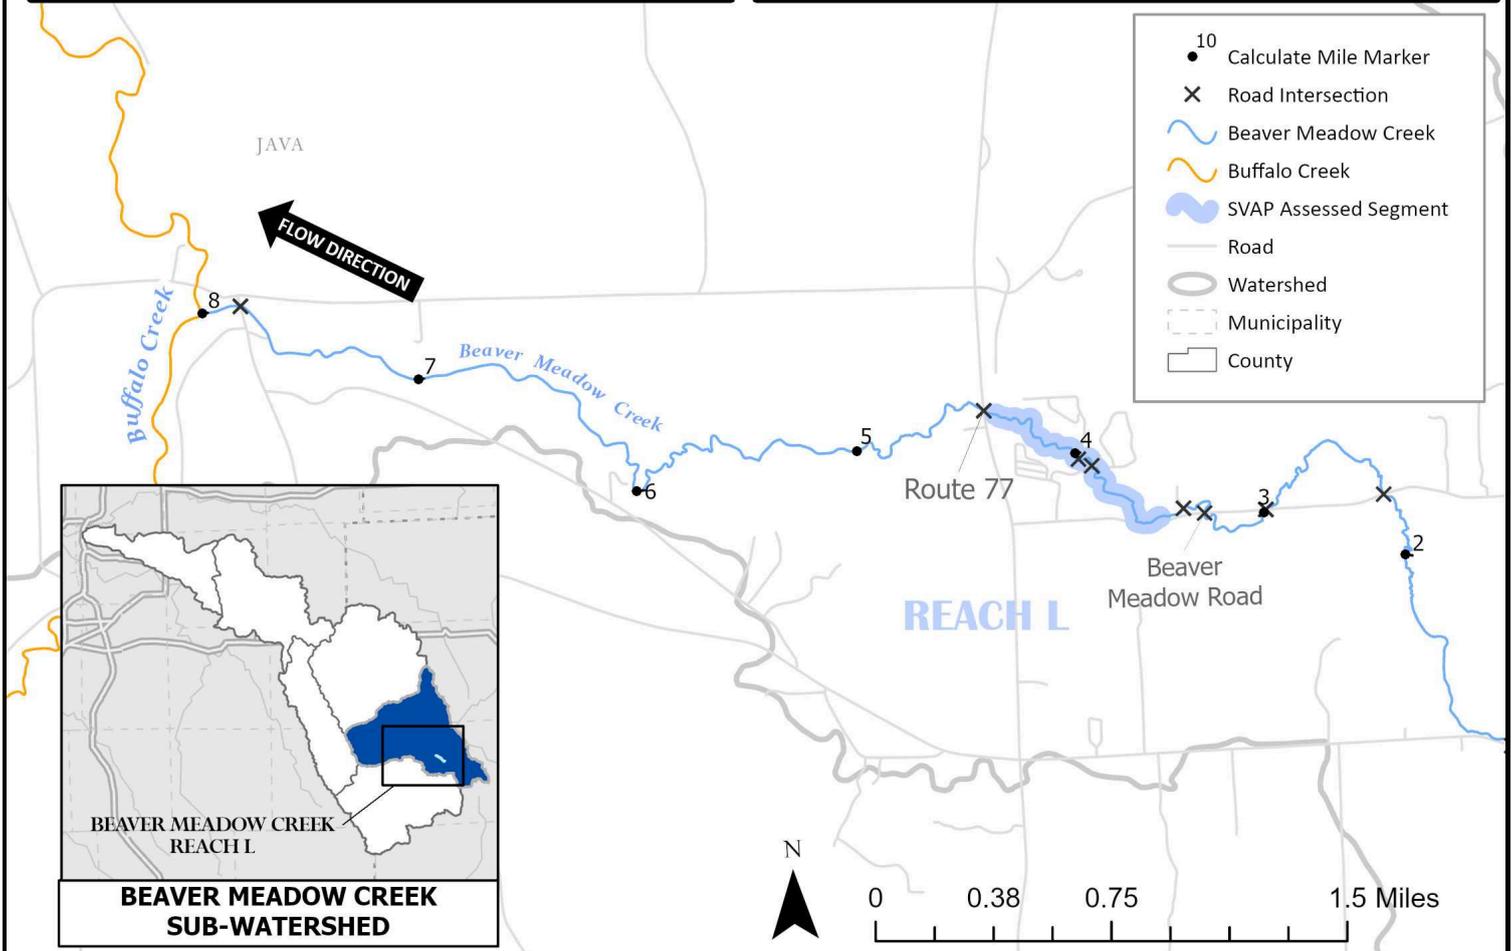
STREAM VISUAL ASSESSMENT PROTOCOL (SVAP) SAMPLING RESULTS FOR REACH L

AVERAGE OVERALL SVAP RATING: **9.0**

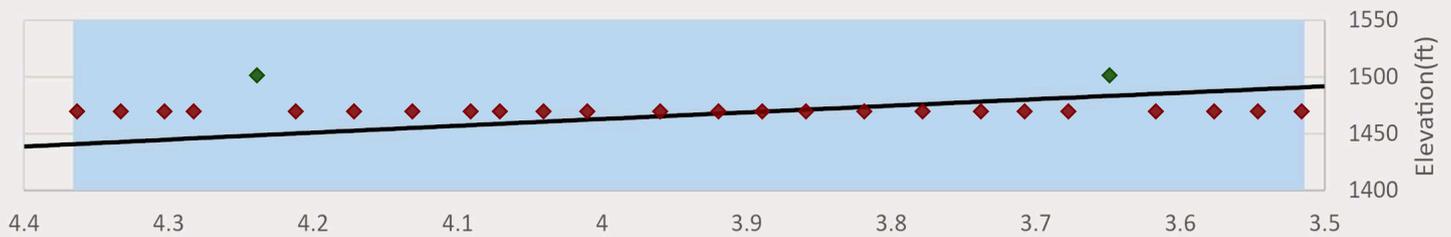
Elevation Profile

Substrate ◆ Cobble ◆ Gravel

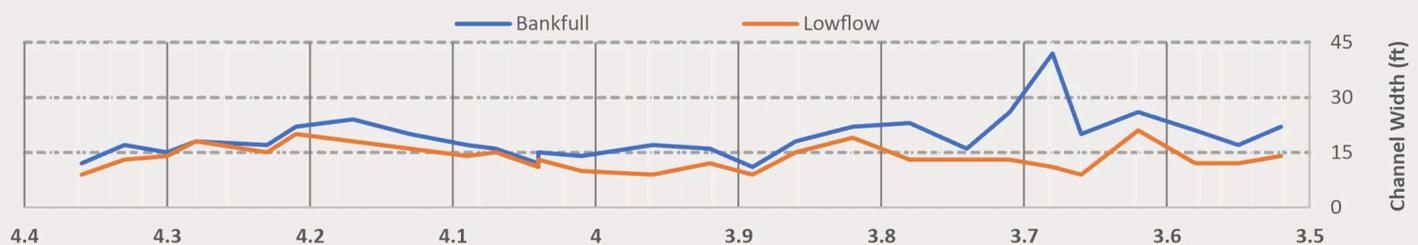
Channel Width

← FLOW DIRECTION Creek Mile (4.36 at Tailwater, 3.52 at Headwater) FLOW DIRECTION →

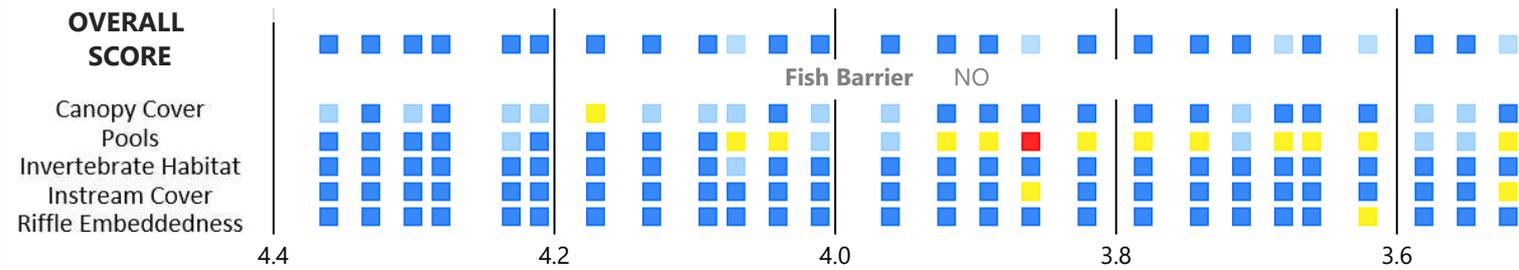
Fish Habitat

Score ■ Excellent ■ Good ■ Mediocre ■ Poor

Note: Overall Score of Fish Habitat was calculated by averaging scores for the five variables shown below.
