# CATTARAUGUS CREEK SUB-WATERSHED SVAP MILEAGE 2024

## Stream Visual Assessment Protocol - SVAP

NOTE: SVAP walked data collected 2024. Desktop analysis conducted with 2022 Orthoimagery and 2023 Eagleview imagery. Reach F assessed through a combination of field and desktop analysis data. Waterway reaches were assessed using a modified SVAP procedure from the USDA Natural Resources Conservation Service. 60.10 miles of waterways were assessed out of a total of 839.15 miles of waterways.

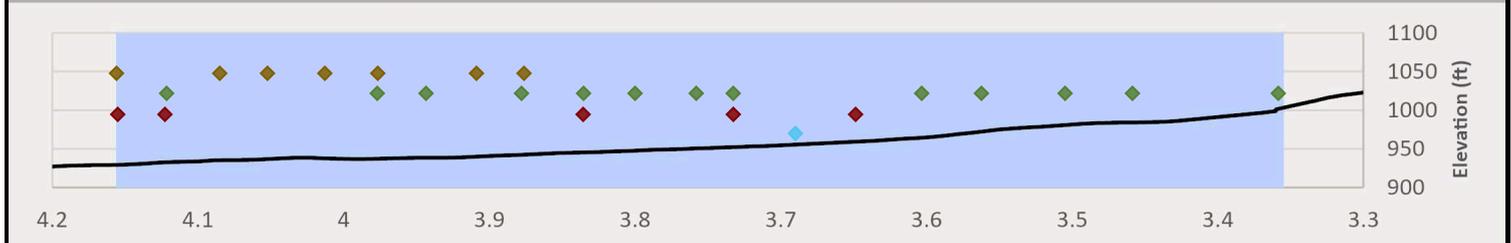
Elevation Profile Substrate ◆ Bedrock/Concrete ◆ Boulder ◆ Cobble ◆ Gravel ◆ Sand ◆ Silt/Clay

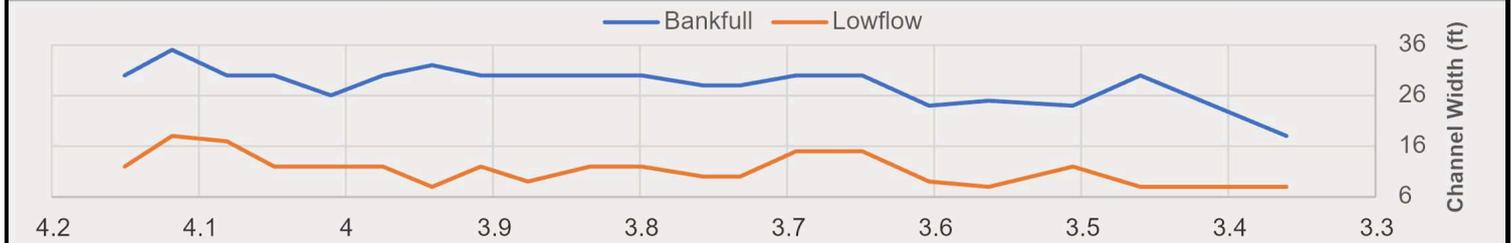
Channel Width

← FLOW DIRECTION Creek Mile (4.15 at Tailwater, 3.36 at Headwater) FLOW DIRECTION →

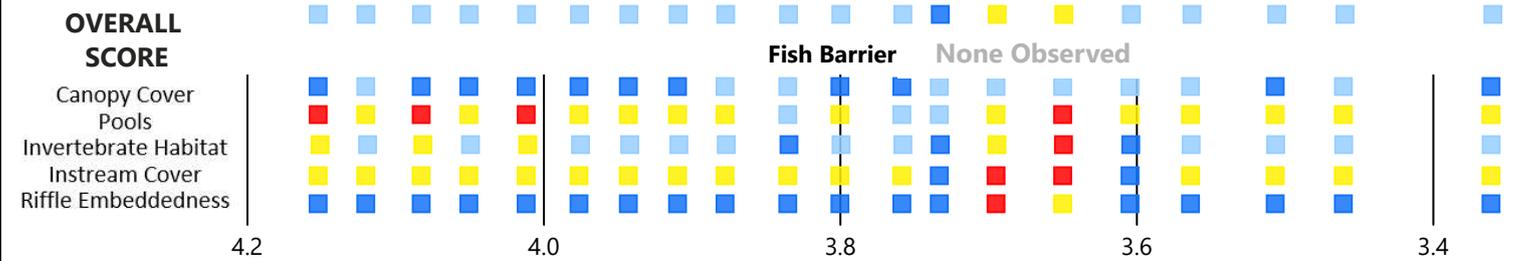
Fish Habitat

Note: Overall Score of Fish Habitat was calculated by averaging scores for the five variables shown below.

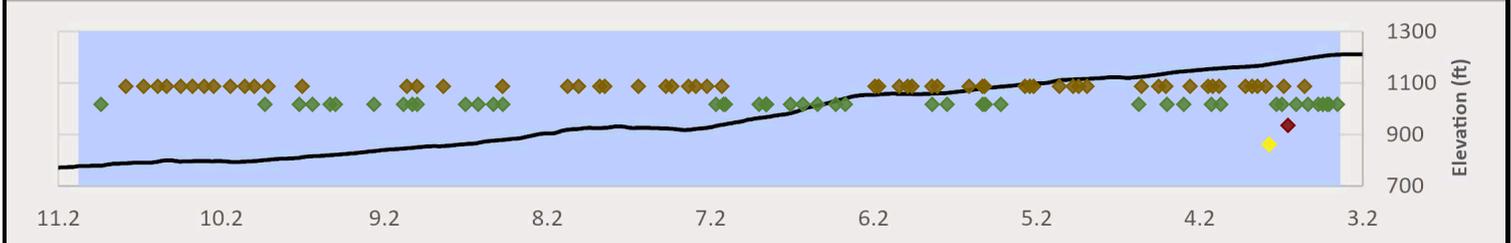
## Elevation Profile

Substrate: ◆ Bedrock/Concrete ◆ Boulder ◆ Cobble ◆ Gravel ◆ Sand ◆ Silt/Clay

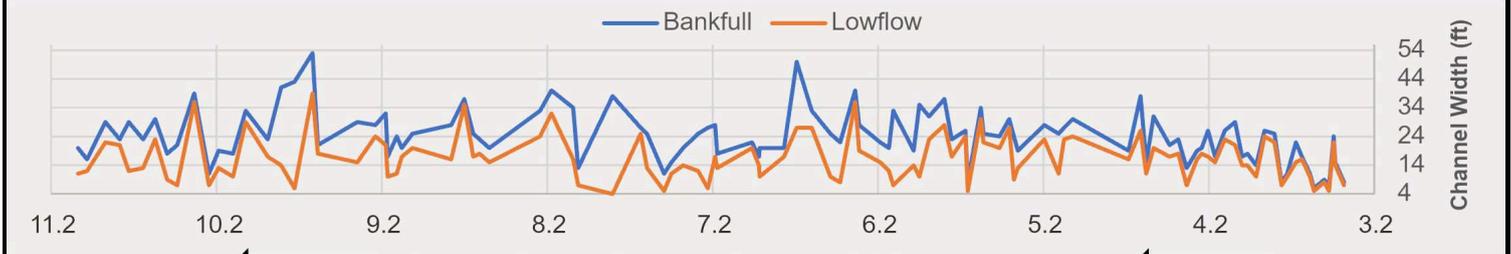
## Channel Width

← **FLOW DIRECTION** **Creek Mile (11.04 at Tailwater, 3.38 at Headwater)** **FLOW DIRECTION** →

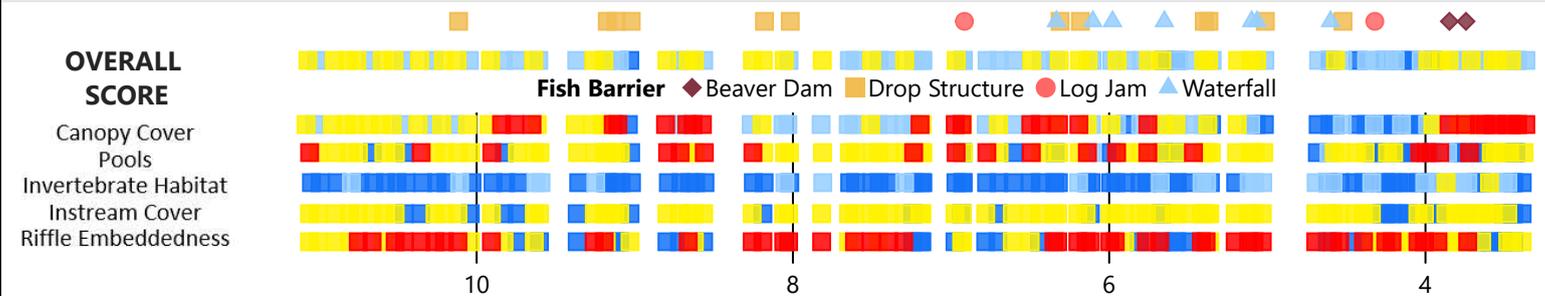
Fish Habitat

Note: Overall Score of Fish Habitat was calculated by averaging scores for the five variables shown below.

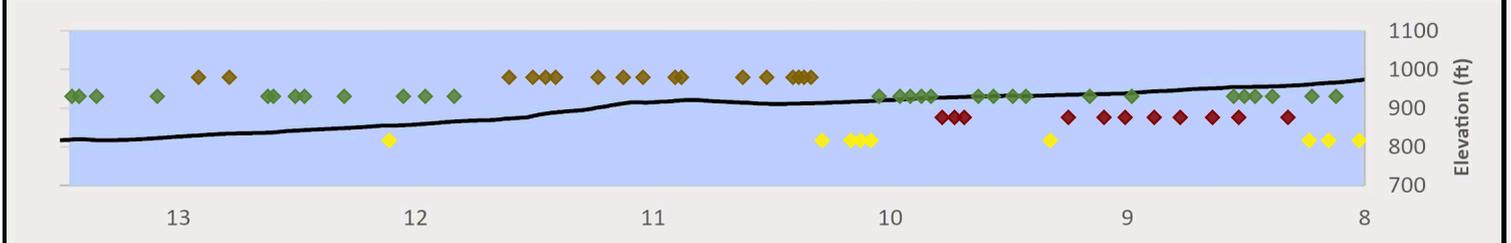
**Elevation Profile** Substrate ◆ Bedrock ◆ Boulder ◆ Cobble ◆ Gravel ◆ Sand ◆ Silt/Clay

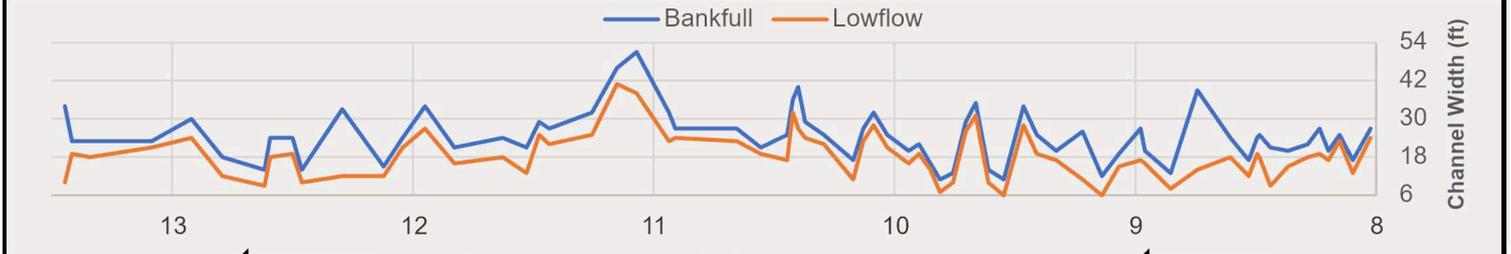
**Channel Width**

← **FLOW DIRECTION** **Creek Mile (13.44 at Tailwater, 8.02 at Headwater)** **FLOW DIRECTION** →

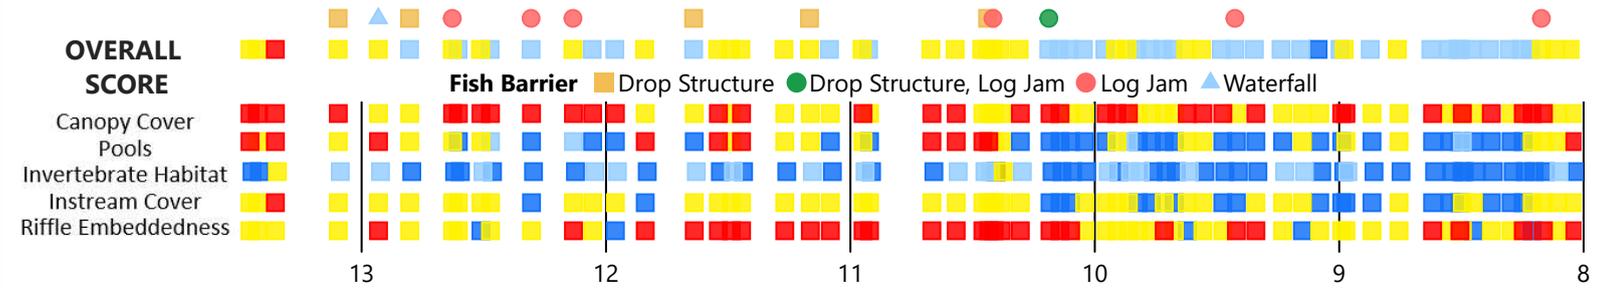
## Fish Habitat

Note: Overall Score of Fish Habitat was calculated by averaging scores for the five variables shown below.

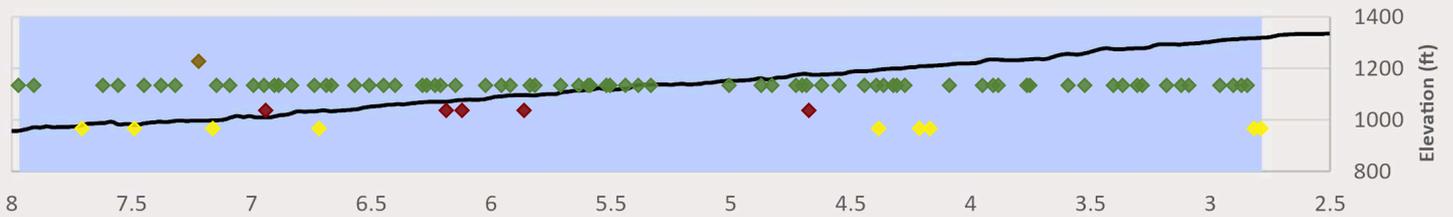
## Elevation Profile

Substrate: ◆ Bedrock ◆ Boulder ◆ Cobble ◆ Gravel ◆ Sand ◆ Silt/Clay

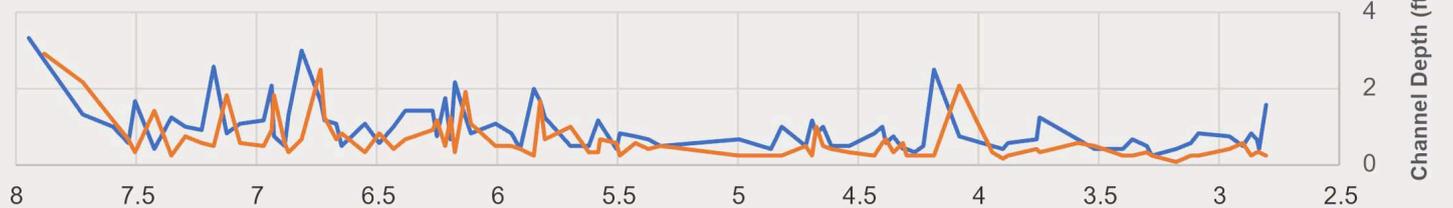
## Channel Depth

— Bankfull — Lowflow

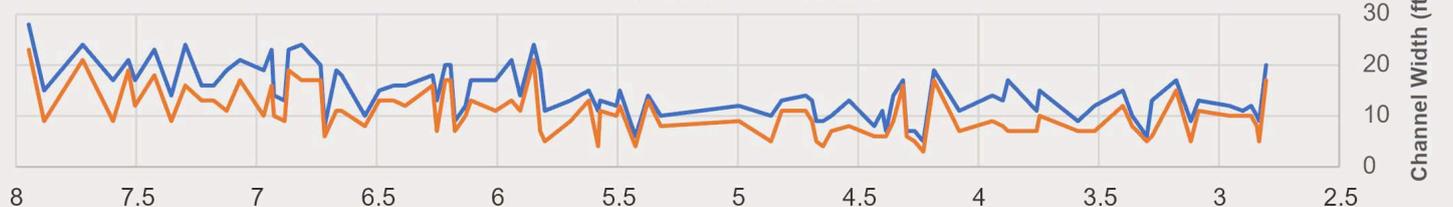
## Channel Width

— Bankfull — Lowflow

Creek Mile (7.95 at Tailwater, 2.80 at Headwater)

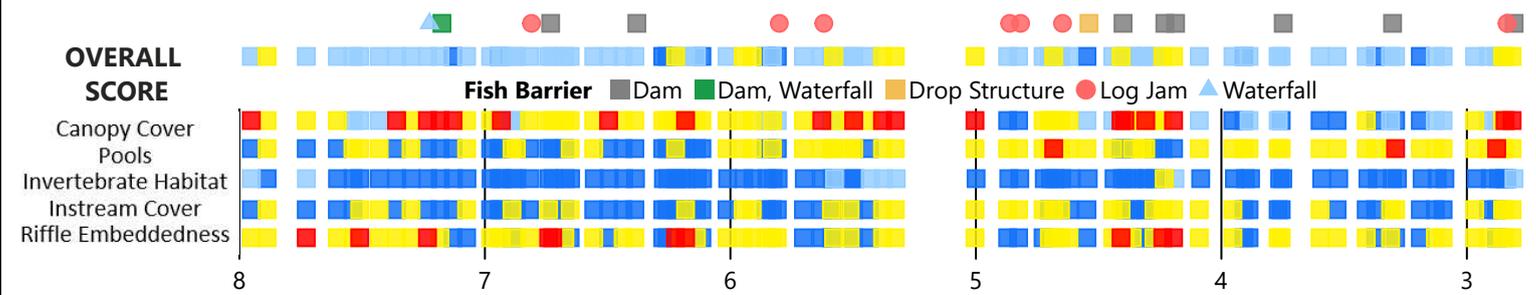
Fish Habitat

Note: Overall Score of Fish Habitat was calculated by averaging scores for the five variables shown below.

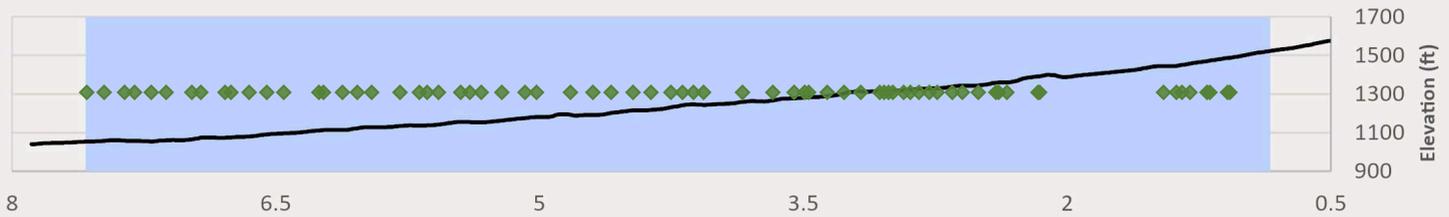
## Elevation Profile

Substrate ◆ Bedrock ◆ Boulder ◆ Cobble ◆ Gravel ◆ Sand ◆ Silt/Clay

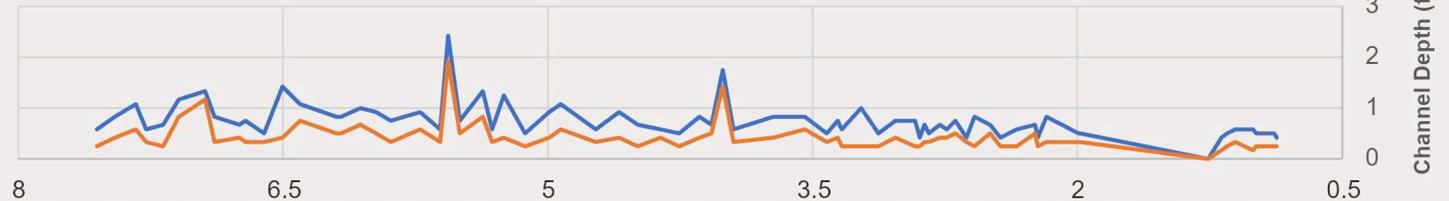
## Channel Depth

— Bankfull — Lowflow

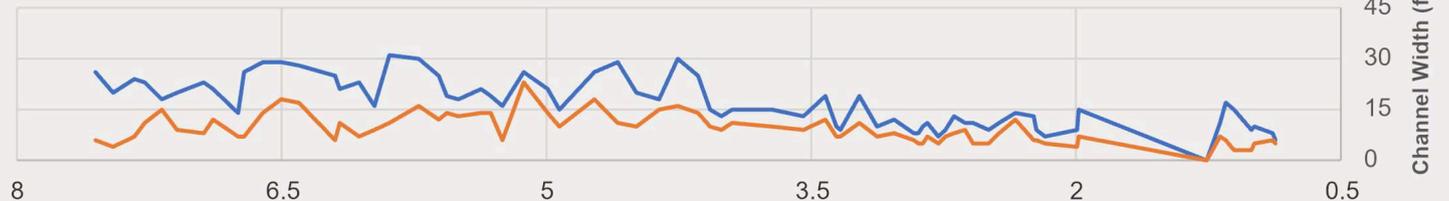
## Channel Width

— Bankfull — Lowflow

← FLOW DIRECTION Creek Mile (7.56 at Tailwater, 0.87 at Headwater) FLOW DIRECTION →

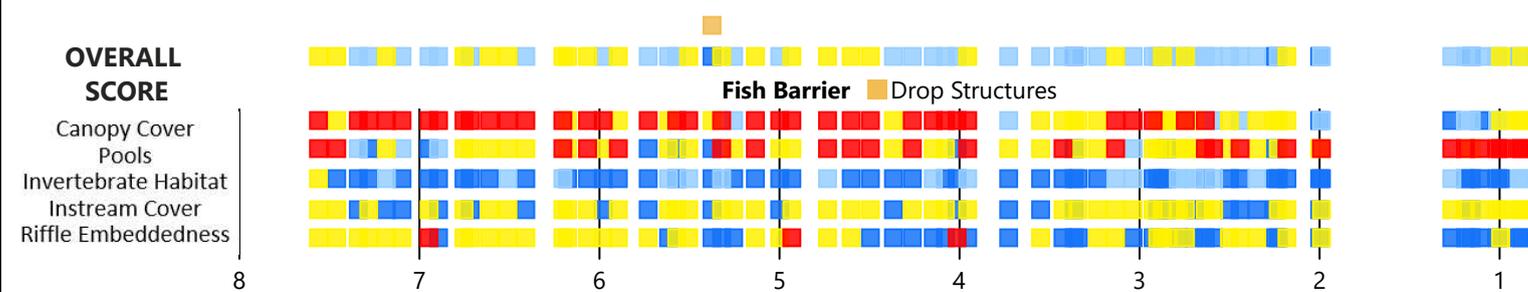
Score ■ Excellent ■ Good ■ Mediocre ■ Poor

Note: Overall Score of Fish Habitat was calculated by averaging scores for the five variables shown below.

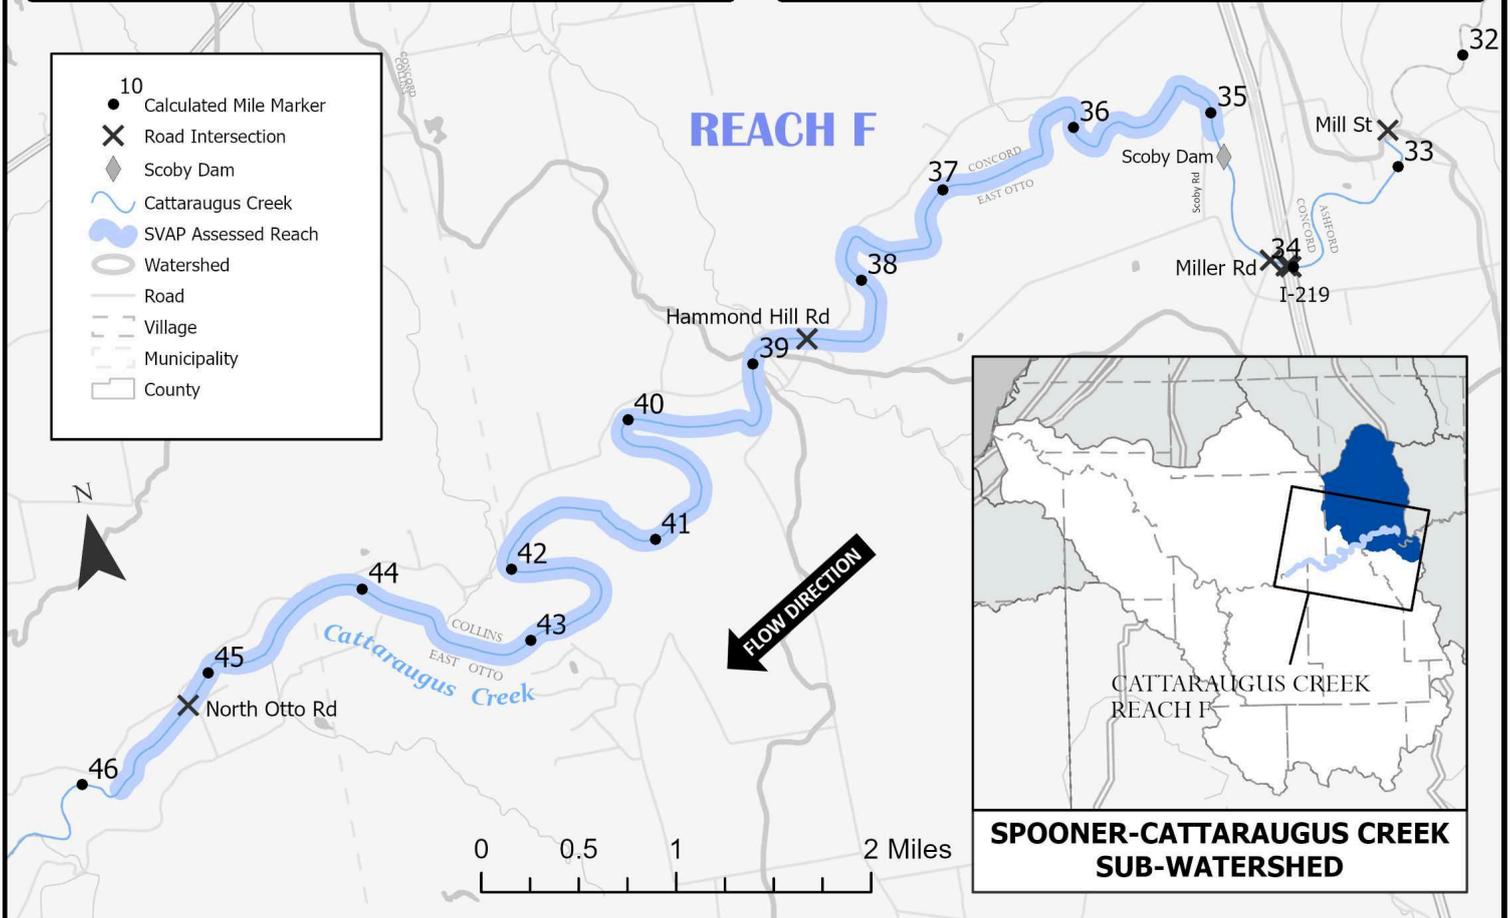
# CATTARAUGUS CREEK

STREAM VISUAL ASSESSMENT PROTOCOL (SVAP) RESULTS FOR REACH F

AVERAGE OVERALL SVAP RATING: **6.1**

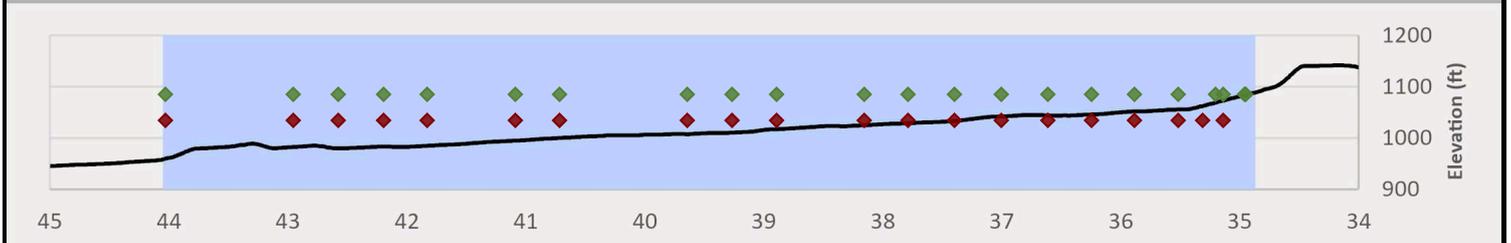
## Elevation Profile

Substrate: ◆ Bedrock ◆ Boulder ◆ Cobble ◆ Gravel ◆ Sand ◆ Silt/Clay

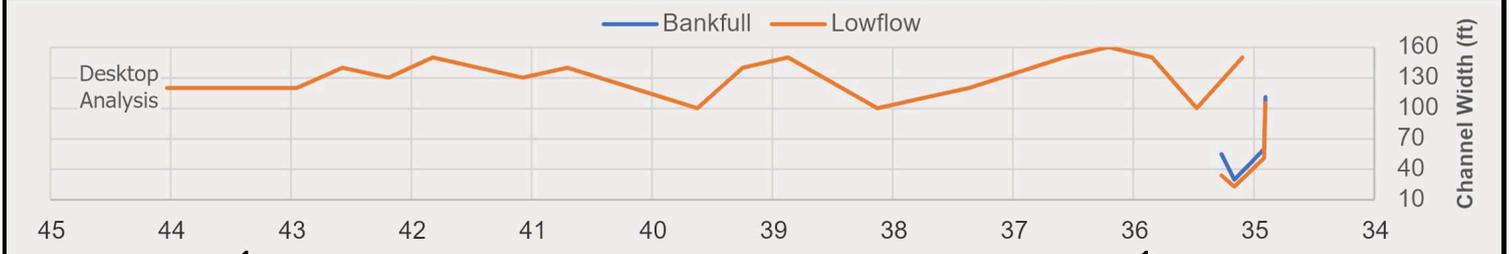
## Channel Width

← **FLOW DIRECTION** Creek Mile (44.03 at Tailwater, 34.90 at Headwater) **FLOW DIRECTION** →

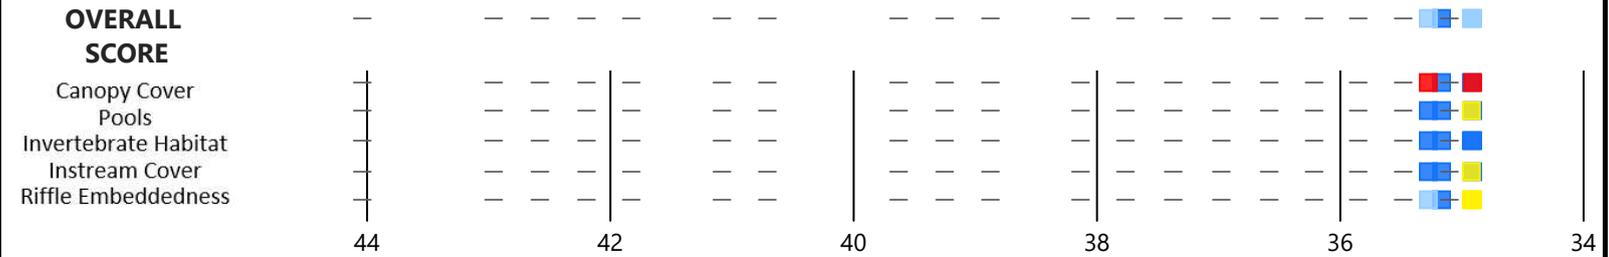
Score ■ Excellent ■ Good ■ Mediocre ■ Poor

Note: Overall Score of Fish Habitat was calculated by averaging scores for the five variables shown below.

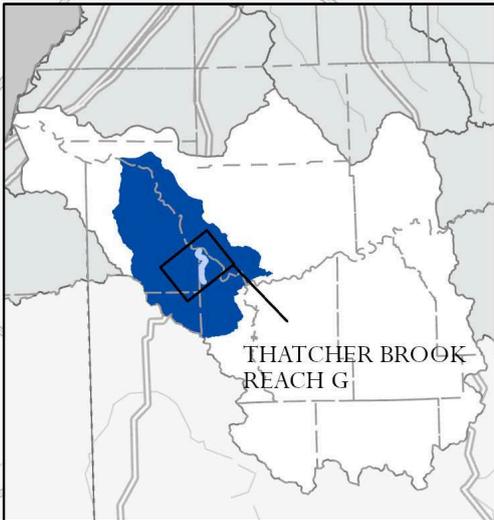
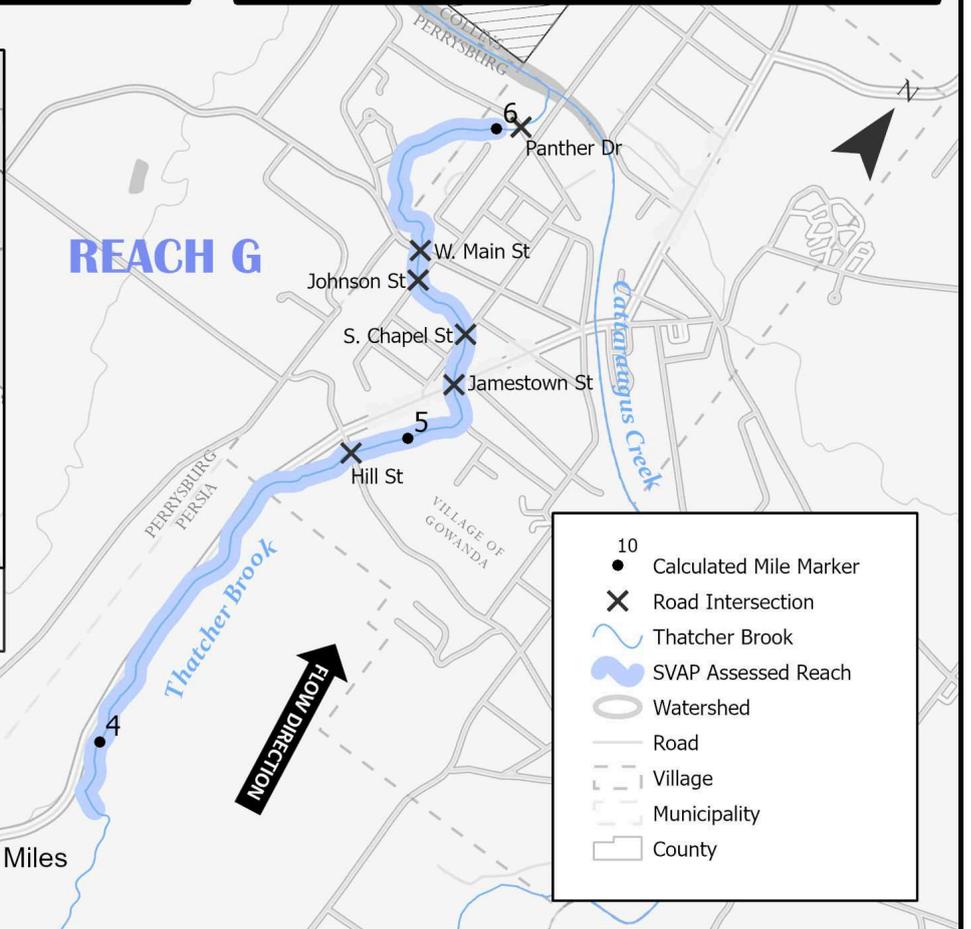
# THATCHER BROOK

STREAM VISUAL ASSESSMENT PROTOCOL (SVAP) RESULTS FOR REACH G

AVERAGE OVERALL SVAP RATING: **6.6**

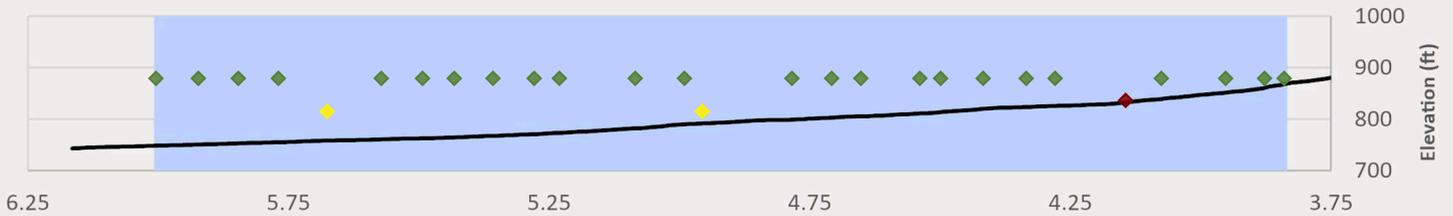
## Elevation Profile

Substrate: ◆ Bedrock ◆ Boulder ◆ Cobble ◆ Gravel ◆ Sand ◆ Silt/Clay

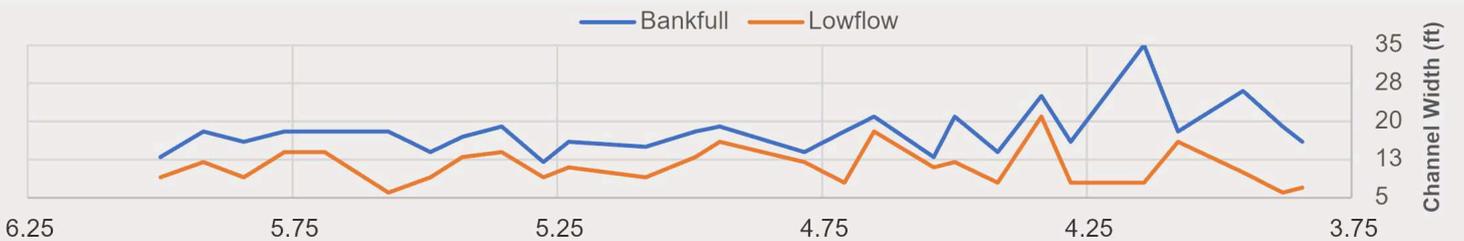
## Channel Width

← FLOW DIRECTION Creek Mile (6.00 at Tailwater, 3.84 at Headwater) ← FLOW DIRECTION

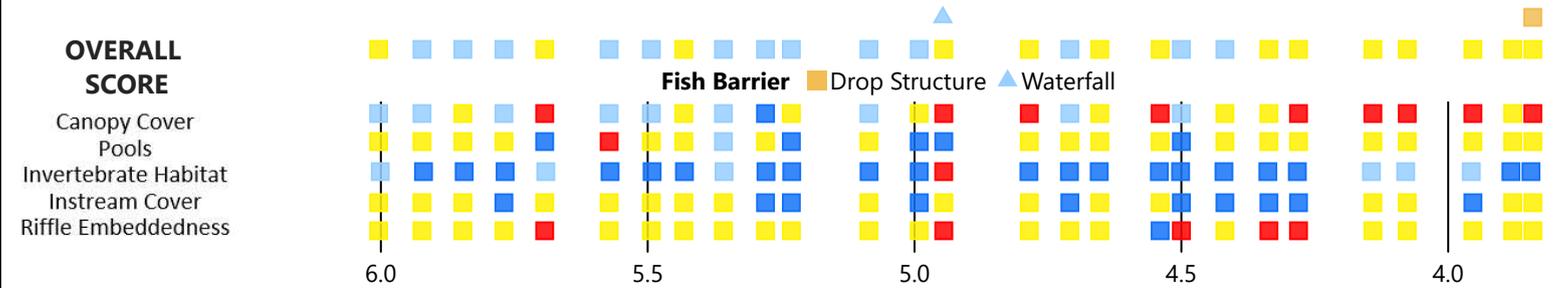
Score ■ Excellent ■ Good ■ Mediocre ■ Poor

Note: Overall Score of Fish Habitat was calculated by averaging scores for the five variables shown below.

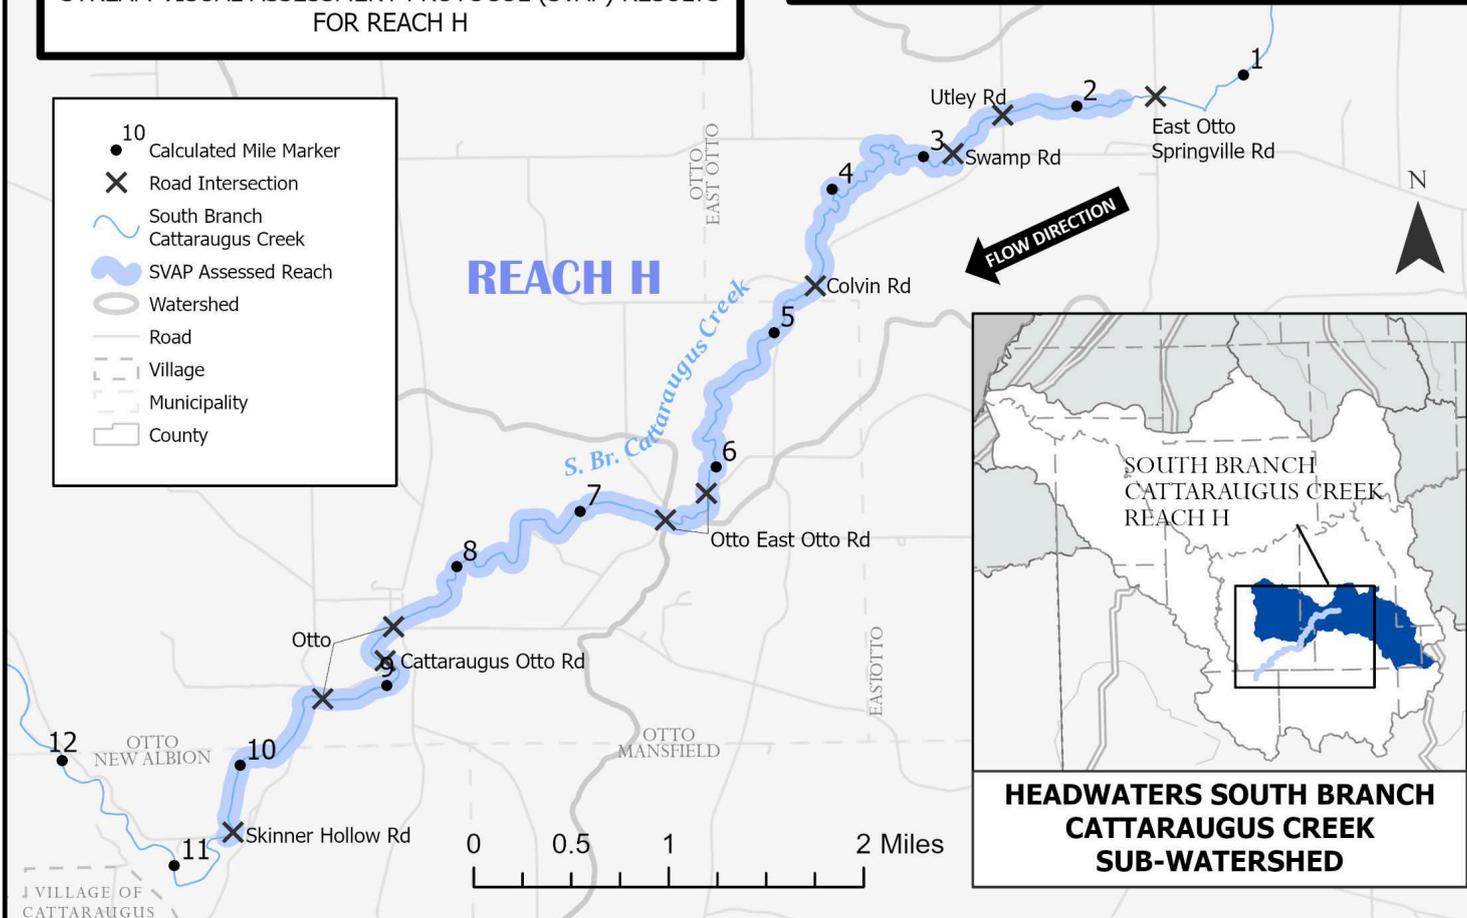
# SOUTH BRANCH CATTARAUGUS CREEK

STREAM VISUAL ASSESSMENT PROTOCOL (SVAP) RESULTS FOR REACH H

AVERAGE OVERALL SVAP RATING: **6.4**

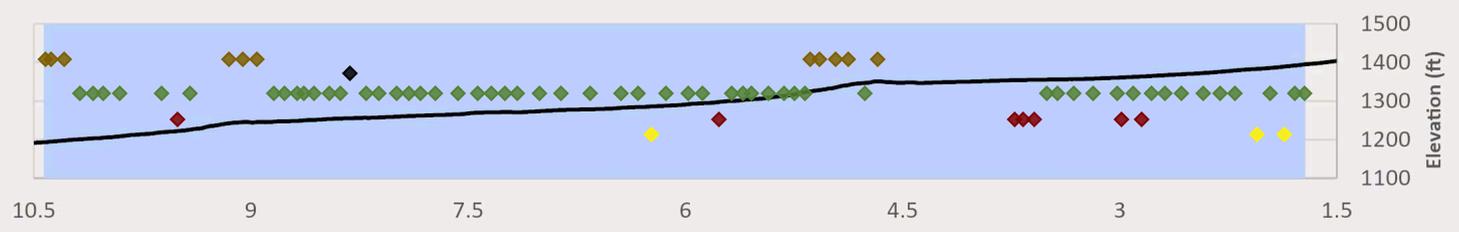
## Elevation Profile

Substrate: ◆ Bedrock ◆ Boulder ◆ Cobble ◆ Gravel ◆ Sand ◆ Silt/Clay

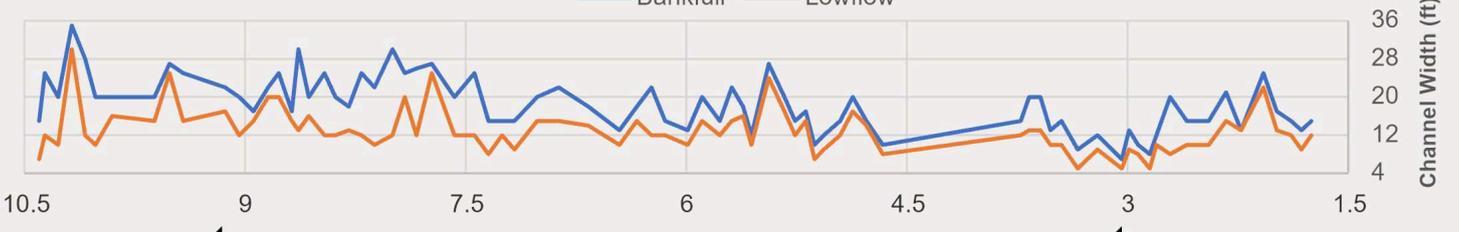
## Channel Width

← **FLOW DIRECTION** Creek Mile (10.40 at Tailwater, 1.75 at Headwater) ← **FLOW DIRECTION**

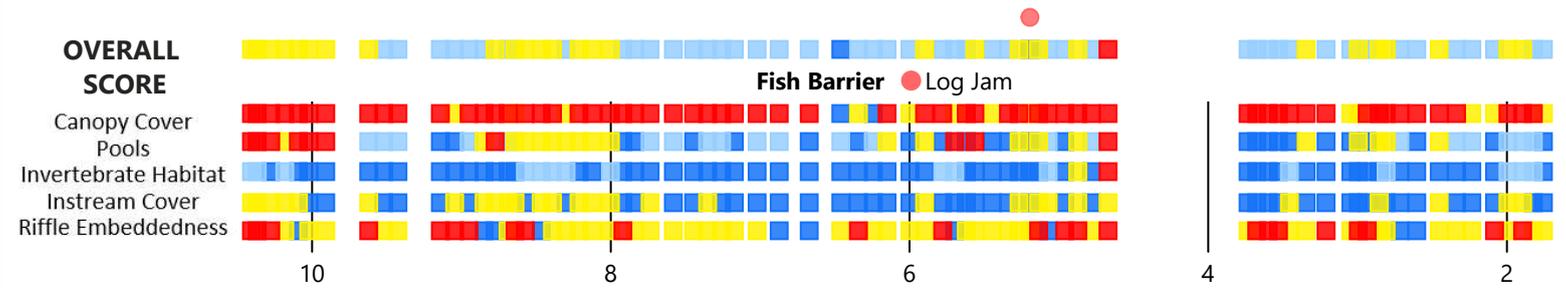
Score ■ Excellent ■ Good ■ Mediocre ■ Poor

Note: Overall Score of Fish Habitat was calculated by averaging scores for the five variables shown below.

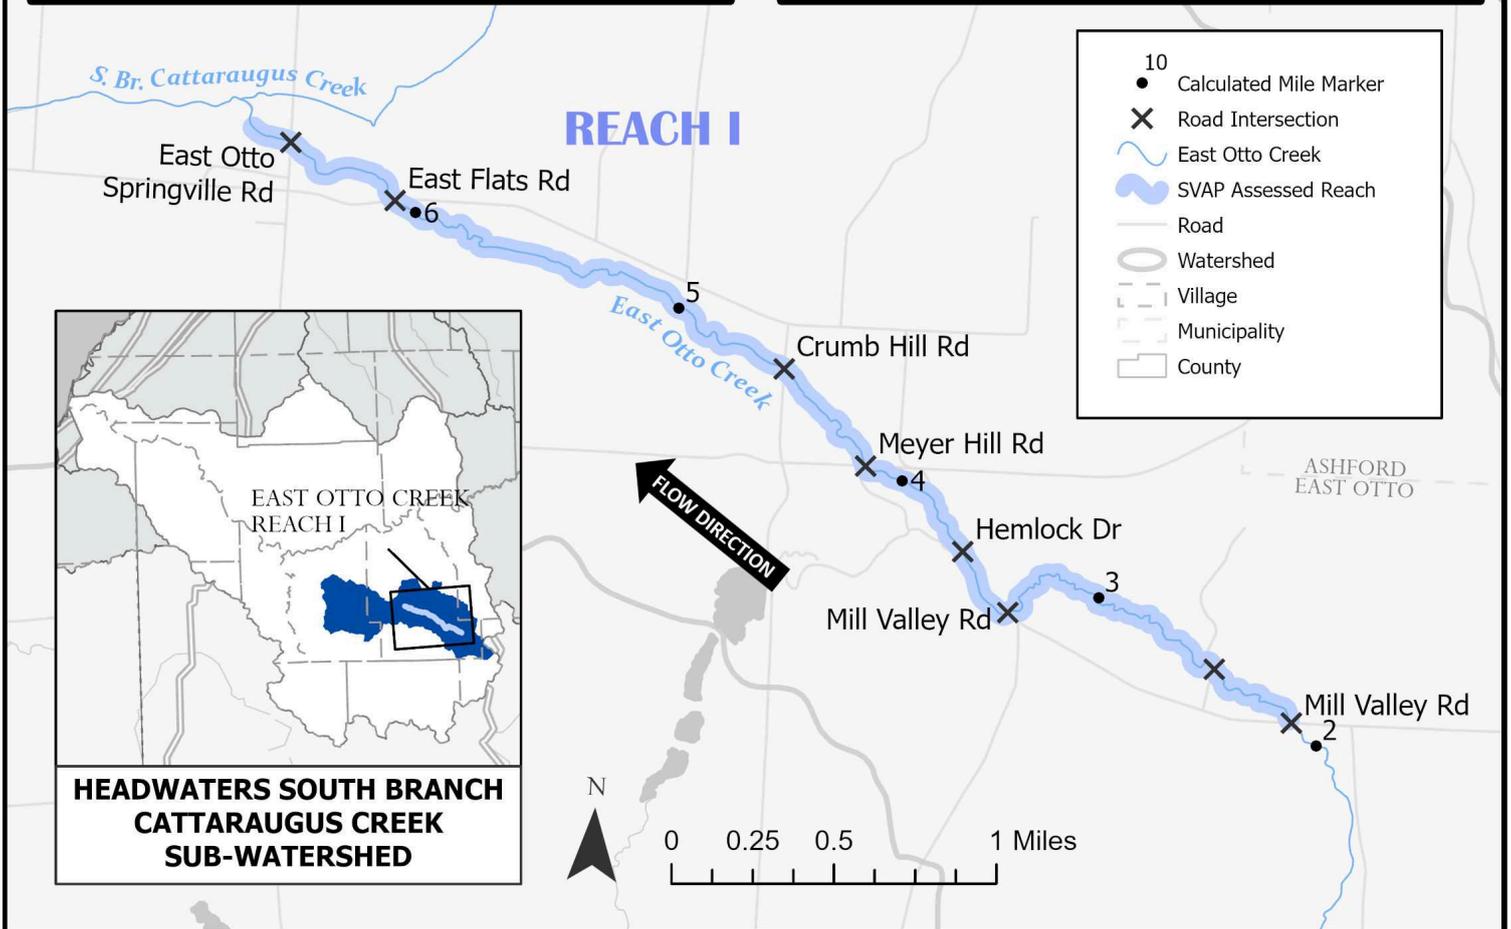
# EAST OTTO CREEK

STREAM VISUAL ASSESSMENT PROTOCOL (SVAP) RESULTS FOR REACH I

AVERAGE OVERALL SVAP RATING: **6.2**

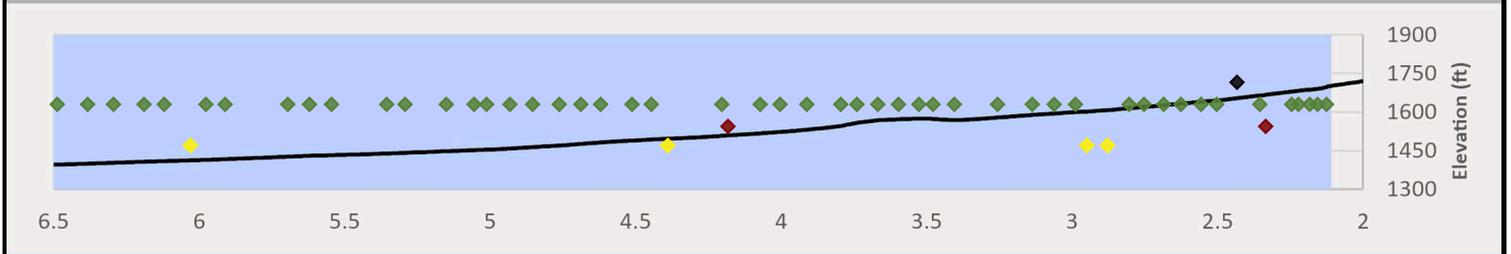
## Elevation Profile

Substrate: ◆ Bedrock ◆ Boulder ◆ Cobble ◆ Gravel ◆ Sand ◆ Silt/Clay

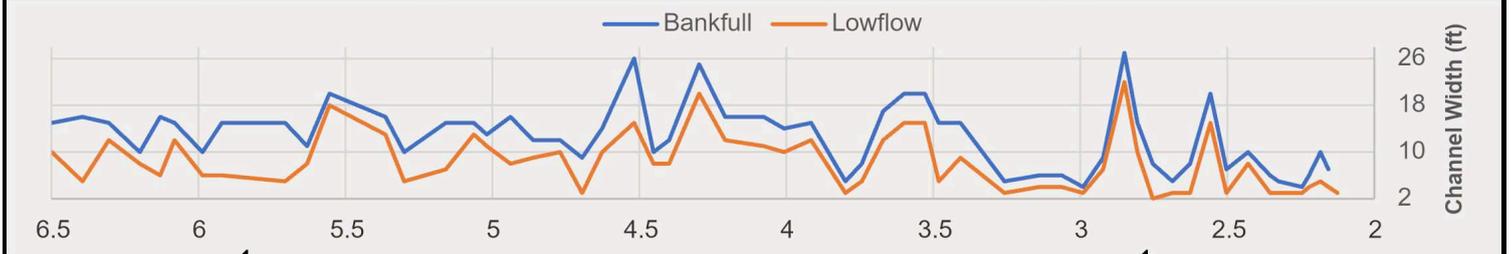
## Channel Width

← FLOW DIRECTION Creek Mile (6.50 at Tailwater, 2.13 at Headwater) → FLOW DIRECTION

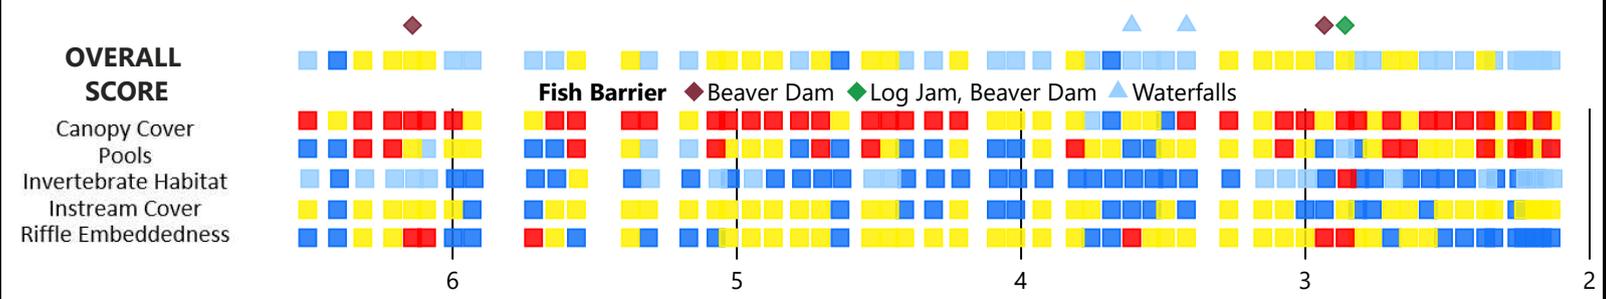
Score ■ Excellent ■ Good ■ Mediocre ■ Poor

Note: Overall Score of Fish Habitat was calculated by averaging scores for the five variables shown below.

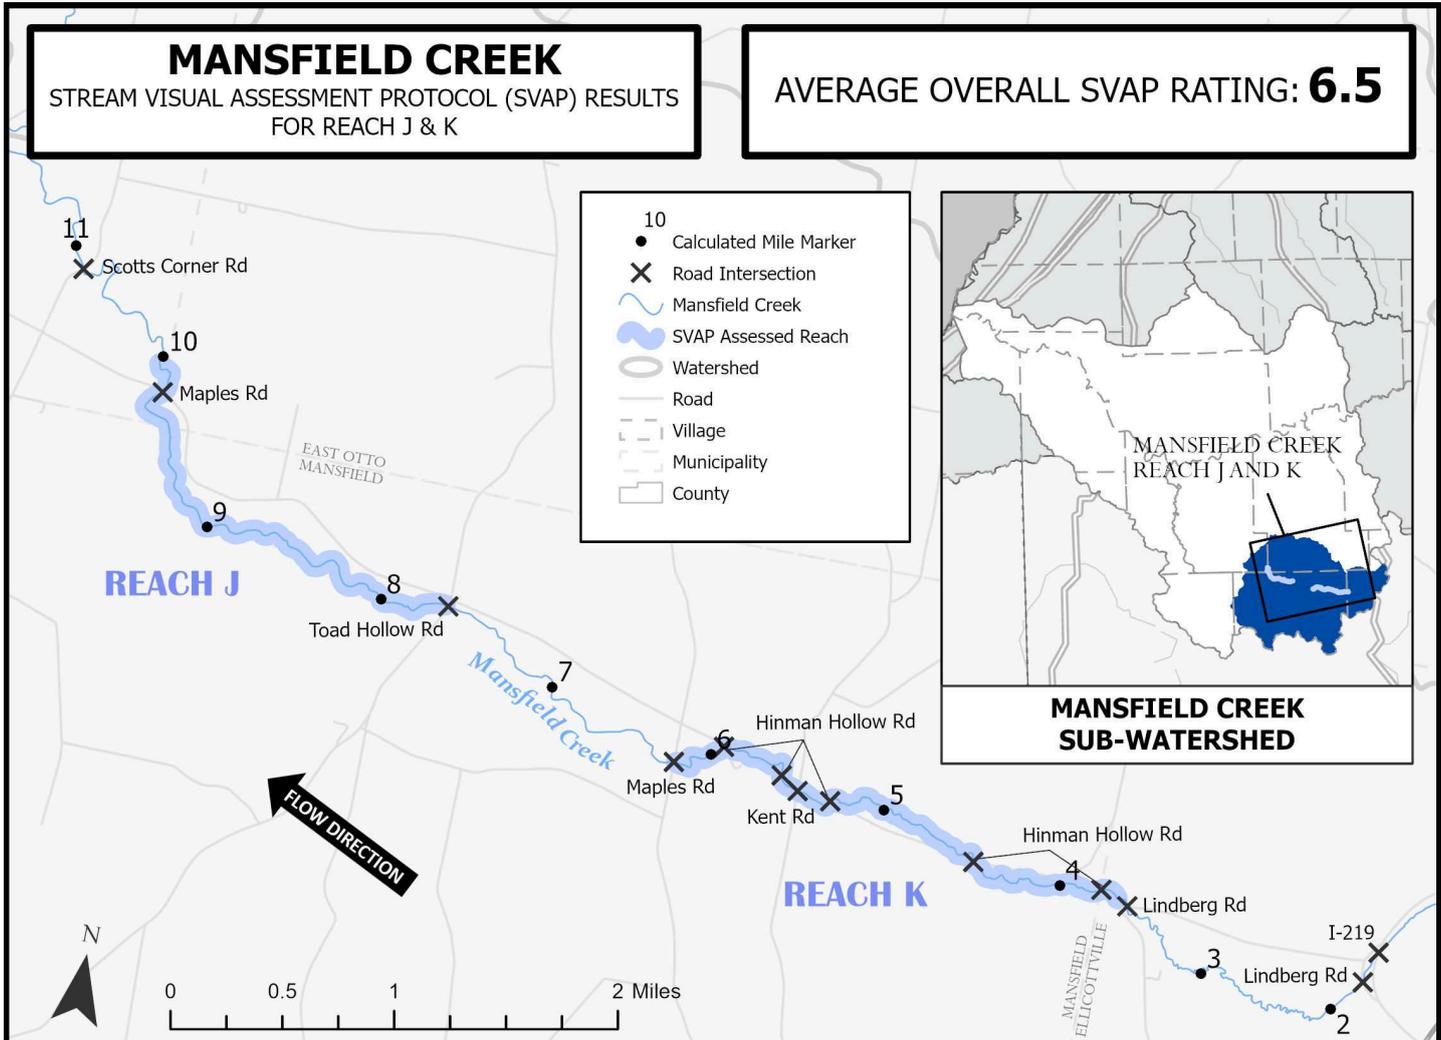
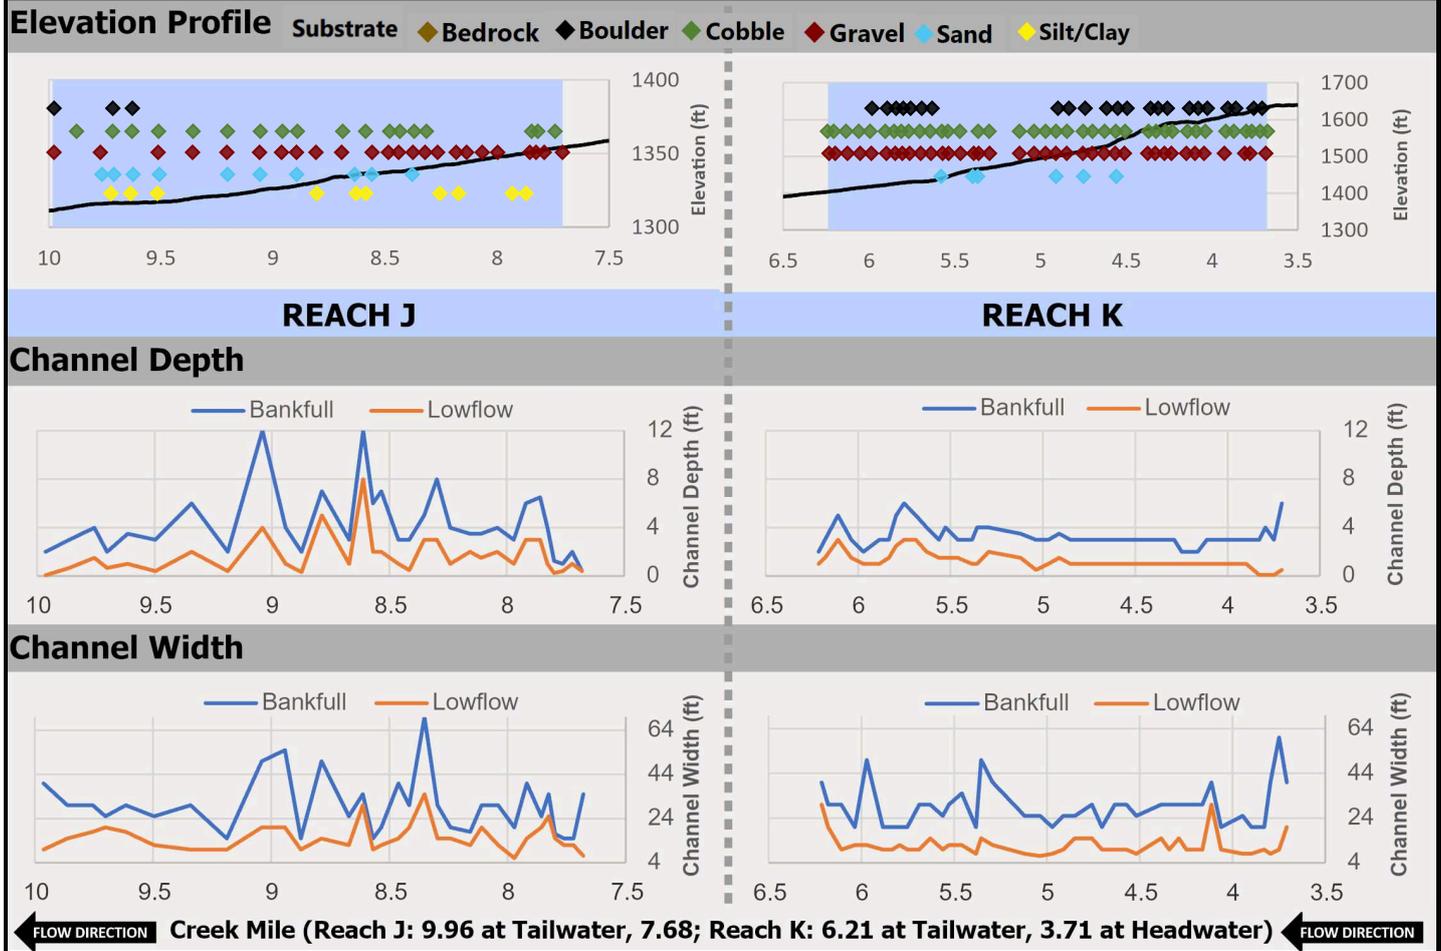
# MANSFIELD CREEK

STREAM VISUAL ASSESSMENT PROTOCOL (SVAP) RESULTS FOR REACH J & K

AVERAGE OVERALL SVAP RATING: **6.5**

← FLOW DIRECTION Creek Mile (Reach J: 9.96 at Tailwater, 7.68; Reach K: 6.21 at Tailwater, 3.71 at Headwater) → FLOW DIRECTION

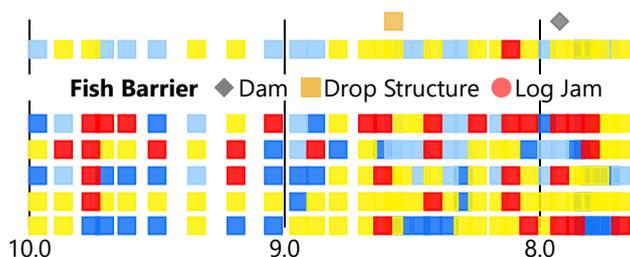
Fish Habitat Score Excellent Good Mediocre Poor

Note: Overall Score of Fish Habitat was calculated by averaging scores for the five variables shown below.

OVERALL SCORE

Canopy Cover Pools Invertebrate Habitat Instream Cover Riffle Embeddedness

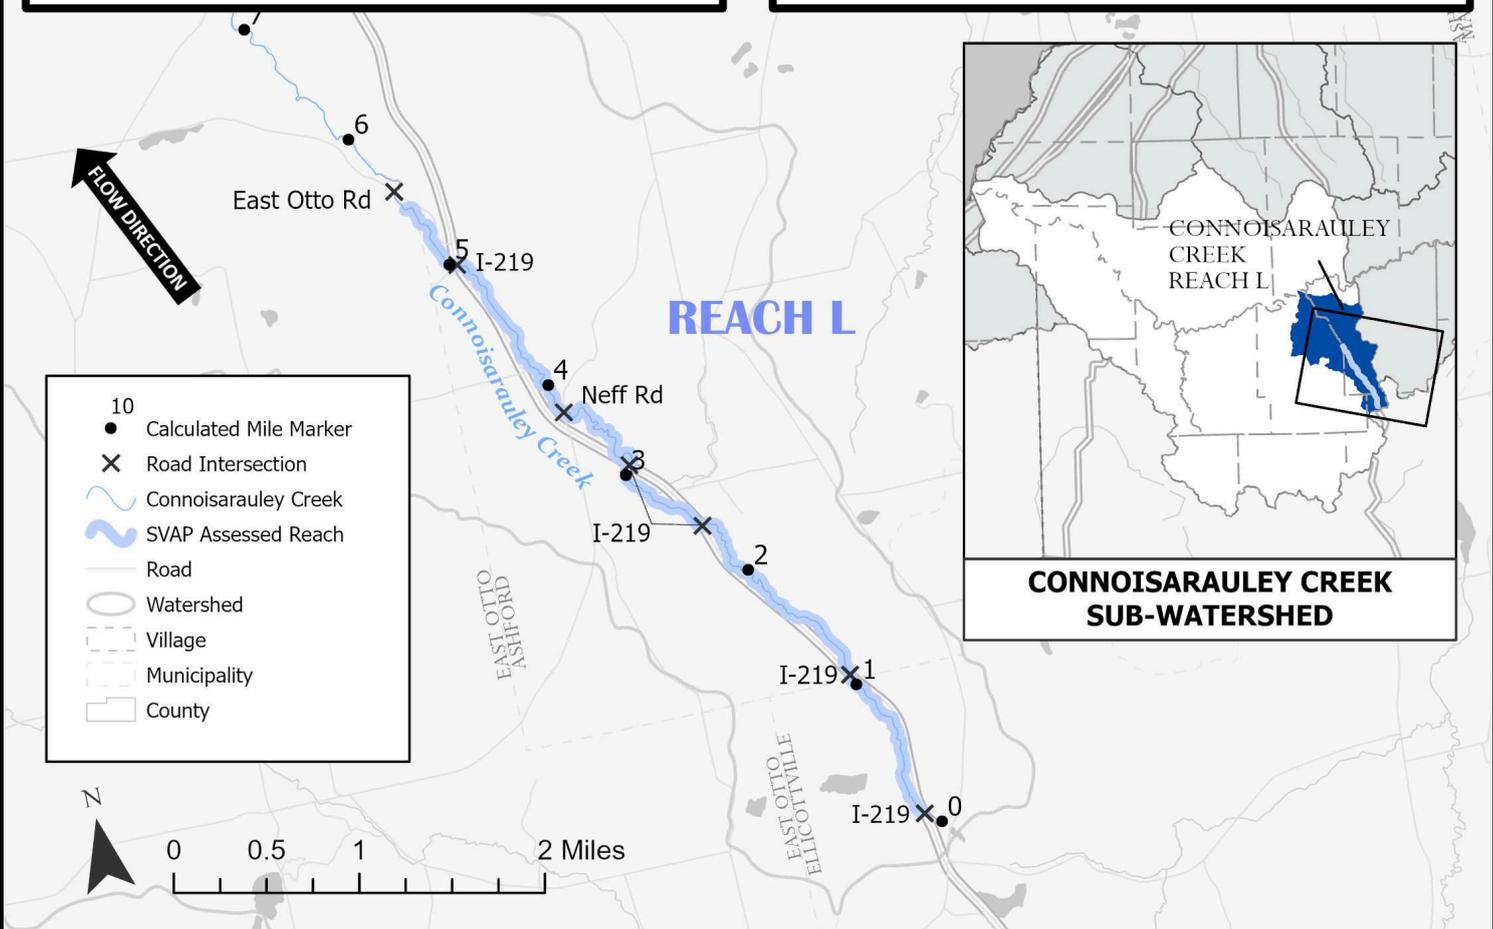
# CONNOISAULEY CREEK

STREAM VISUAL ASSESSMENT PROTOCOL (SVAP) RESULTS FOR REACH L

AVERAGE OVERALL SVAP RATING: **6.6**

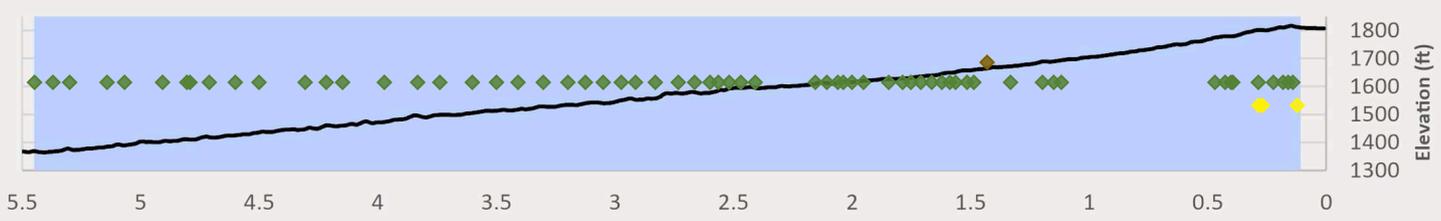
## Elevation Profile

Substrate ◆ Bedrock/Concrete ◆ Boulder ◆ Cobble ◆ Gravel ◆ Sand ◆ Silt/Clay

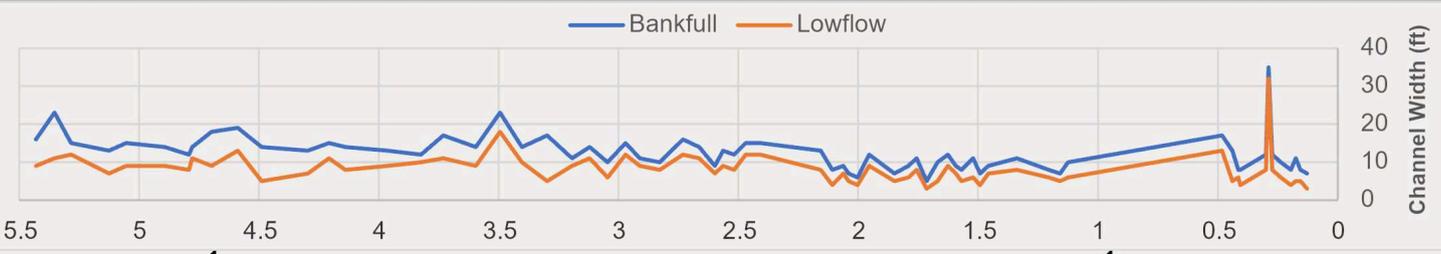
## Channel Width

← FLOW DIRECTION Creek Mile (5.43 at Tailwater, 0.13 at Headwater) ← FLOW DIRECTION

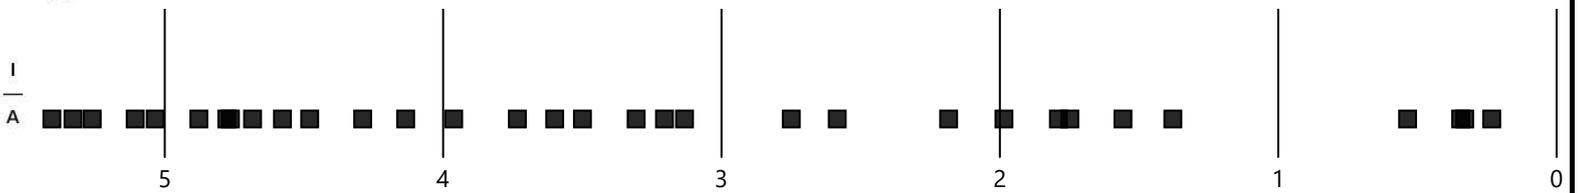
### Aggradation/Incision

■ Aggradation ▲ Incision

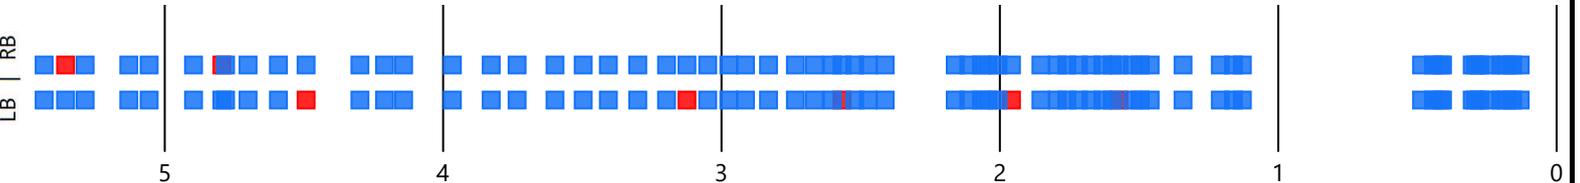
### Bank Condition

■ Hardened Structure ■ Natural
