# CATTARAUGUS CREEK SUB-WATERSHED SVAP MILEAGE 2024

## Stream Visual Assessment Protocol - SVAP

NOTE: SVAP walked data collected 2024. Desktop analysis conducted with 2022 Orthoimagery and 2023 Eagleview imagery. Reach F assessed through a combination of field and desktop analysis data. Waterway reaches were assessed using a modified SVAP procedure from the USDA Natural Resources Conservation Service. 60.10 miles of waterways were assessed out of a total of 839.15 miles of waterways.

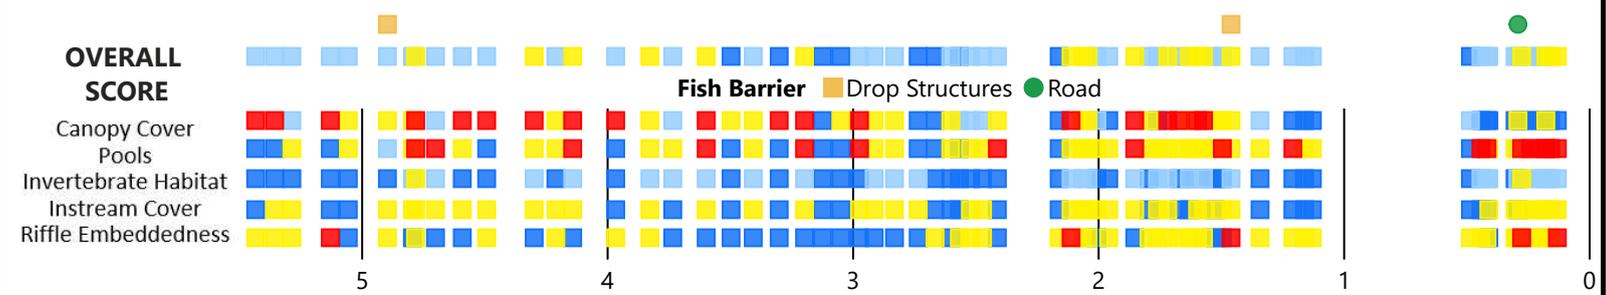
Score ■ Excellent ■ Good ■ Mediocre ■ Poor

Note: Overall Score of Fish Habitat was calculated by averaging scores for the five variables shown below.

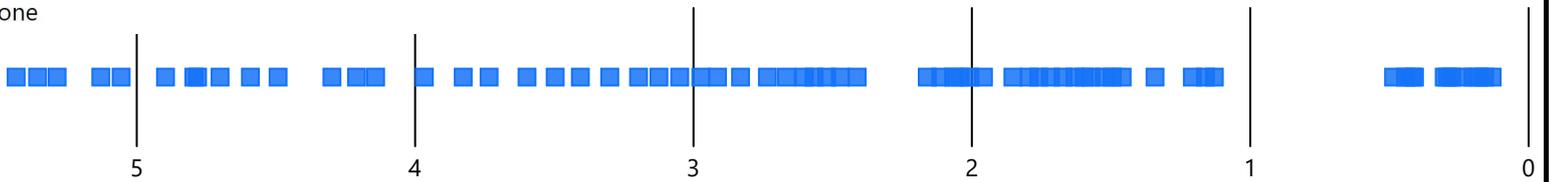
Manure Presence

■ None
