# CAYUGA CREEK SUB-WATERSHED SVAP MILEAGE 2021

**Stream Visual Assessment Protocol - SVAP**

NOTE: Waterway reaches were assessed using a modified SVAP procedure from the USDA Natural Resources Conservation Service. 31.54 miles of waterways were assessed out of a total of 356.91 miles of waterways.

STREAM VISUAL ASSESSMENT PROTOCOL (SVAP) RESULTS FOR REACH A & B

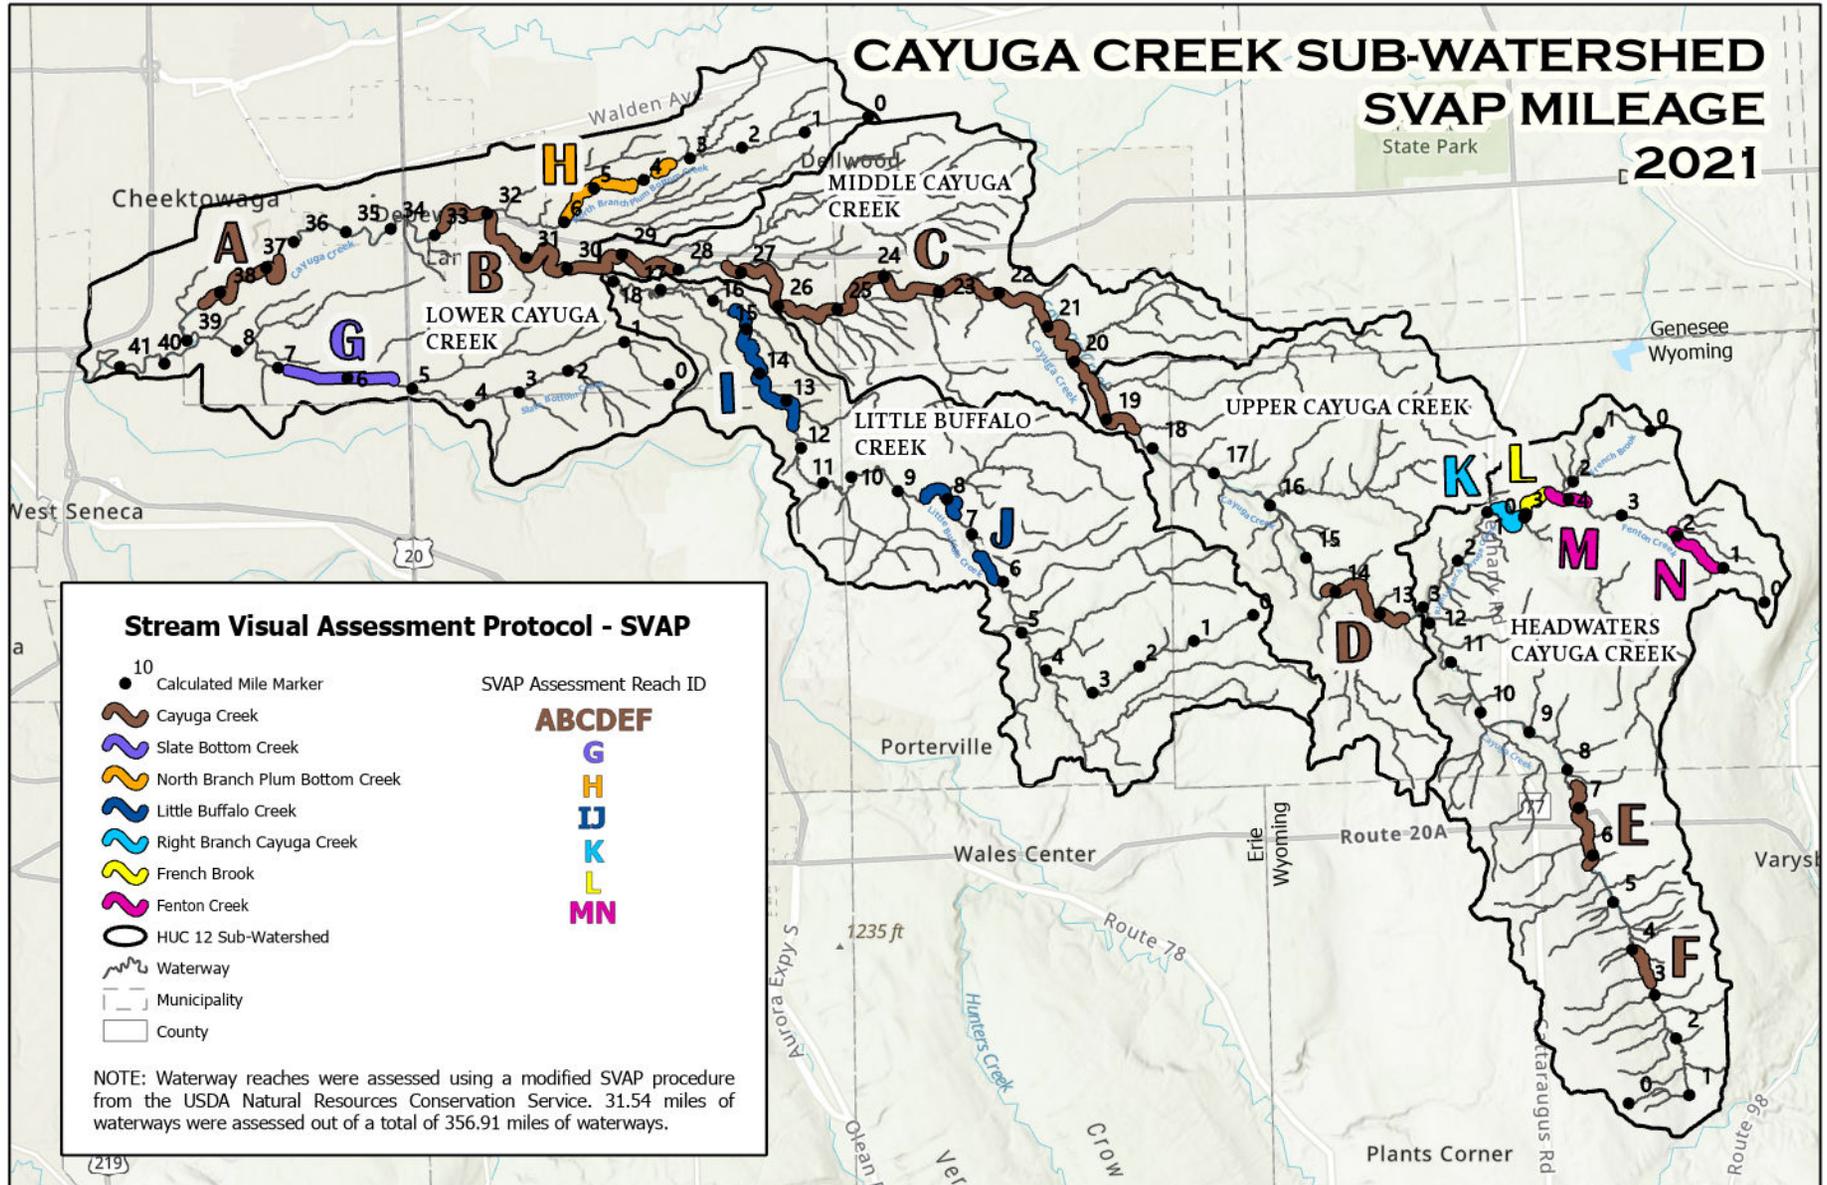
- 10 Calculated Mile Marker
- Cayuga Creek
- Slate Bottom Creek
- North Branch Plum Bottom Creek
- Little Buffalo Creek
- Right Branch Cayuga Creek
- French Brook
- Fenton Creek
- HUC 12 Sub-Watershed
- Waterway
- Municipality
- County

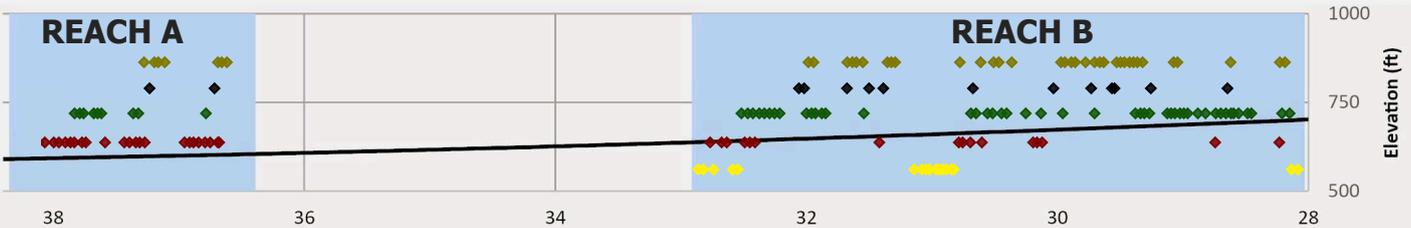
## Elevation Profile

← FLOW DIRECTION Creek Mile (38.30 at Tailwater, 28.08 at Headwater) → FLOW DIRECTION

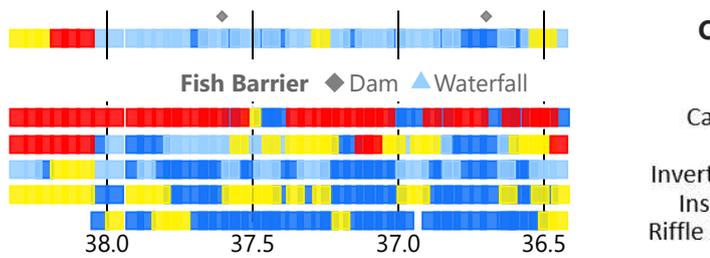
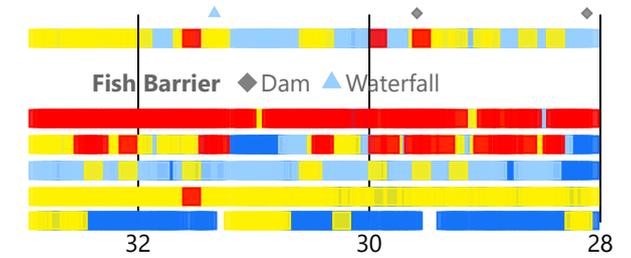
Note: Overall Score of Fish Habitat was calculated by averaging scores for the five variables shown below.

- Canopy Cover Pools Invertebrate Habitat Instream Cover Riffle Embeddedness

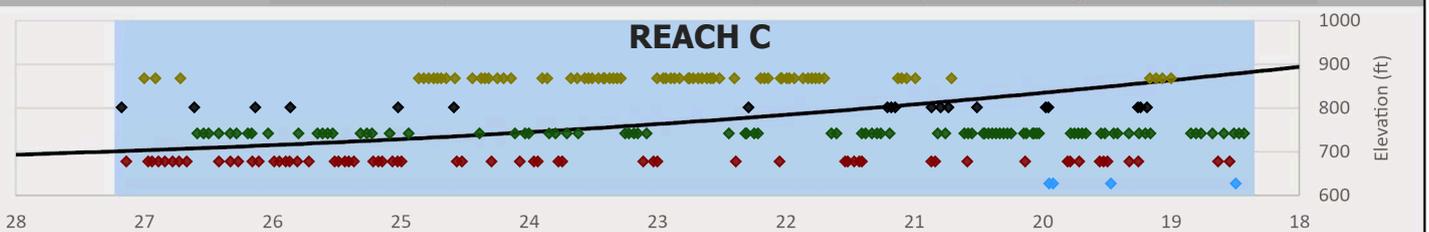
**Elevation Profile** Substrate ◆ Bedrock/Concrete ◆ Boulder ◆ Cobble ◆ Gravel ◆ Sand

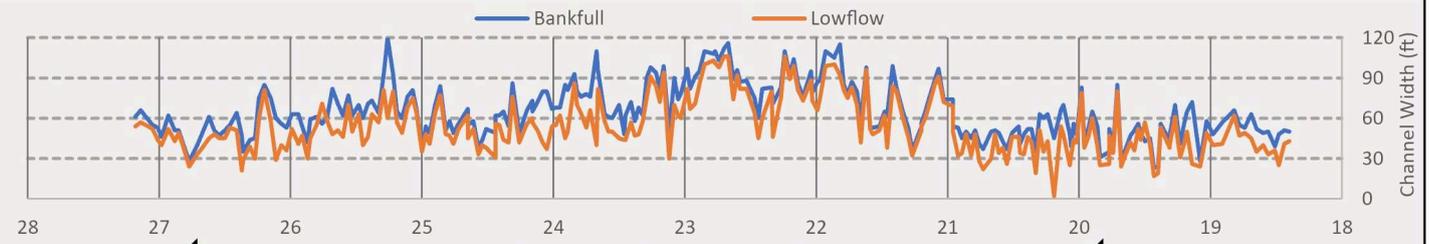
**Channel Width**

← **FLOW DIRECTION** Creek Mile (27.18 at Tailwater, 18.40 at Headwater) **FLOW DIRECTION** →

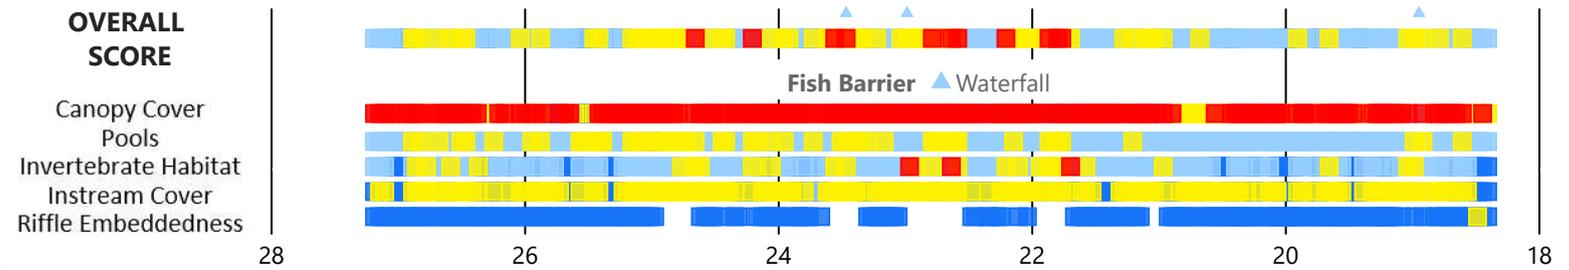
## Fish Habitat

Note: Overall Score of Fish Habitat was calculated by averaging scores for the five variables shown below.

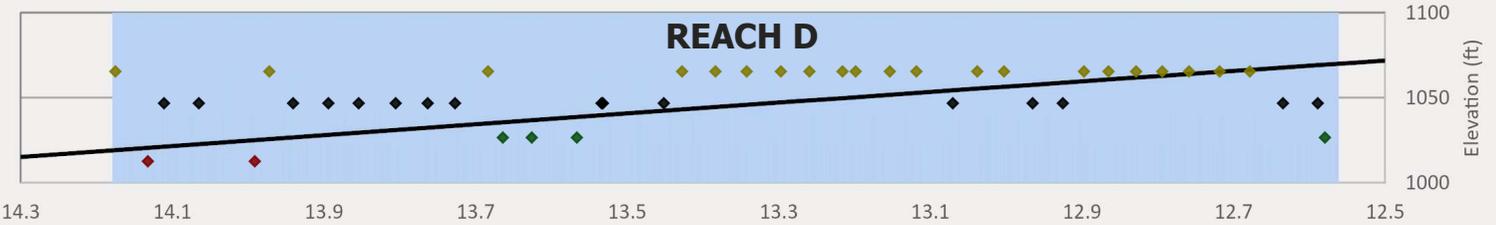
**Elevation Profile** Substrate ◆ Bedrock/Concrete ◆ Boulder ◆ Cobble ◆ Gravel

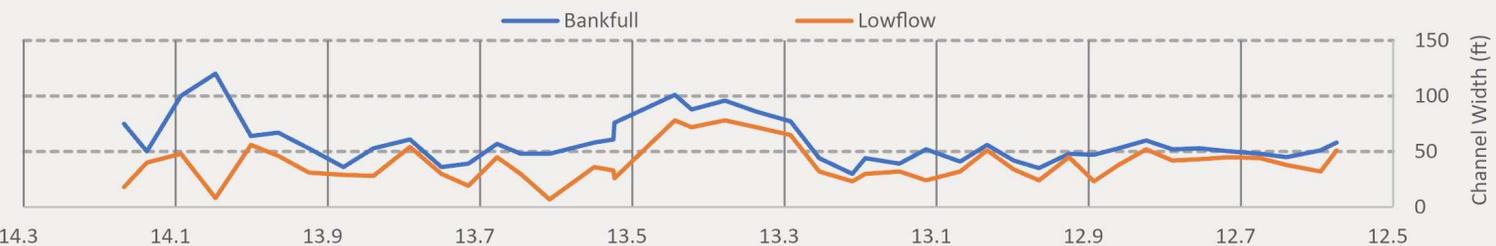
**Channel Width**

Creek Mile (14.17 at Tailwater, 12.57 at Headwater)

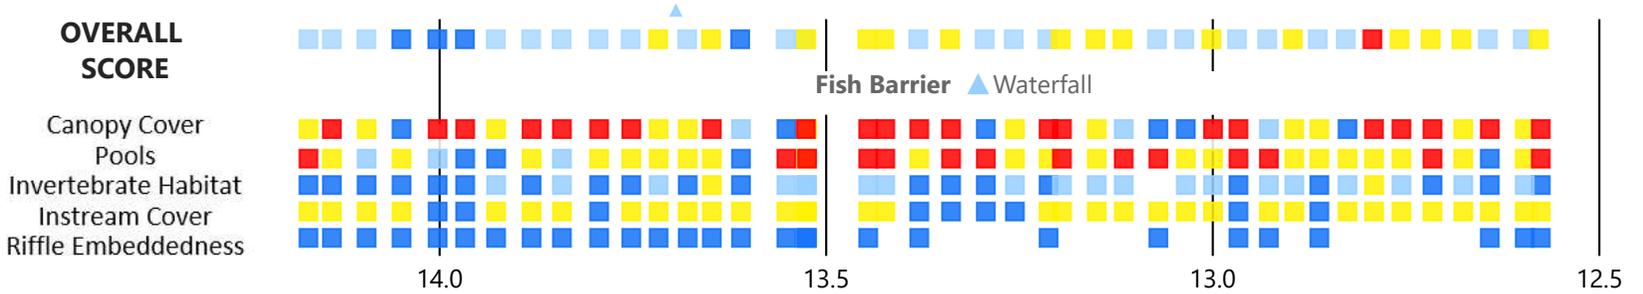
Note: Overall Score of Fish Habitat was calculated by averaging scores for the five variables shown below.

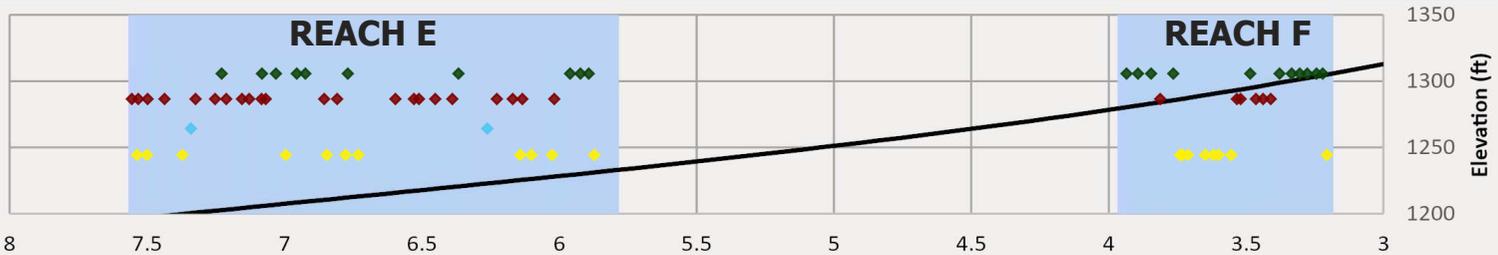
**Elevation Profile**    Substrate    ◆ Cobble    ◆ Gravel    ◆ Sand    ◆ Silt/Clay

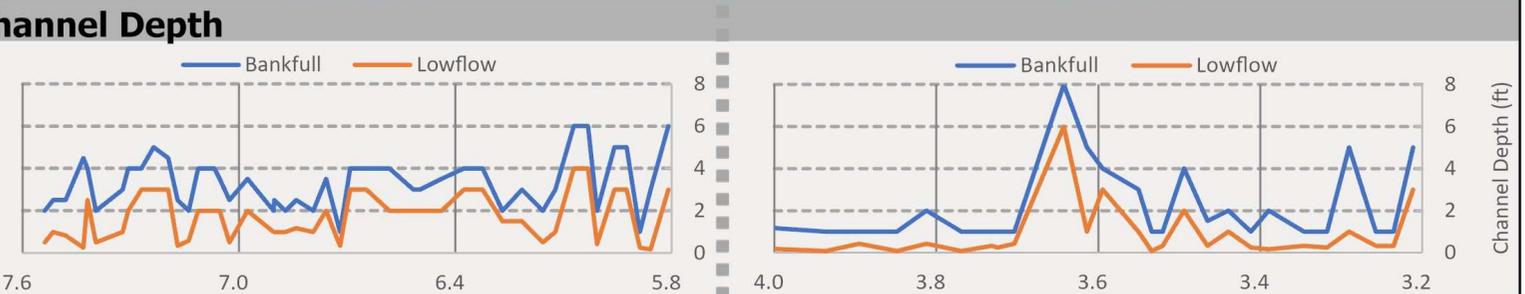
**Channel Depth**    **REACH E**    **REACH F**

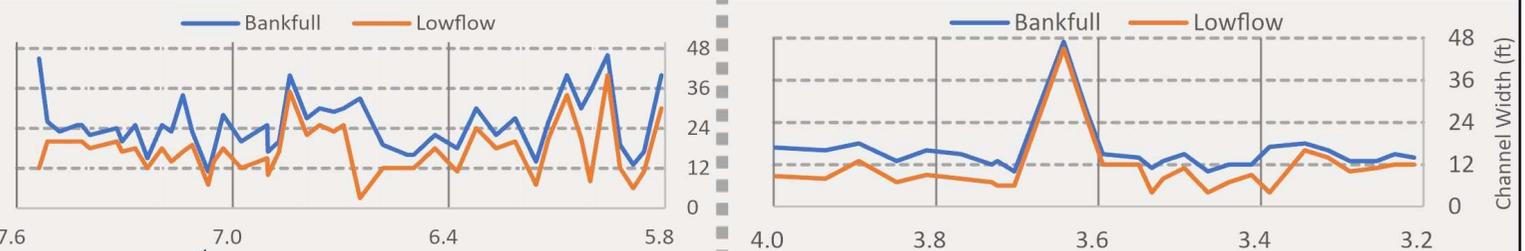
**Channel Width**

← **FLOW DIRECTION**    **Creek Mile (7.54 at Tailwater, 3.21 at Headwater)**    **FLOW DIRECTION** →

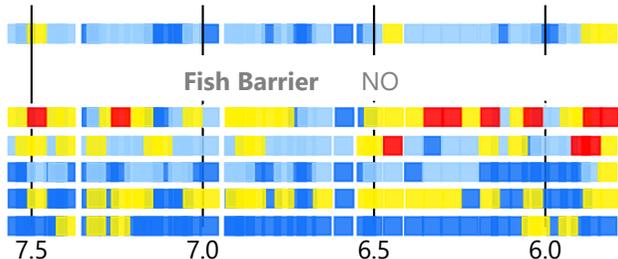
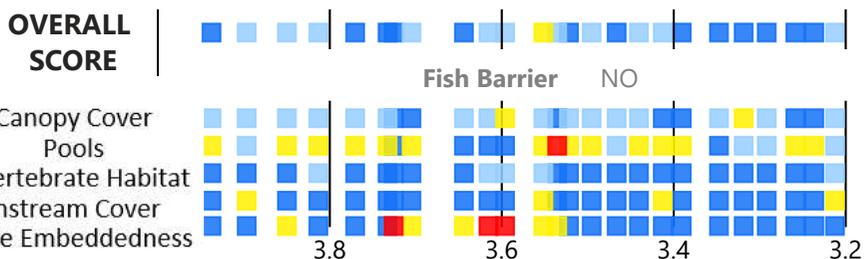
Note: Overall Score of Fish Habitat was calculated by averaging scores for the five variables shown below.

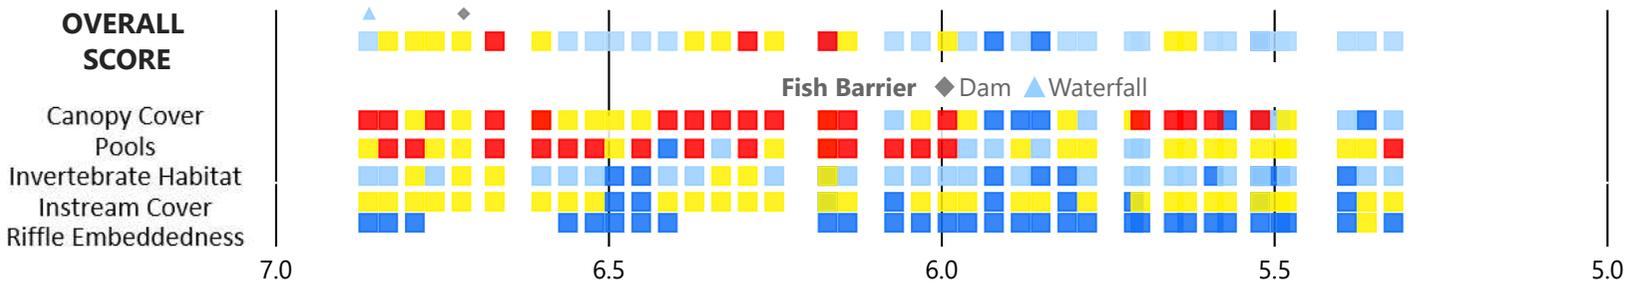
## Fish Habitat

Note: Overall Score of Fish Habitat was calculated by averaging scores for the five variables shown below.

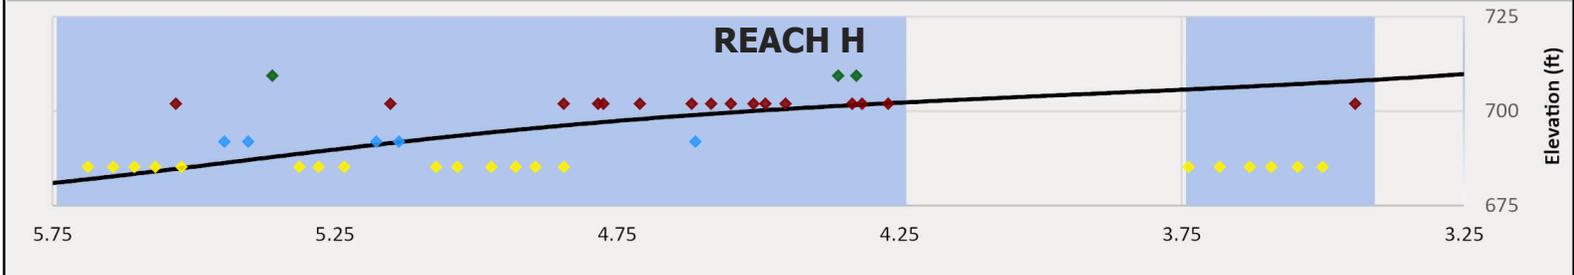
**Elevation Profile** Substrate ◆ Cobble ◆ Gravel ◆ Sand ◆ Silt/Clay

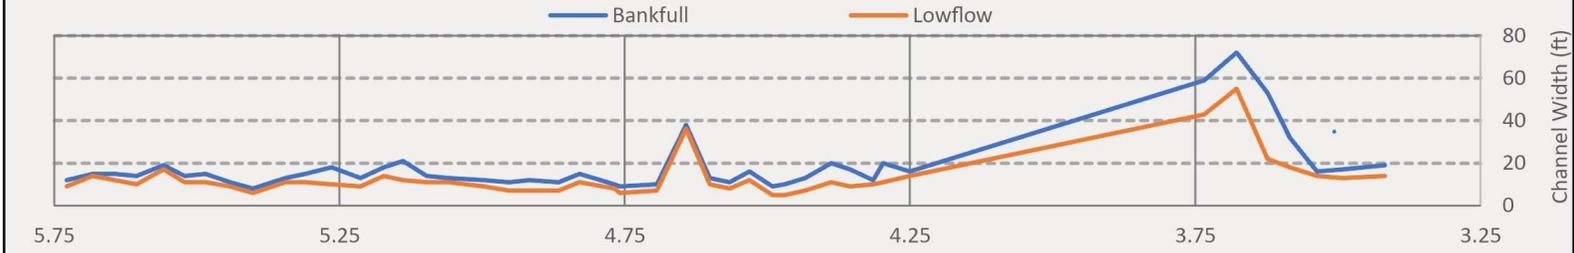
**Channel Width**

← **FLOW DIRECTION** **Creek Mile (5.73 at Tailwater, 3.42 at Headwater)** ← **FLOW DIRECTION**

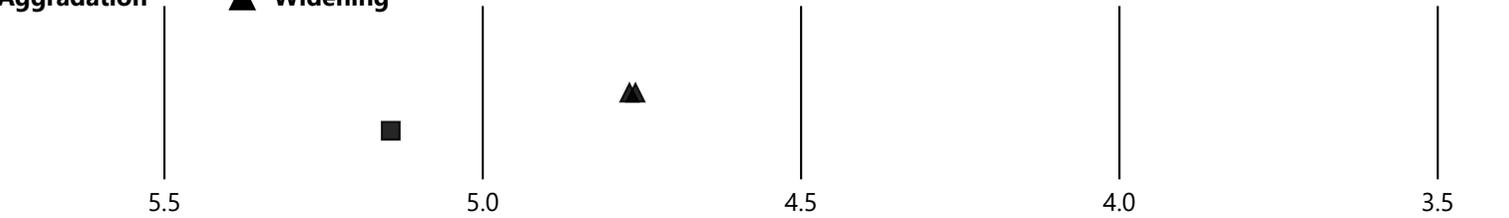
## Bank Stability

Average LB/RB ■ Excellent ■ Good ■ Mediocre ■ Poor

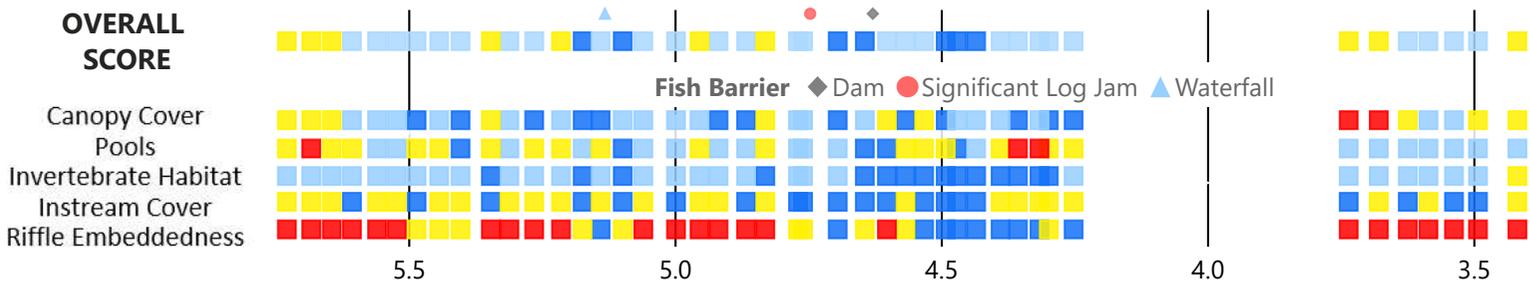
Score ■ Excellent ■ Good ■ Mediocre ■ Poor

Note: Overall Score of Fish Habitat was calculated by averaging scores for the five variables shown below.

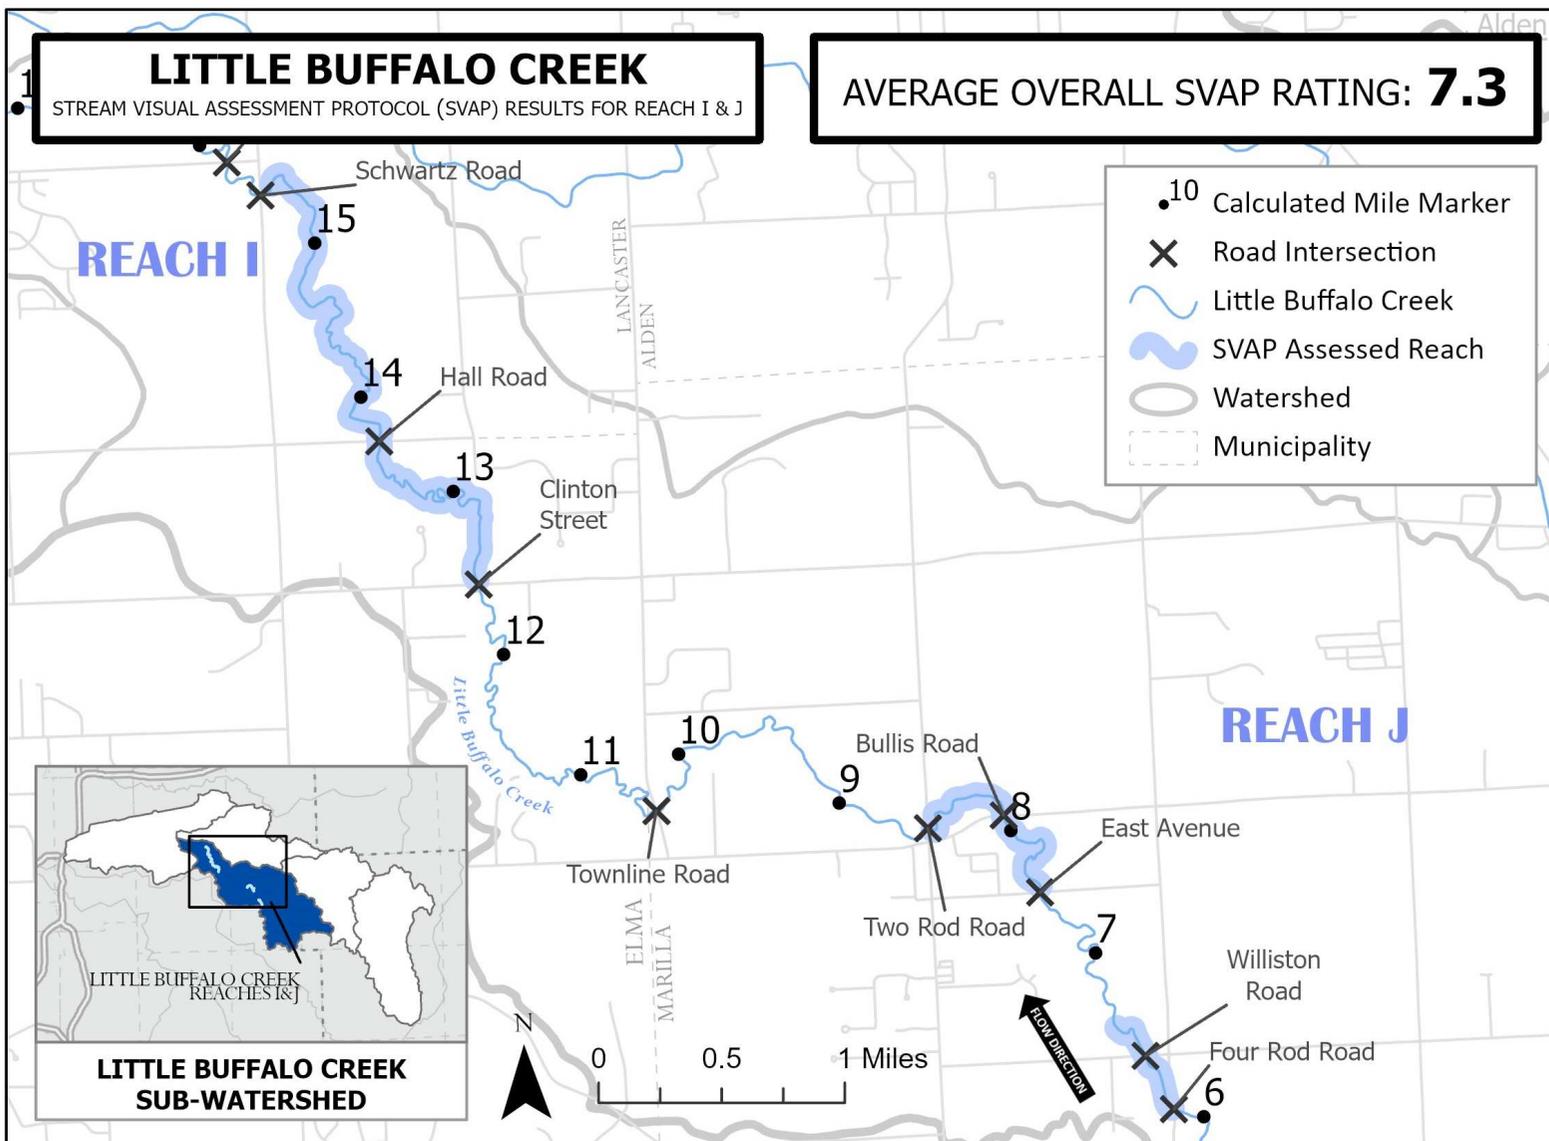
# LITTLE BUFFALO CREEK

STREAM VISUAL ASSESSMENT PROTOCOL (SVAP) RESULTS FOR REACH I & J

AVERAGE OVERALL SVAP RATING: **7.3**

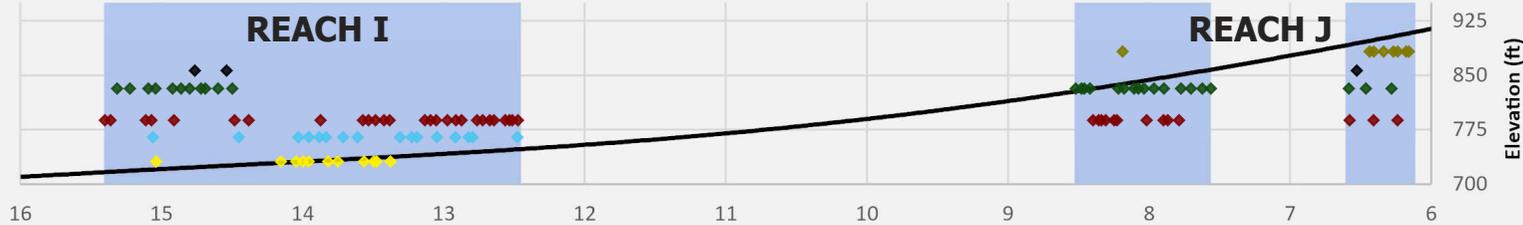
## Elevation Profile

**FLOW DIRECTION** ← **Creek Mile (15.40 at Tailwater, 6.12 at Headwater)** ← **FLOW DIRECTION**

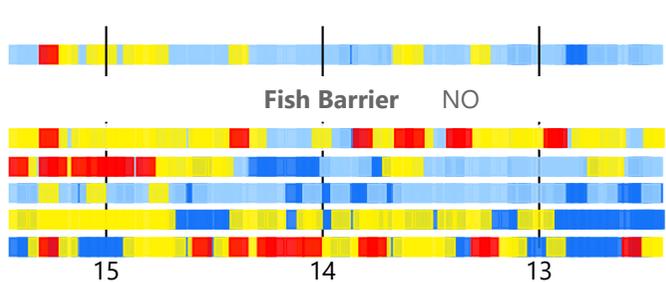
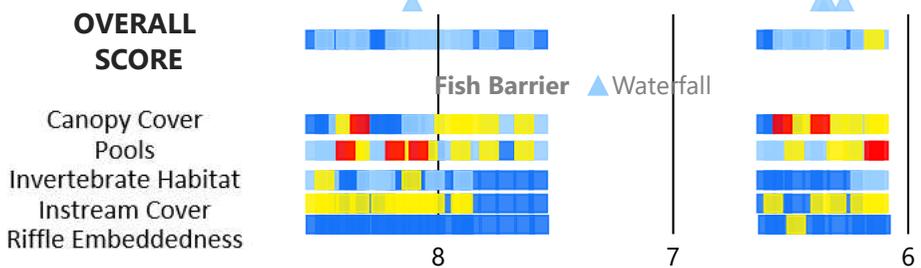
Score Excellent Good Mediocre Poor

Note: Overall Score of Fish Habitat was calculated by averaging scores for the five variables shown below.

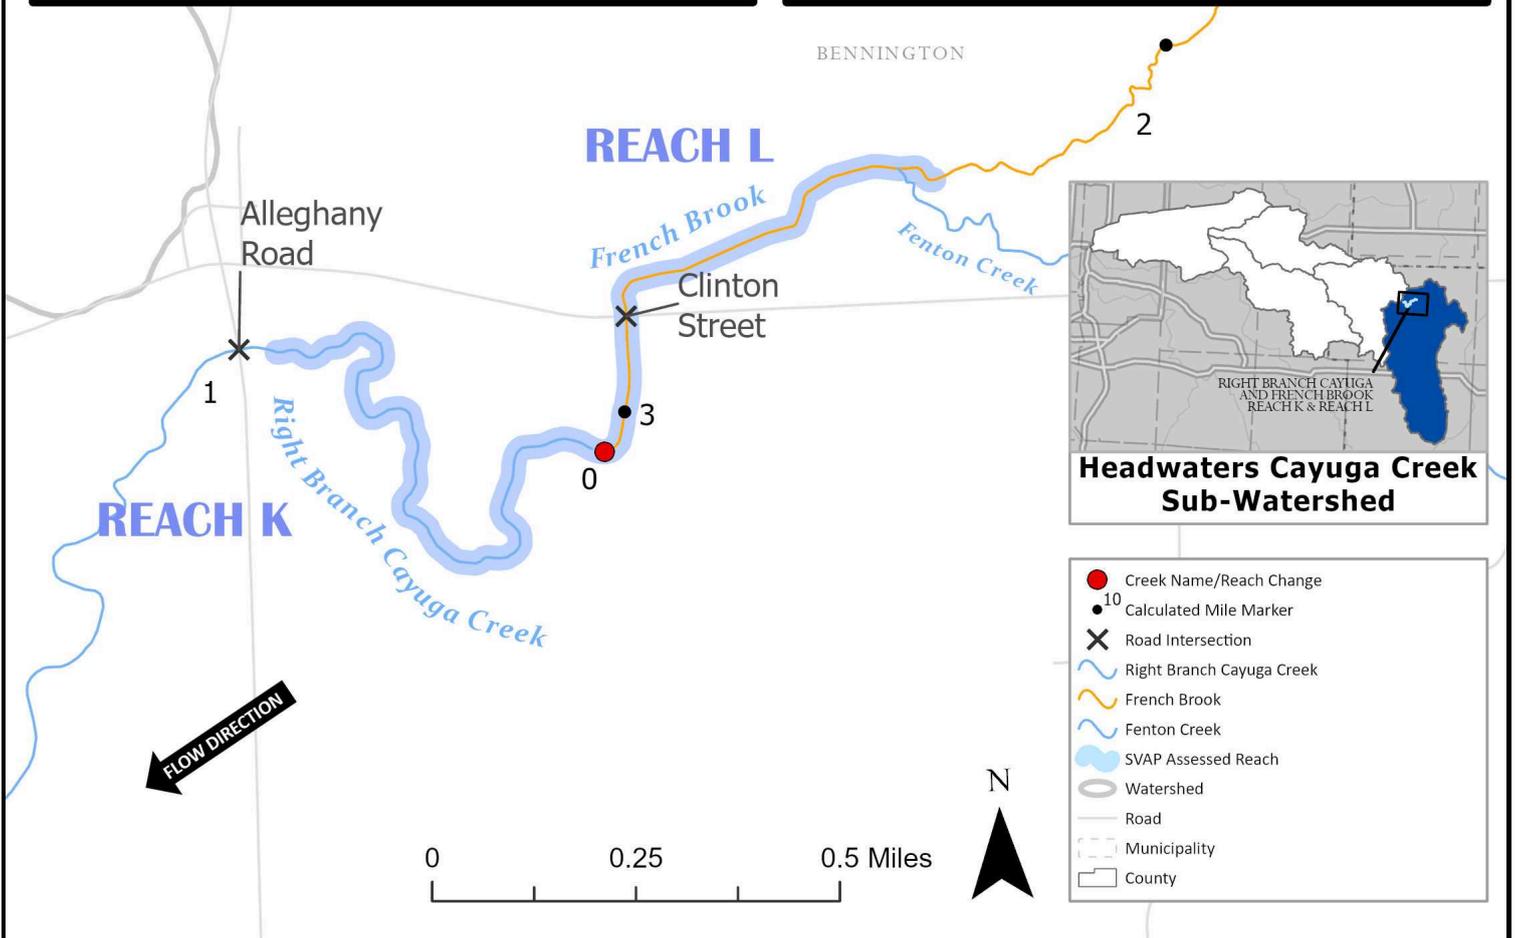
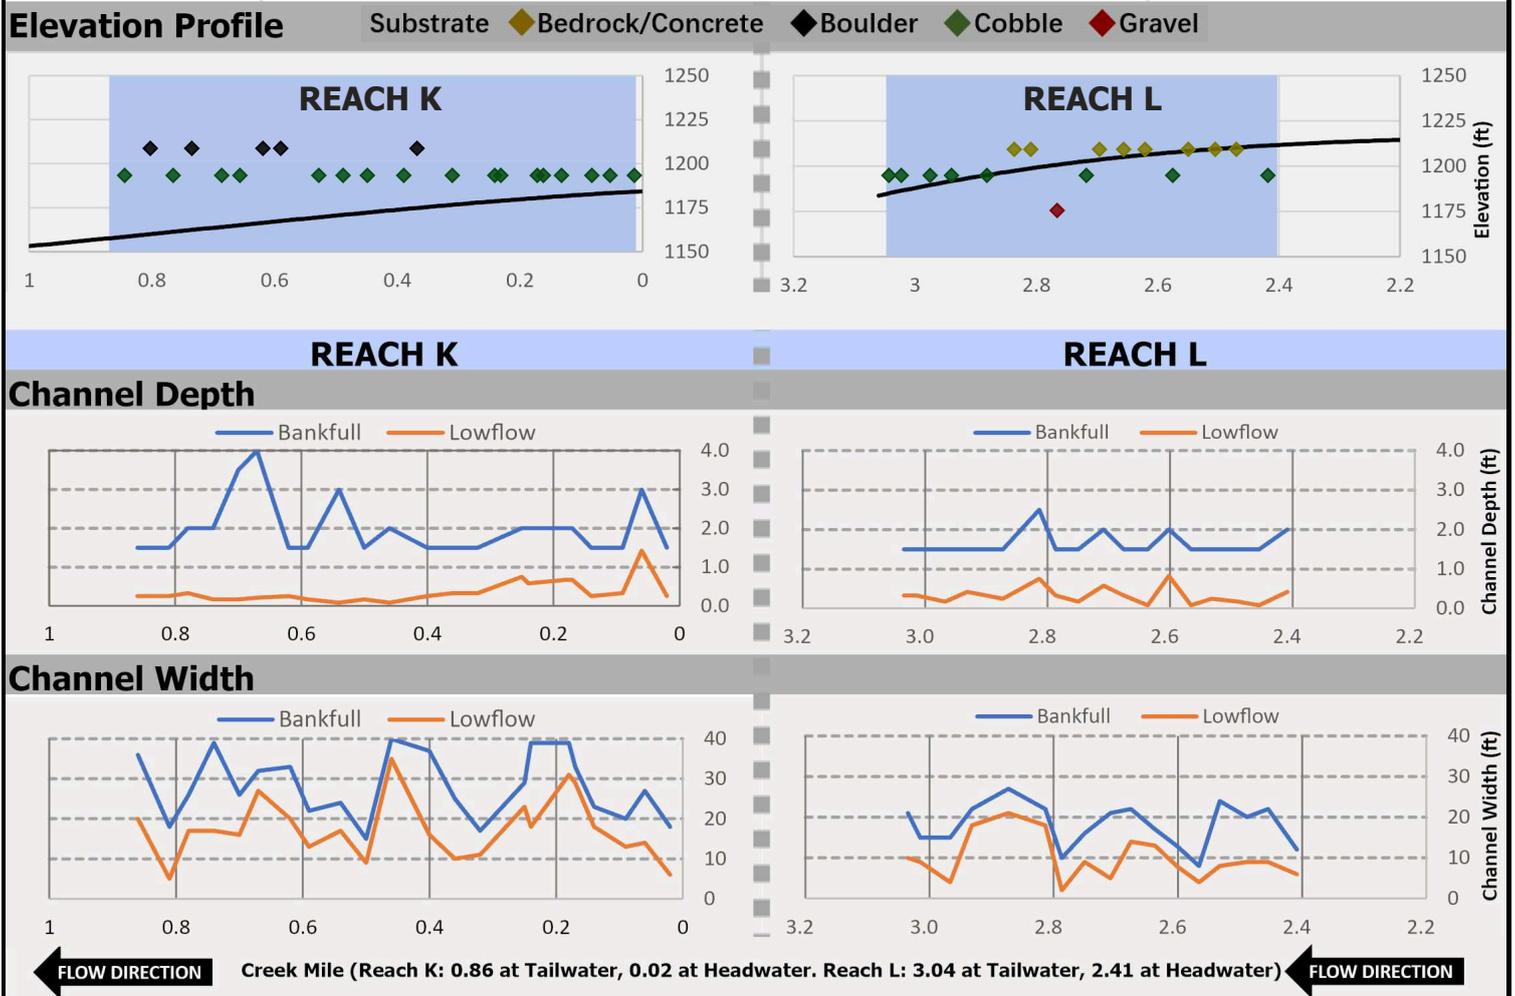
**RIGHT BRANCH CAYUGA CREEK AND FRENCH BROOK**  
SVAP SAMPLING RESULTS FOR REACH K AND L

**AVERAGE OVERALL SVAP RATING:**  
REACH K: **7.2**, REACH L: **6.9**

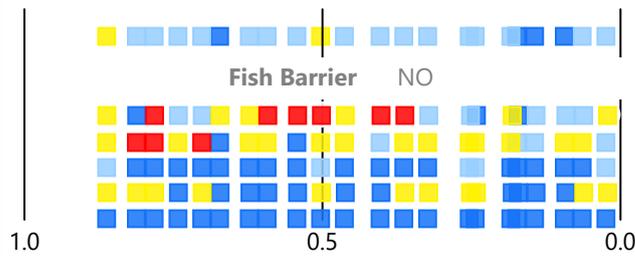
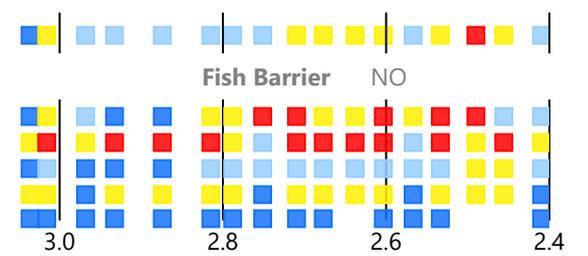
Score Excellent Good Mediocre Poor

Note: Overall Score of Fish Habitat was calculated by averaging scores for the five variables shown below.

Canopy Cover Pools Invertebrate Habitat Instream Cover Riffle Embeddedness

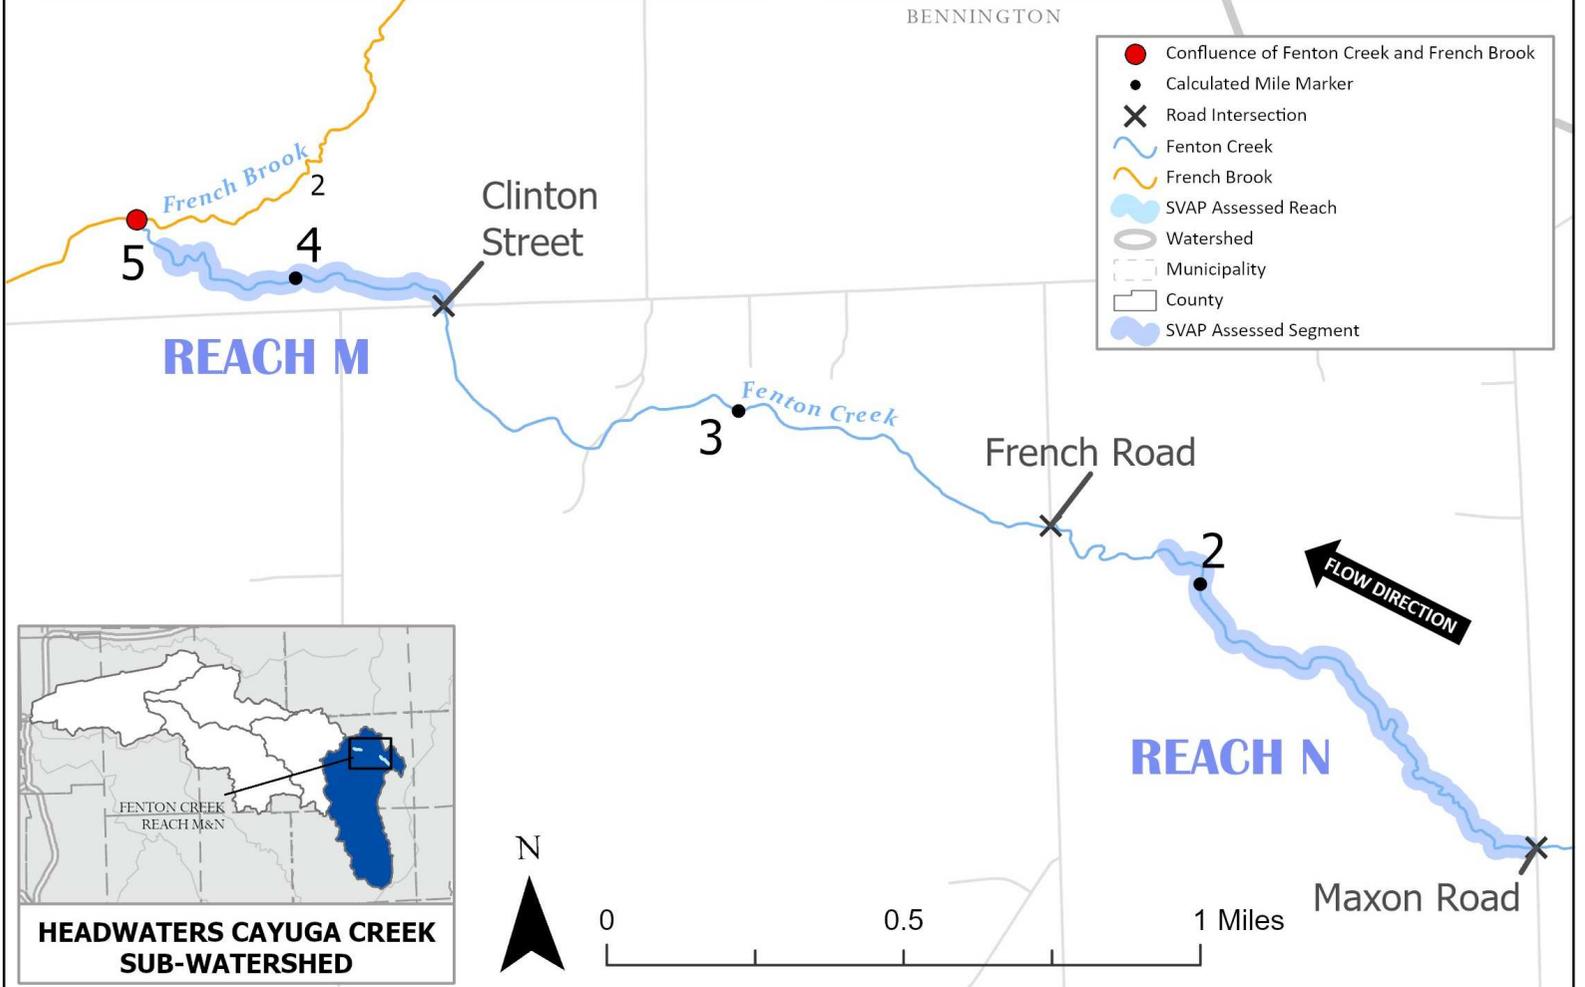
# FENTON CREEK

STREAM VISUAL ASSESSMENT (SVAP) RESULTS FOR REACH M & N

AVERAGE OVERALL SVAP RATING: **6.8**

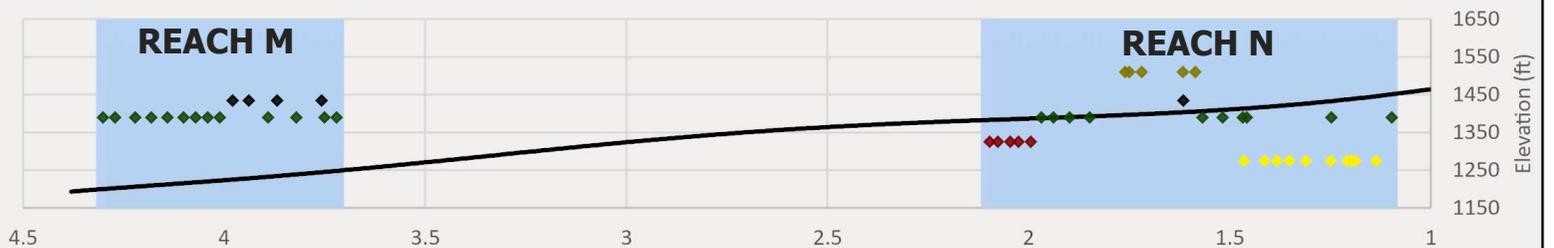
## Elevation Profile

Substrate ◆ Bedrock/Concrete ◆ Boulder ◆ Cobble ◆ Gravel ◆ Silt/Clay

← FLOW DIRECTION Creek Mile (4.30 at Tailwater, 1.10 at Headwater) ← FLOW DIRECTION

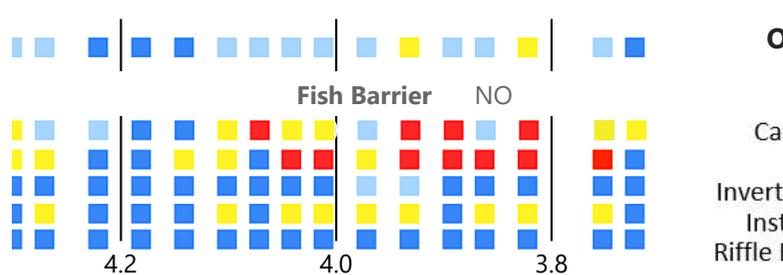
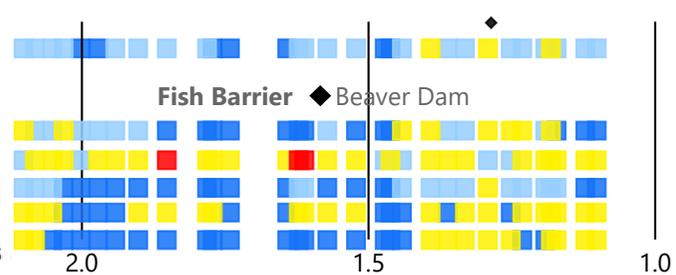
Score Excellent Good Mediocre Poor

Note: Overall Score of Fish Habitat was calculated by averaging scores for the five variables shown below.

Canopy Cover Pools Invertebrate Habitat Instream Cover Riffle Embeddedness
