HEADWATERS CATTARAUGUS CREEK SUB-WATERSHED SVAP MILEAGE 2021

Stream Visual Assessment Protocol - SVAP

STREAM VISUAL ASSESSMENT PROTOCOL (SVAP) FOR REACH A & B

AVERAGE OVERALL SVAP RATING: **6.5**

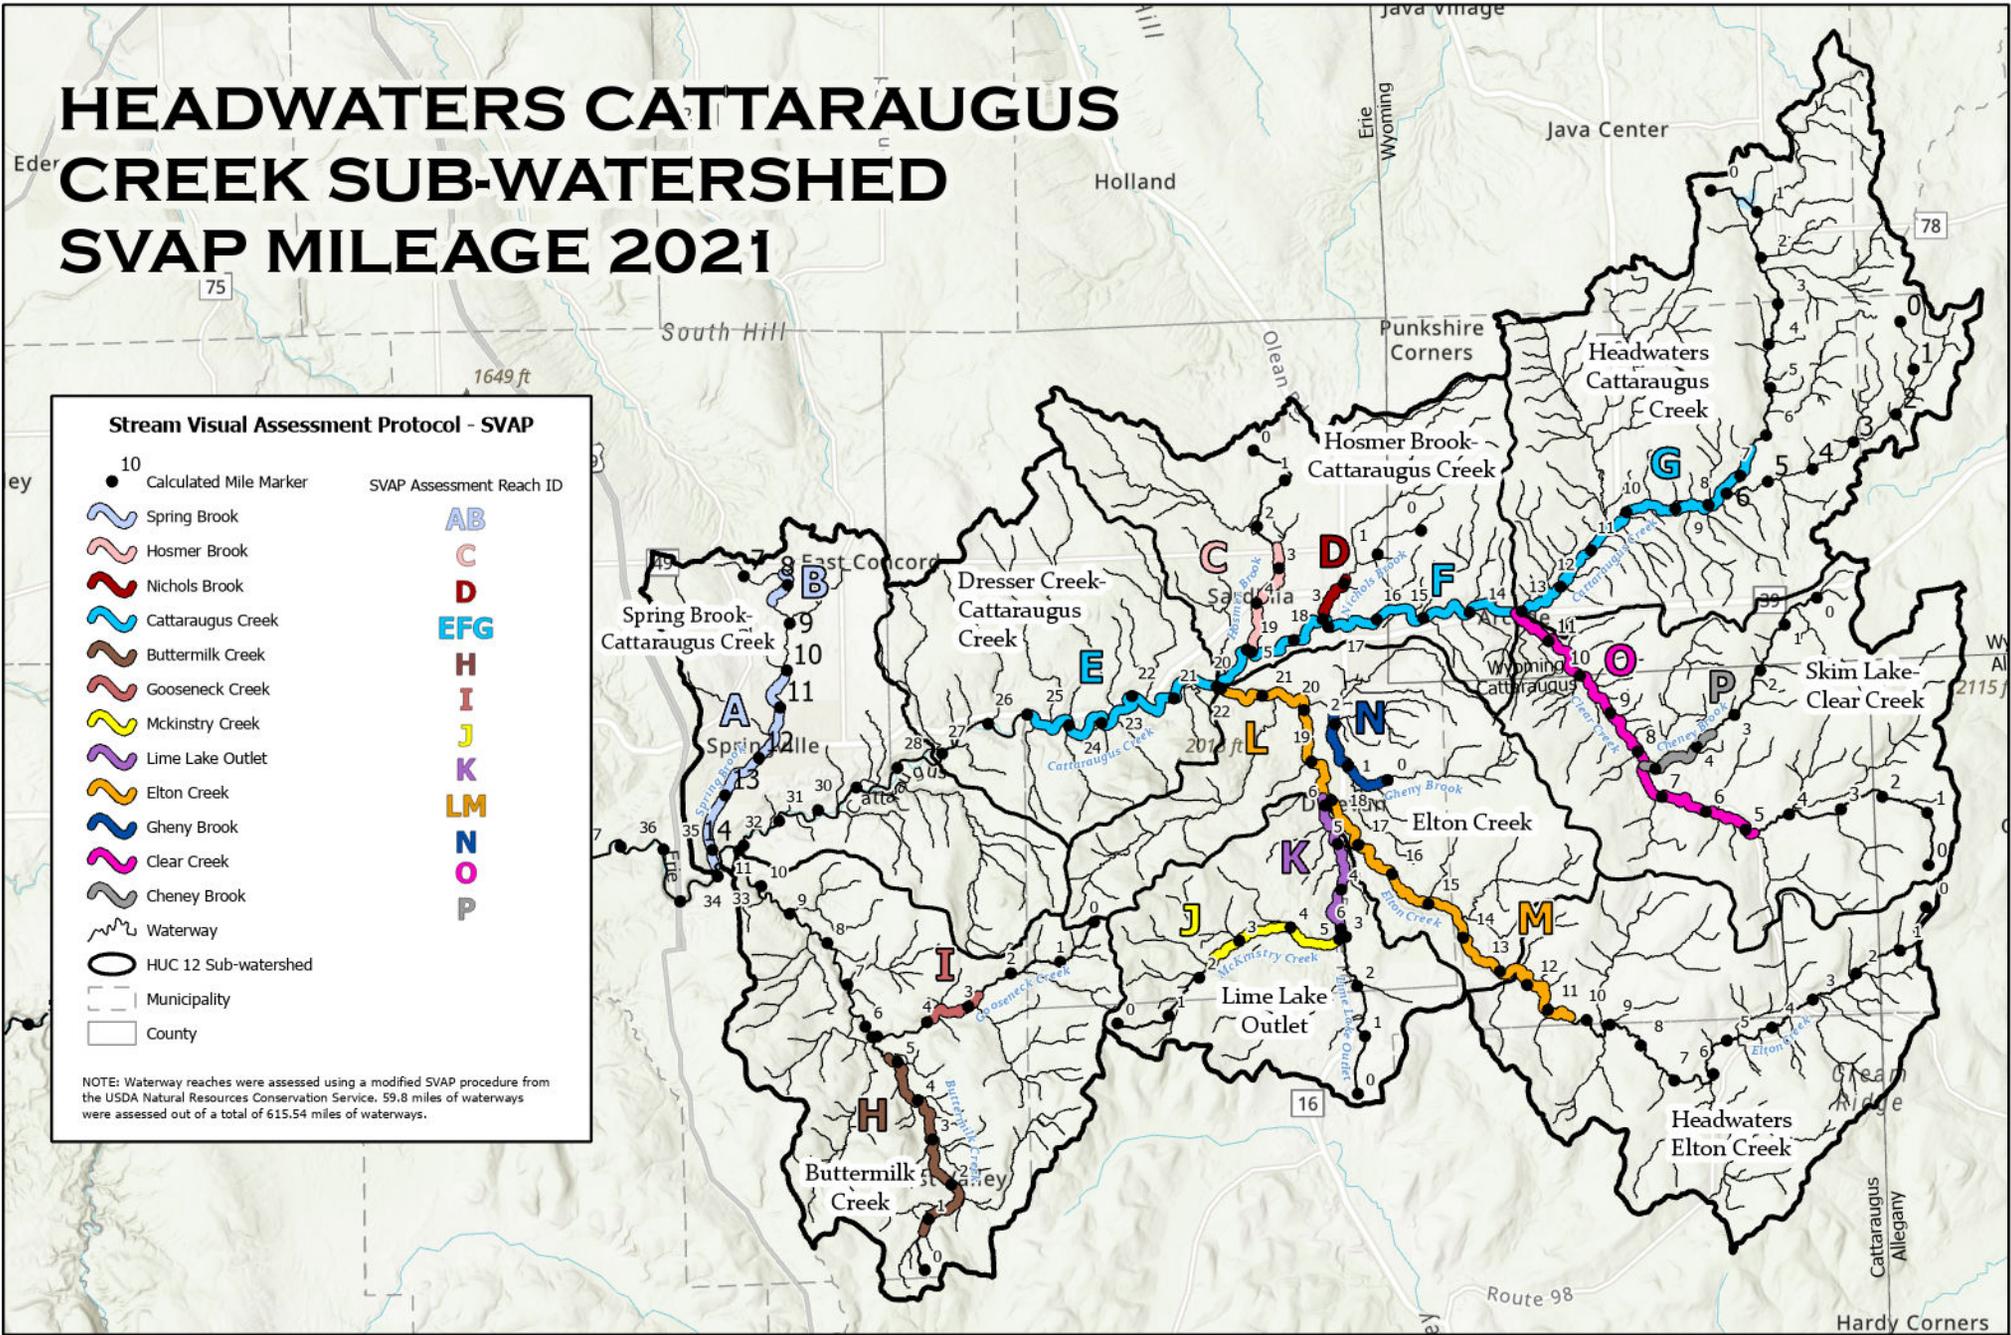
- 10 Calculated Mile Marker
- SVAP Assessment Reach ID
- Spring Brook
- Hosmer Brook
- Nichols Brook
- Cattaraugus Creek
- Buttermilk Creek
- Gooseneck Creek
- Mckinstry Creek
- Lime Lake Outlet
- Elton Creek
- Gheny Brook
- Clear Creek
- Cheney Brook
- Waterway
- HUC 12 Sub-watershed
- Municipality
- County

SVAP Assessment Reach ID: A, B, C, D, E, F, G, H, I, J, K, L, M, N, O, P

NOTE: Waterway reaches were assessed using a modified SVAP procedure from the USDA Natural Resources Conservation Service. 59.8 miles of waterways were assessed out of a total of 615.54 miles of waterways.

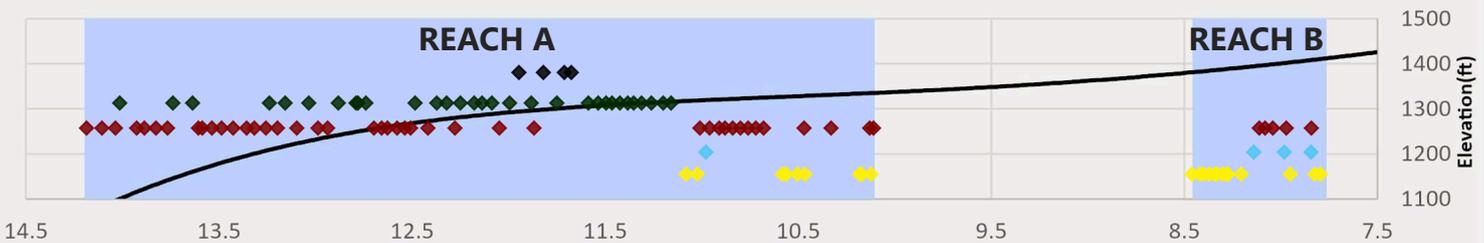
Elevation Profile

Substrate: ◆ Boulder ◆ Cobble ◆ Gravel ◆ Sand ◆ Silt/Clay

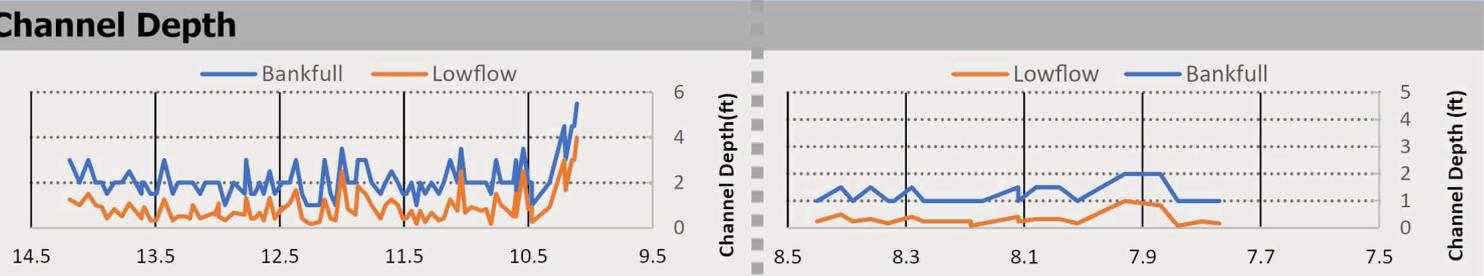
Channel Depth

← FLOW DIRECTION Creek Mile: Reach A (14.19 at Tailwater, 10.11 at Headwater), Reach B (8.45 at Tailwater, 7.7 at Headwater) → FLOW DIRECTION

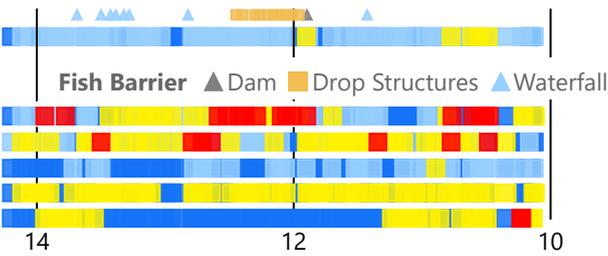
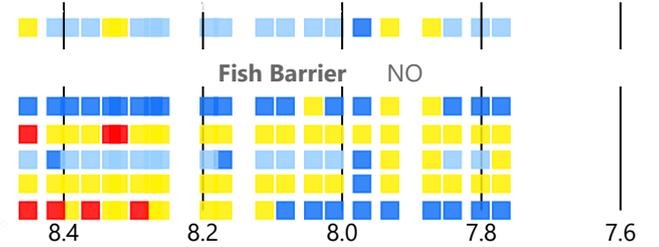
Fish Habitat Score Excellent Good Mediocre Poor

Note: Overall Score of Fish Habitat was calculated by averaging scores for the five variables shown below.

OVERALL SCORE

Canopy Cover Pools Invertebrate Habitat Instream Cover Riffle Embeddedness

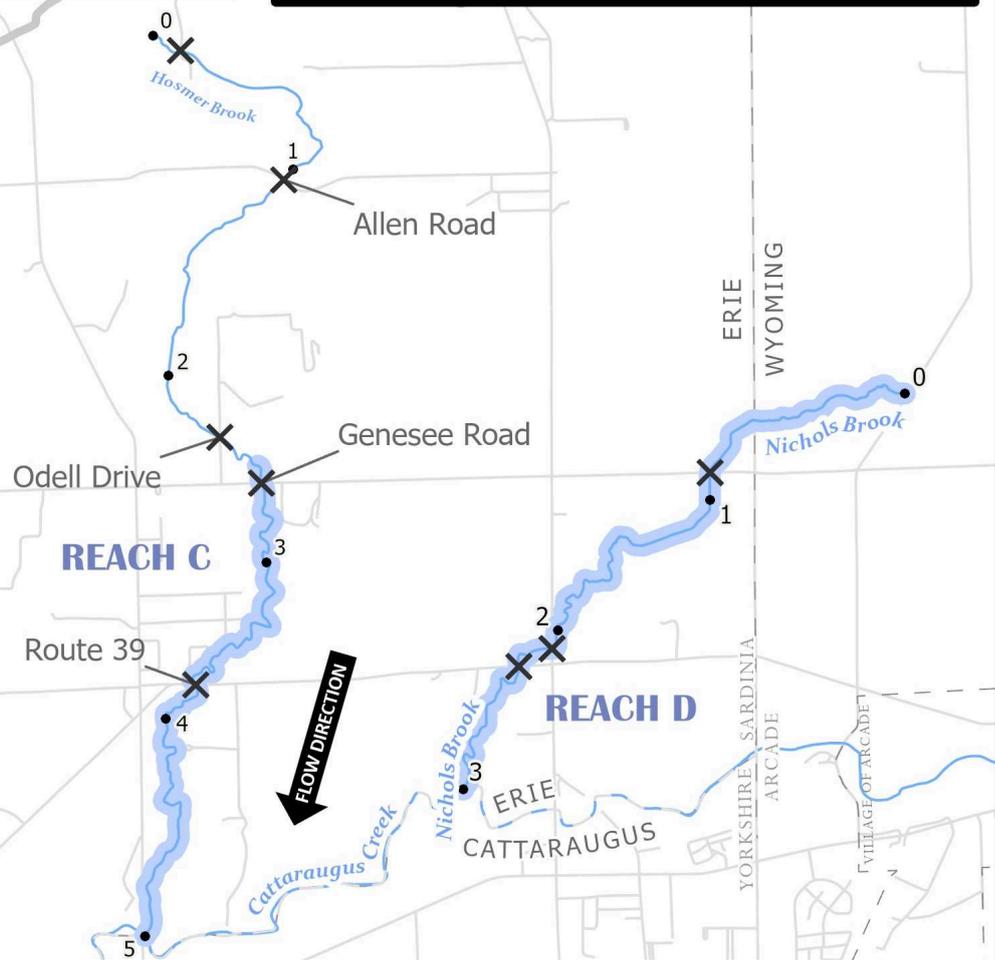
STREAM VISUAL ASSESSMENT PROTOCOL (SVAP) FOR REACH C & D

AVERAGE OVERALL SVAP RATING:
REACH C: **7.5**, REACH D: **7.1**

- 10 Calculated Mile Marker
- ✕ Road Intersection
- ~ Waterways of Interest
- ~ SVAP Assessed Reach
- Road
- Watershed
- ⋮ Village
- ⋮ Municipality
- ⋮ County

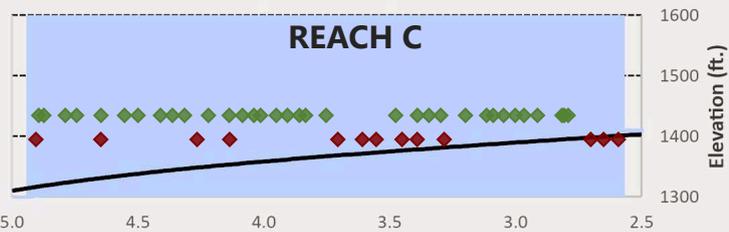
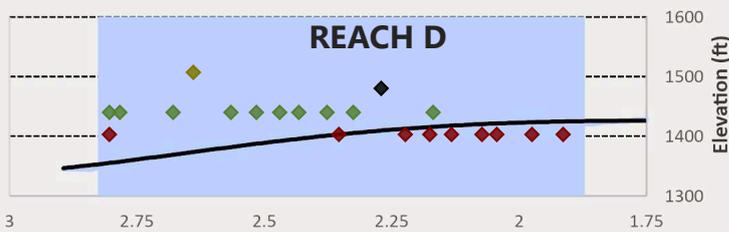
Elevation Profile Substrate ◆ Bedrock/Concrete ◆ Boulder ◆ Cobble ◆ Gravel

REACH C

REACH D

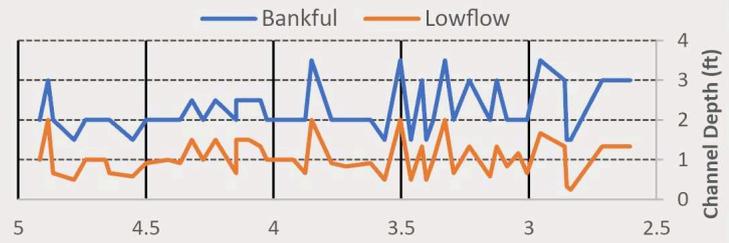
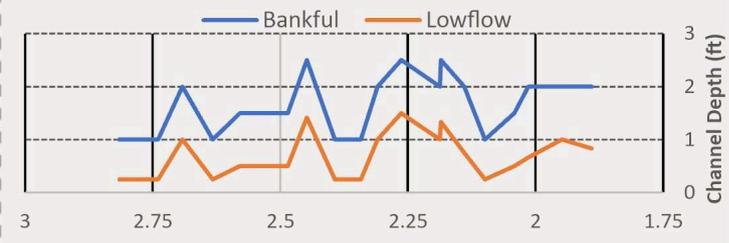
Channel Depth

← FLOW DIRECTION Creek Mile: Reach C (4.90 at Tailwater, 2.60 at Headwater), Reach D (2.80 at Tailwater, 1.90 at Headwater) → FLOW DIRECTION

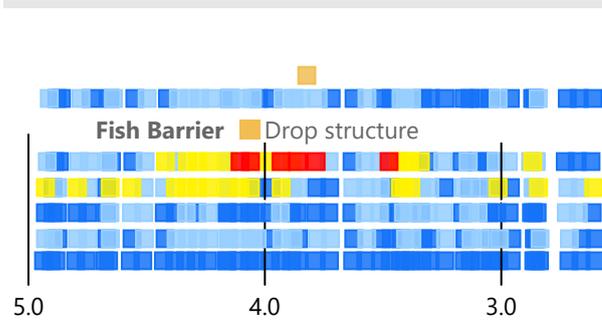
Fish Habitat Score Excellent Good Mediocre Poor

Note: Overall Score of Fish Habitat was calculated by averaging scores for the five variables shown below.

OVERALL SCORE

Canopy Cover Pools Invertebrate Habitat Instream Cover Riffle Embeddedness

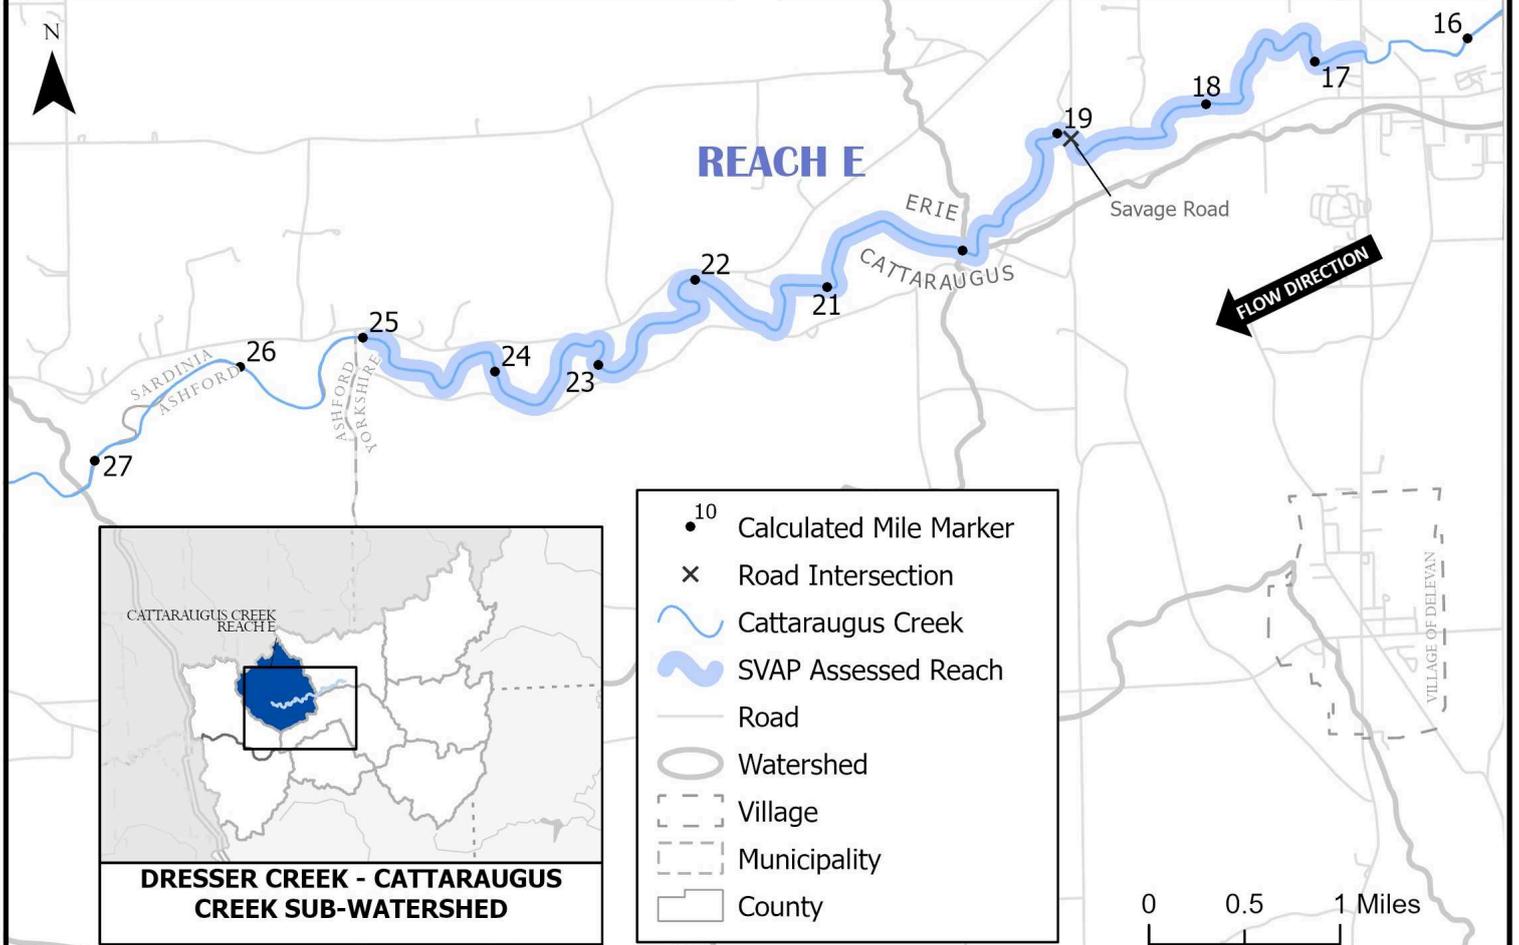
STREAM VISUAL ASSESSMENT PROTOCOL (SVAP) FOR REACH E

AVERAGE OVERALL SVAP RATING: **6.3**

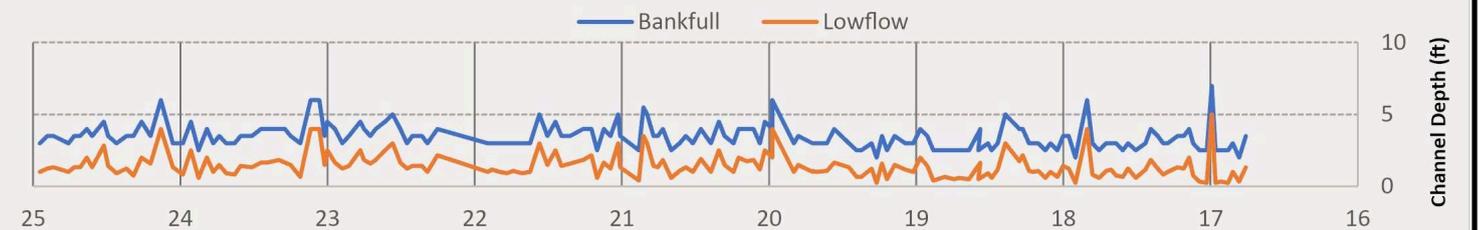
Channel Depth

← **FLOW DIRECTION** **Creek Mile (24.95 at Tailwater, 16.76 at Headwater)** **FLOW DIRECTION** →

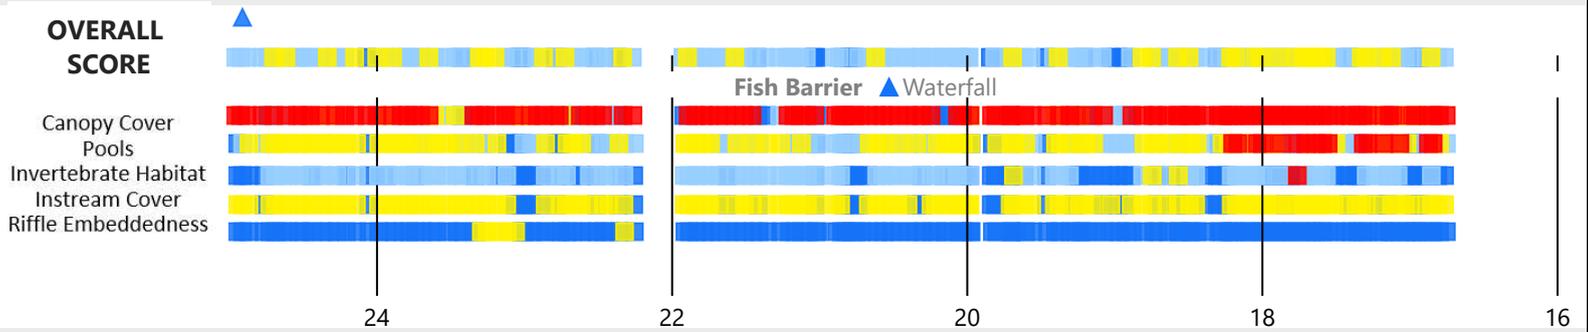
Score ■ Excellent ■ Good ■ Mediocre ■ Poor *Note: Overall Score of Fish Habitat was calculated by averaging scores for the five variables shown below.*

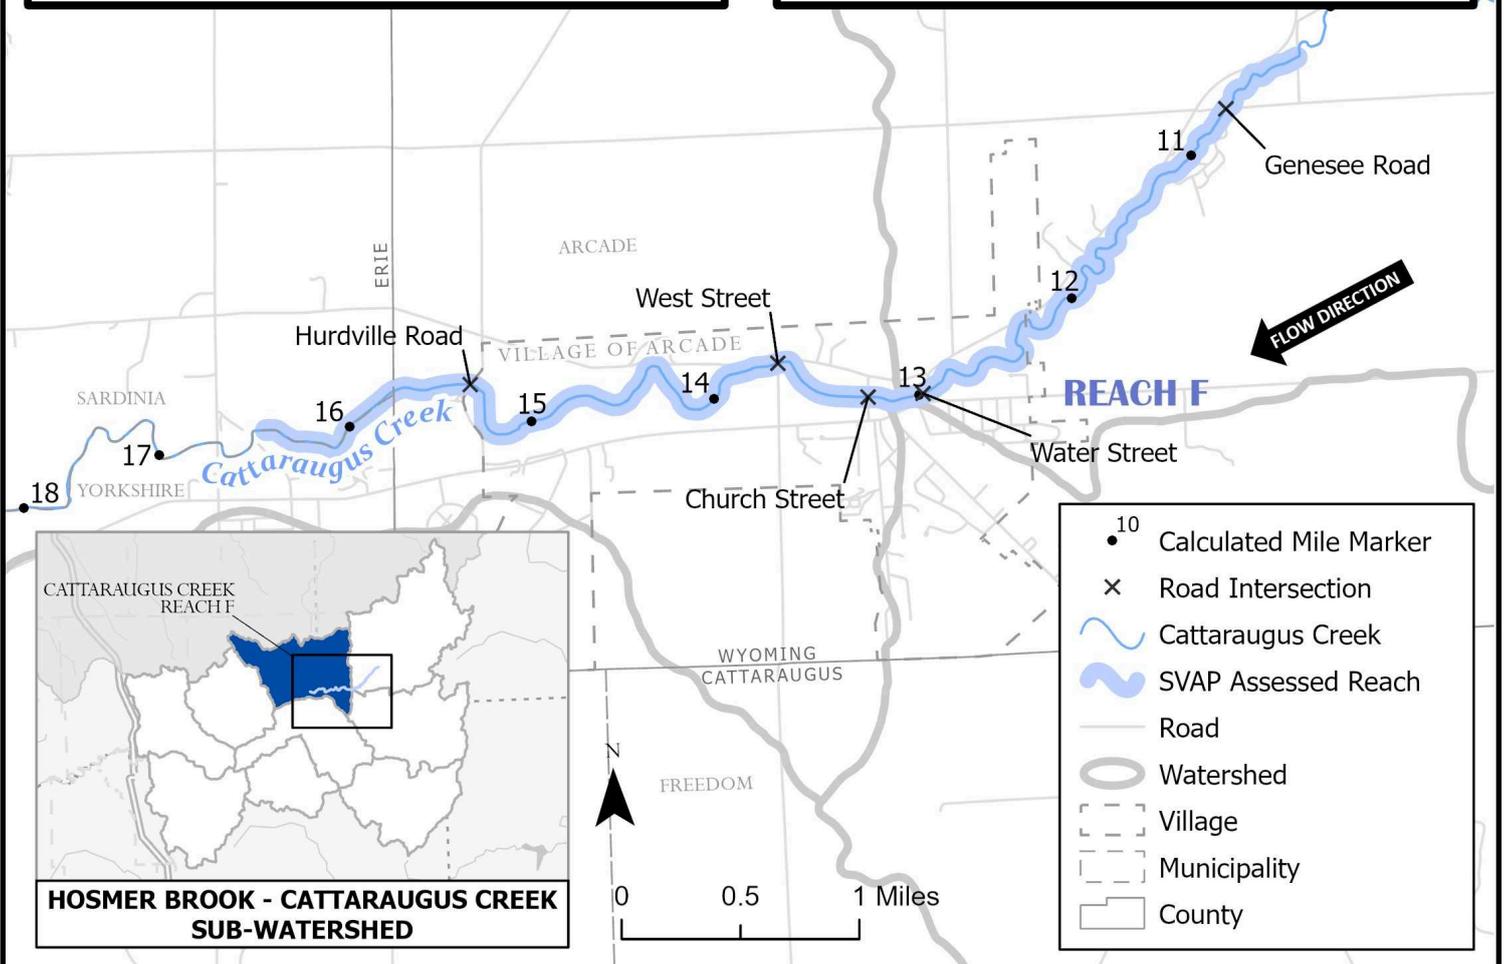
STREAM VISUAL ASSESSMENT PROTOCOL (SVAP) FOR REACH F

AVERAGE OVERALL SVAP RATING: **7.2**

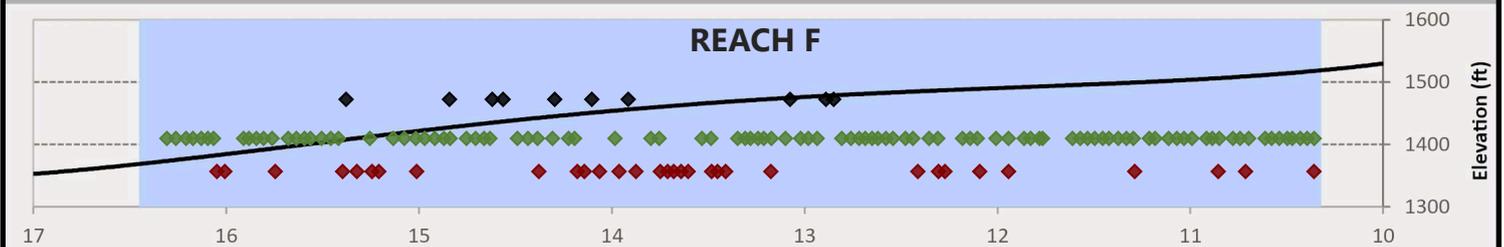
Elevation Profile

Substrate: ◆ Boulder ◆ Cobble ◆ Gravel

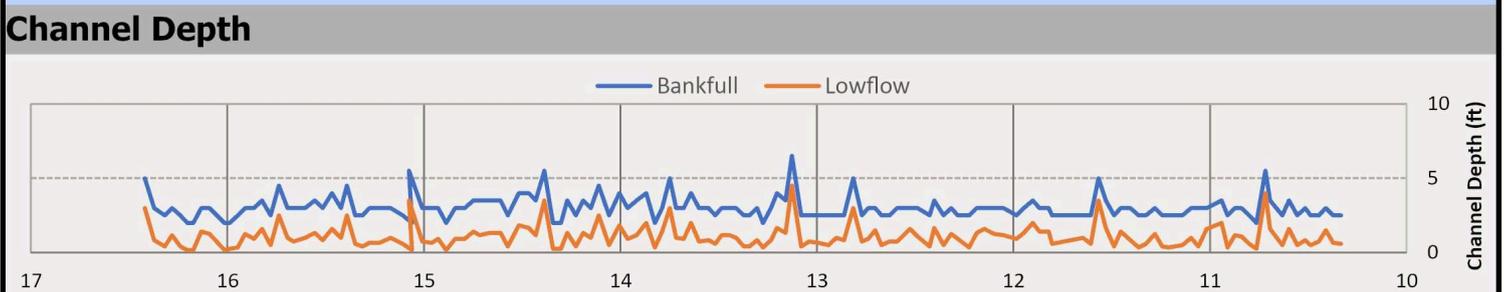
Channel Depth

← FLOW DIRECTION **Creek Mile (16.42 at Tailwater, 10.33 at Headwater)** ← FLOW DIRECTION

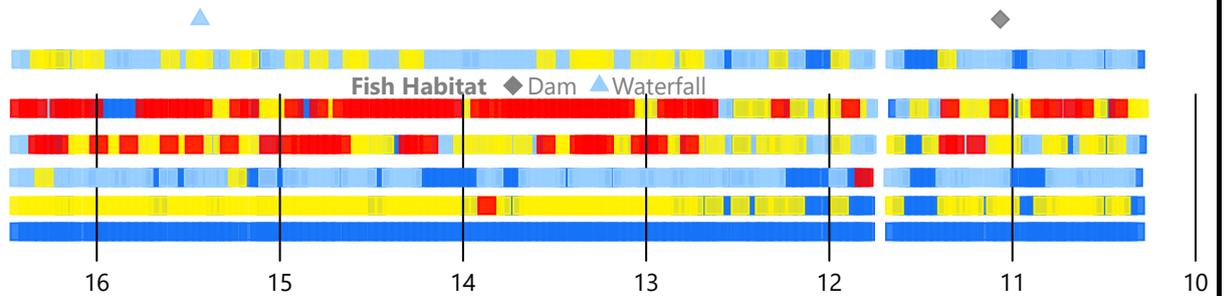
Note: Overall Score of Fish Habitat was calculated by averaging scores for the five variables shown below.

OVERALL SCORE

- Canopy Cover
- Pools
- Invertebrate Habitat
- Instream Cover
- Riffle Embeddedness

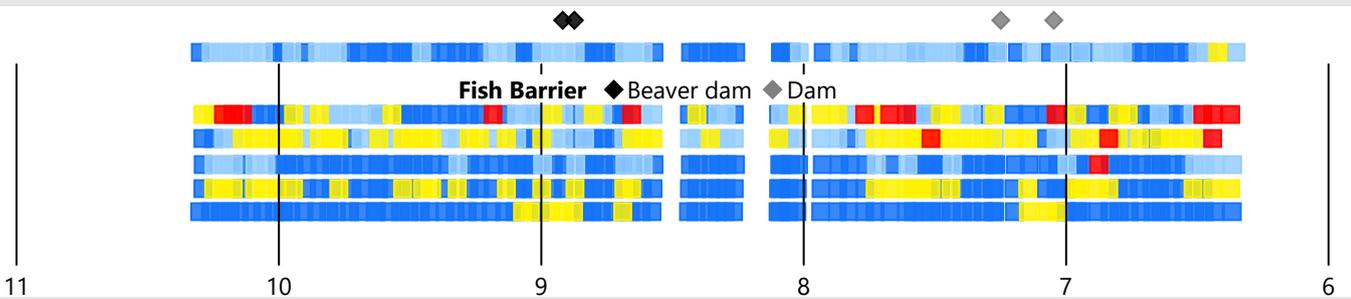
Score ■ Excellent ■ Good ■ Mediocre ■ Poor *Note: Overall Score of Fish Habitat was calculated by averaging scores for the five variables shown below*

- Canopy Cover
- Pools
- Invertebrate Habitat
- Instream Cover
- Riffle Embeddedness

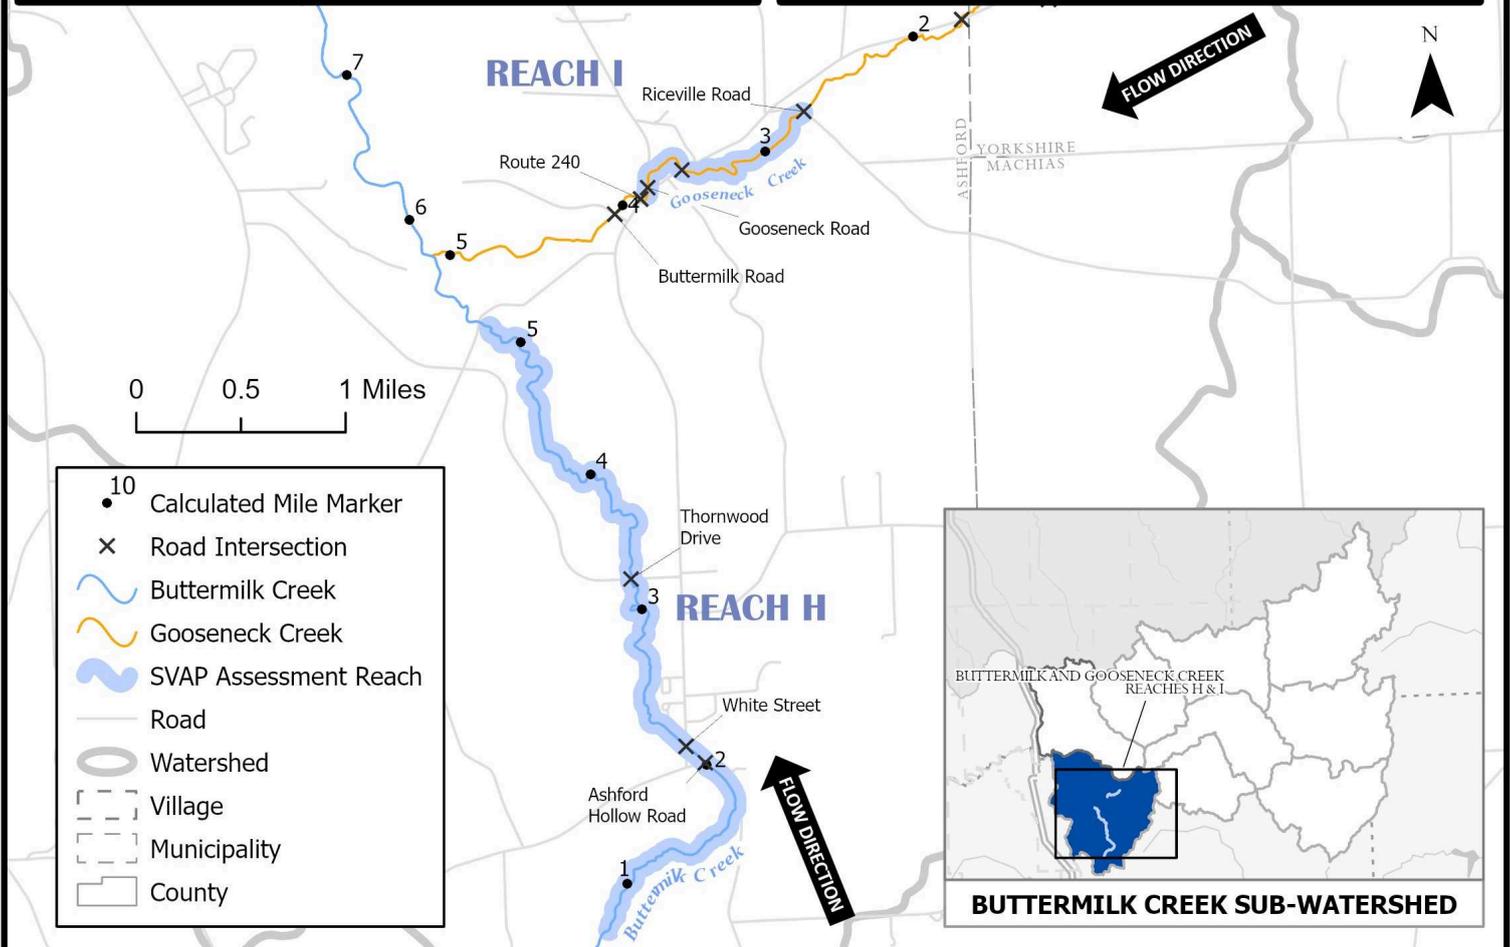
Stream Visual Assessment Protocol (SVAP) Reach H & I

REACH H: **7.2**, REACH I: **7.1**

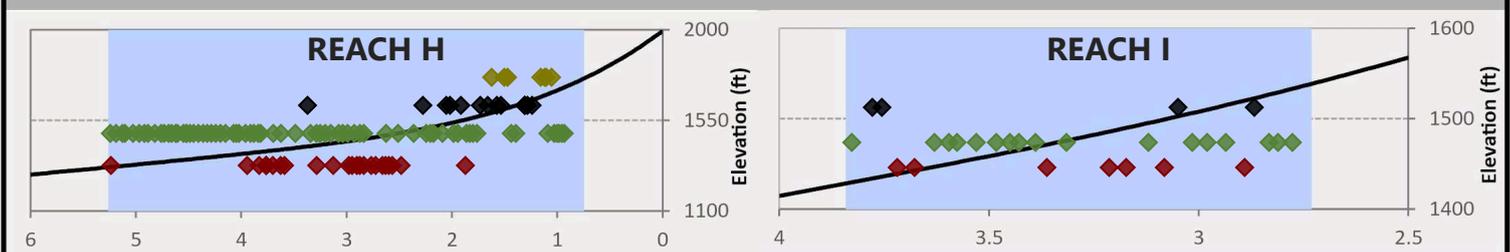
Elevation Profile

Substrate: ◆ Bedrock/Concrete ◆ Boulder ◆ Cobble ◆ Gravel

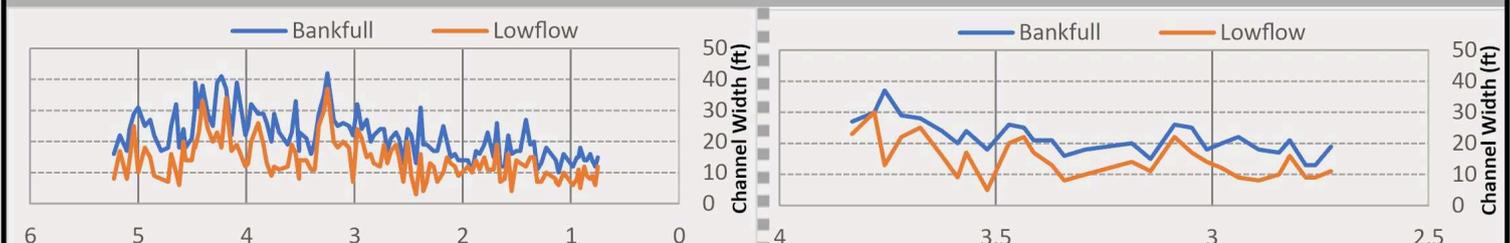
Channel Width

← FLOW DIRECTION Creek Mile: Reach H (5.22 at Tailwater, 0.75 at Headwater), Reach I (3.83 at Tailwater, 2.73 at Headwater) → FLOW DIRECTION

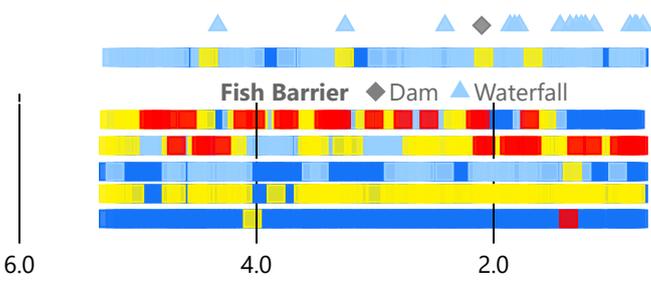
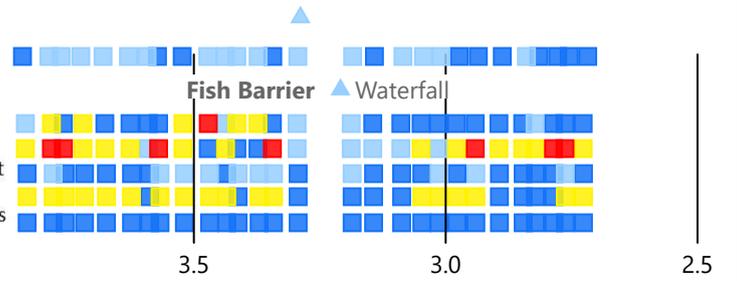
Fish Habitat Score Excellent Good Mediocre Poor

Note: Overall Score of Fish Habitat was calculated by averaging scores for the five variables shown below.

Canopy Cover Pools Invertebrate Habitat Instream Cover Riffle Embeddedness

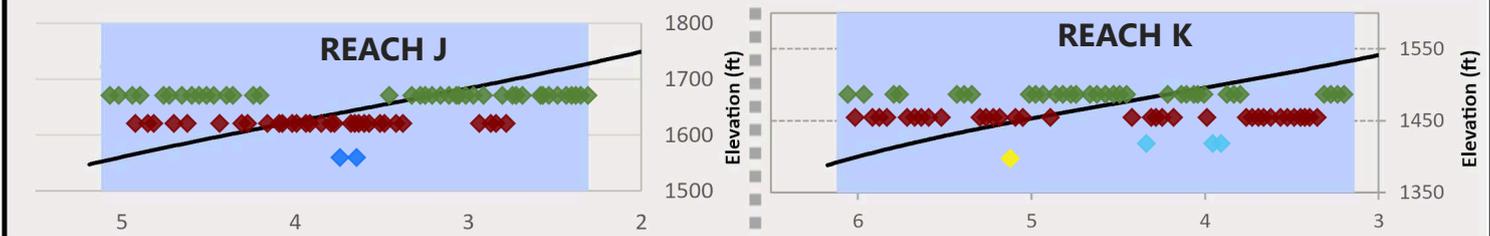
Elevation Profile Substrate: ◆ Cobble ◆ Gravel ◆ Sand ◆ Silt/Clay

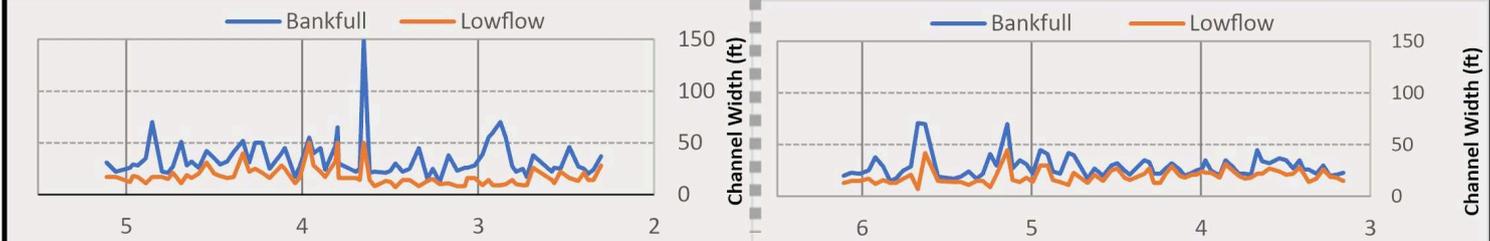
Channel Width

← FLOW DIRECTION Creek Mile: Reach J (5.10 at Tailwater, 2.30 at Headwater), Reach K (6.10 at Tailwater, 3.15 at Headwater) → FLOW DIRECTION

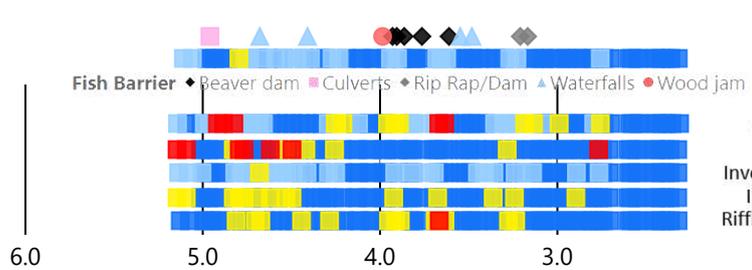
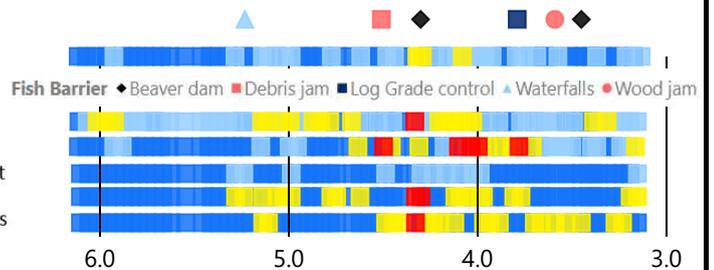
Note: Overall Score of Fish Habitat was calculated by averaging scores for the five variables shown below.

Canopy Cover
Pools
Invertebrate Habitat
Instream Cover
Riffle Embeddedness

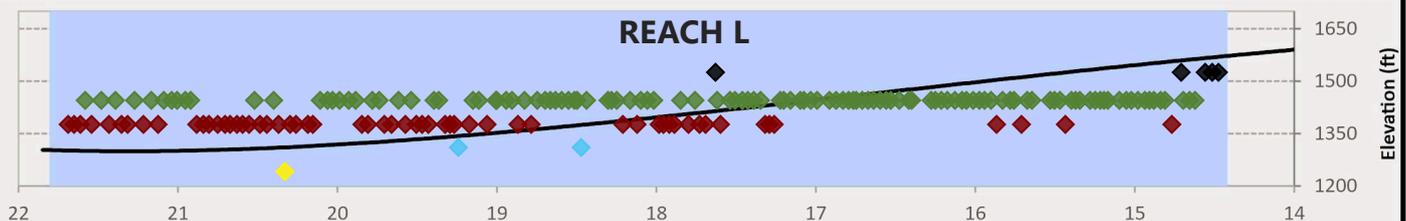
Elevation Profile Substrate: ◆ Boulder ◆ Cobble ◆ Gravel ◆ Sand ◆ Silt/Clay

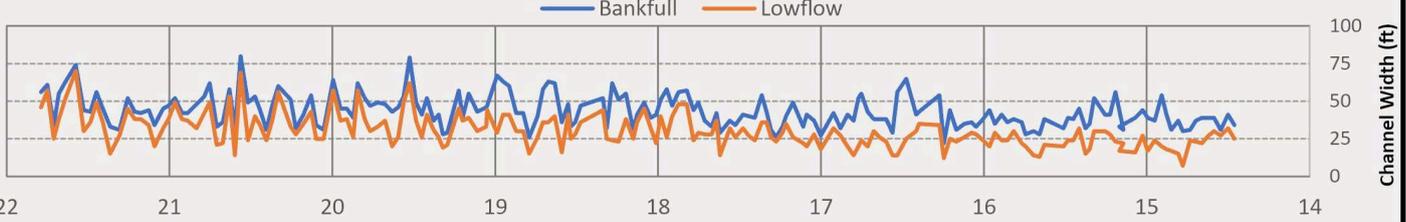
Channel Width

Creek Mile: Reach L (21.80 at Tailwater, 14.40 at Headwater)

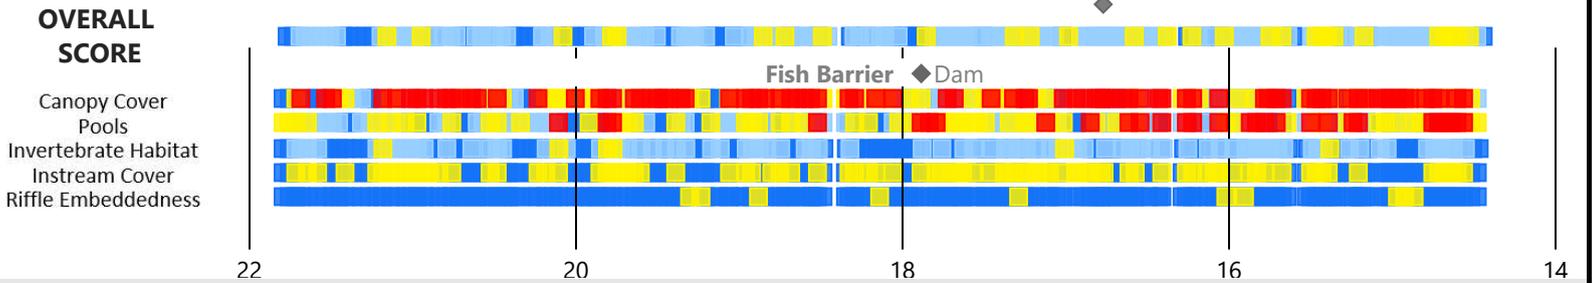
Score ■ Excellent ■ Good ■ Mediocre ■ Poor

Note: Overall Score of Fish Habitat was calculated by averaging scores for the five variables shown below.

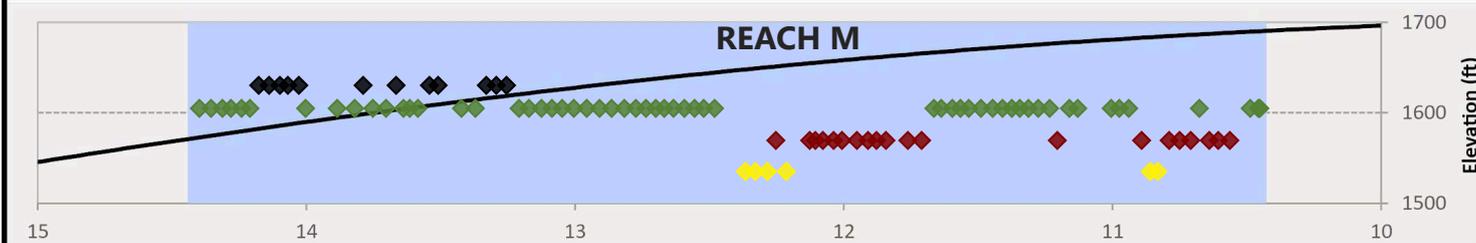
Elevation Profile

Substrate: ◆ Boulder ◆ Cobble ◆ Gravel ◆ Silt/Clay

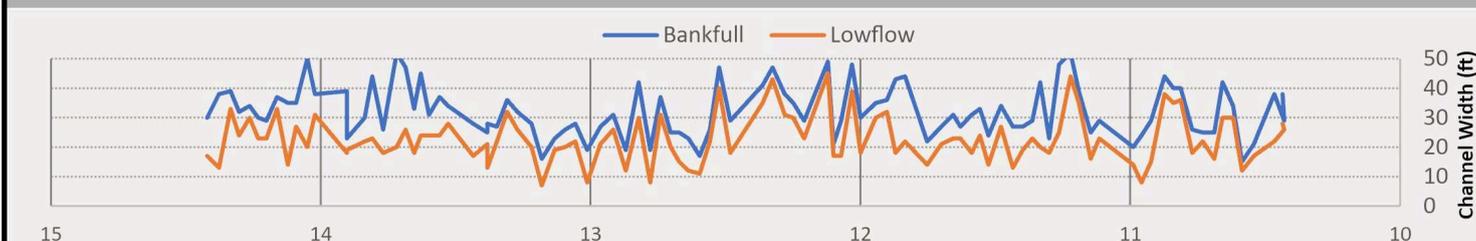
Channel Width

← FLOW DIRECTION Creek Mile: Reach M (14.40 at Tailwater, 10.40 at Headwater) → FLOW DIRECTION

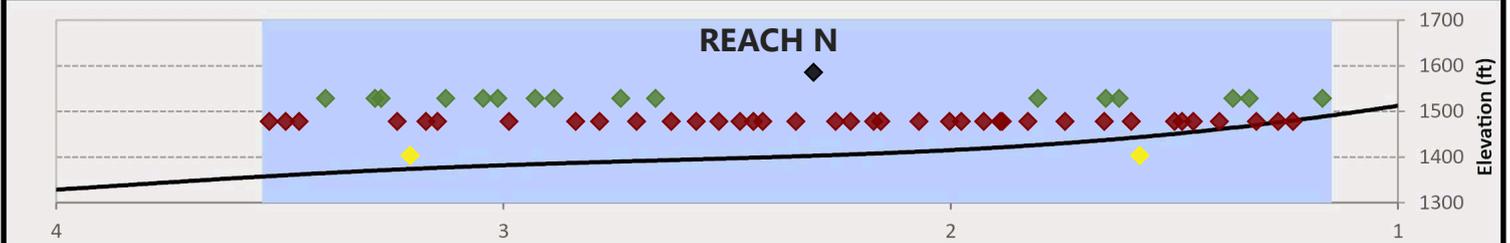
Elevation Profile

Substrate: ◆ Boulder ◆ Cobble ◆ Gravel ◆ Silt/Clay

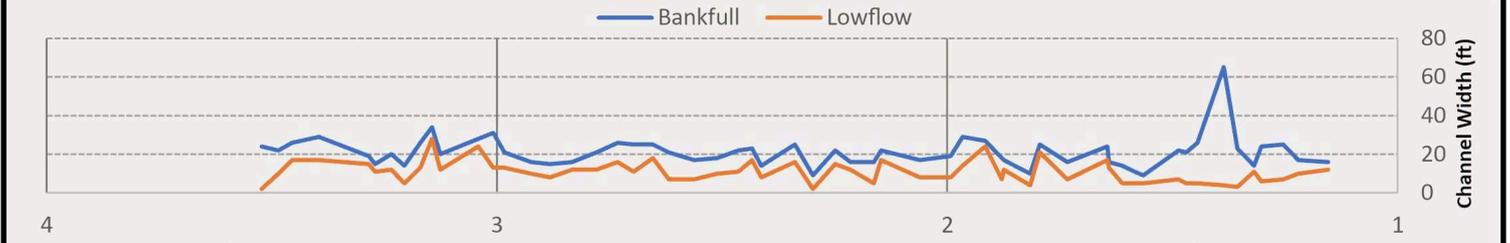
Channel Width

← FLOW DIRECTION Creek Mile: Reach N (3.50 at Tailwater, 1.15 at Headwater) FLOW DIRECTION →

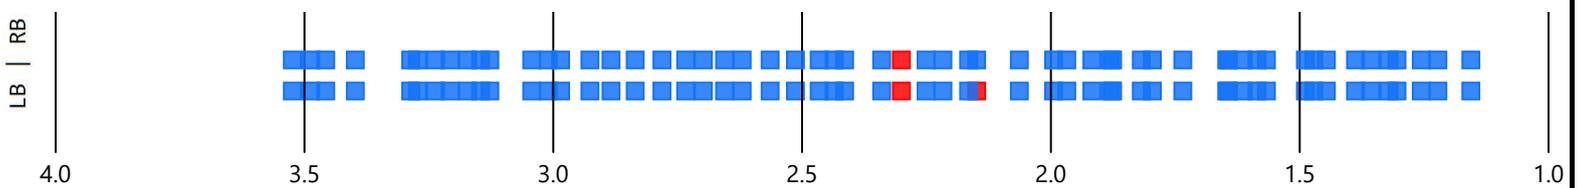
Bank Condition

■ Hardened Structure ■ Natural

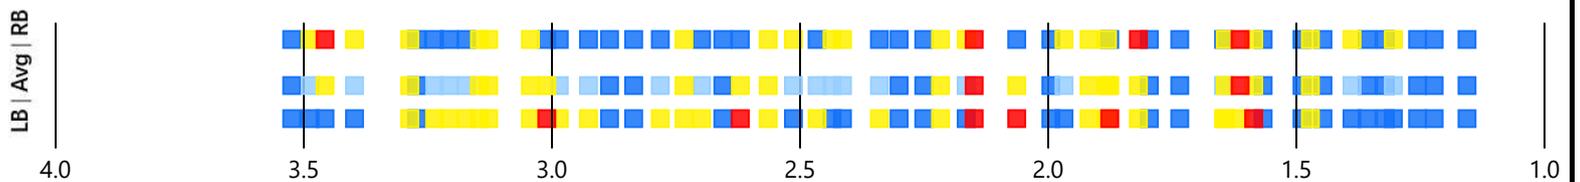
Riparian Zone

Score ■ Excellent ■ Good ■ Mediocre ■ Poor

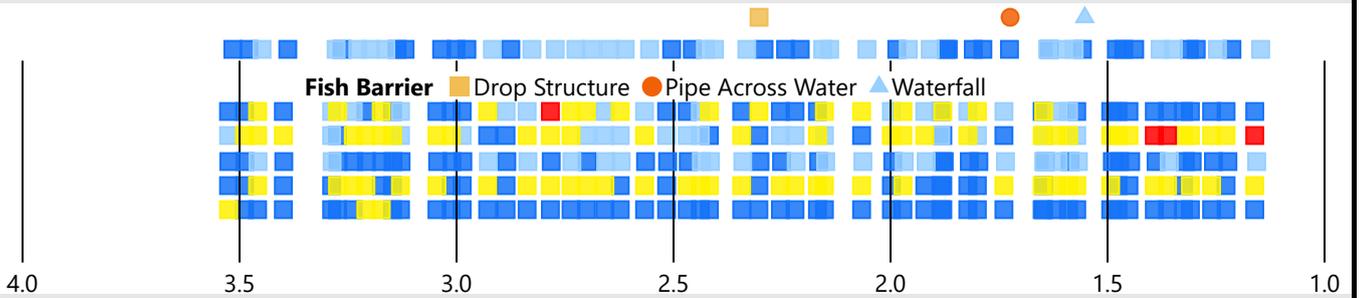
Note: Overall Score of Fish Habitat was calculated by averaging scores for the five variables shown below.

Canopy Cover
Pools
Invertebrate Habitat
Instream Cover
Riffle Embeddedness

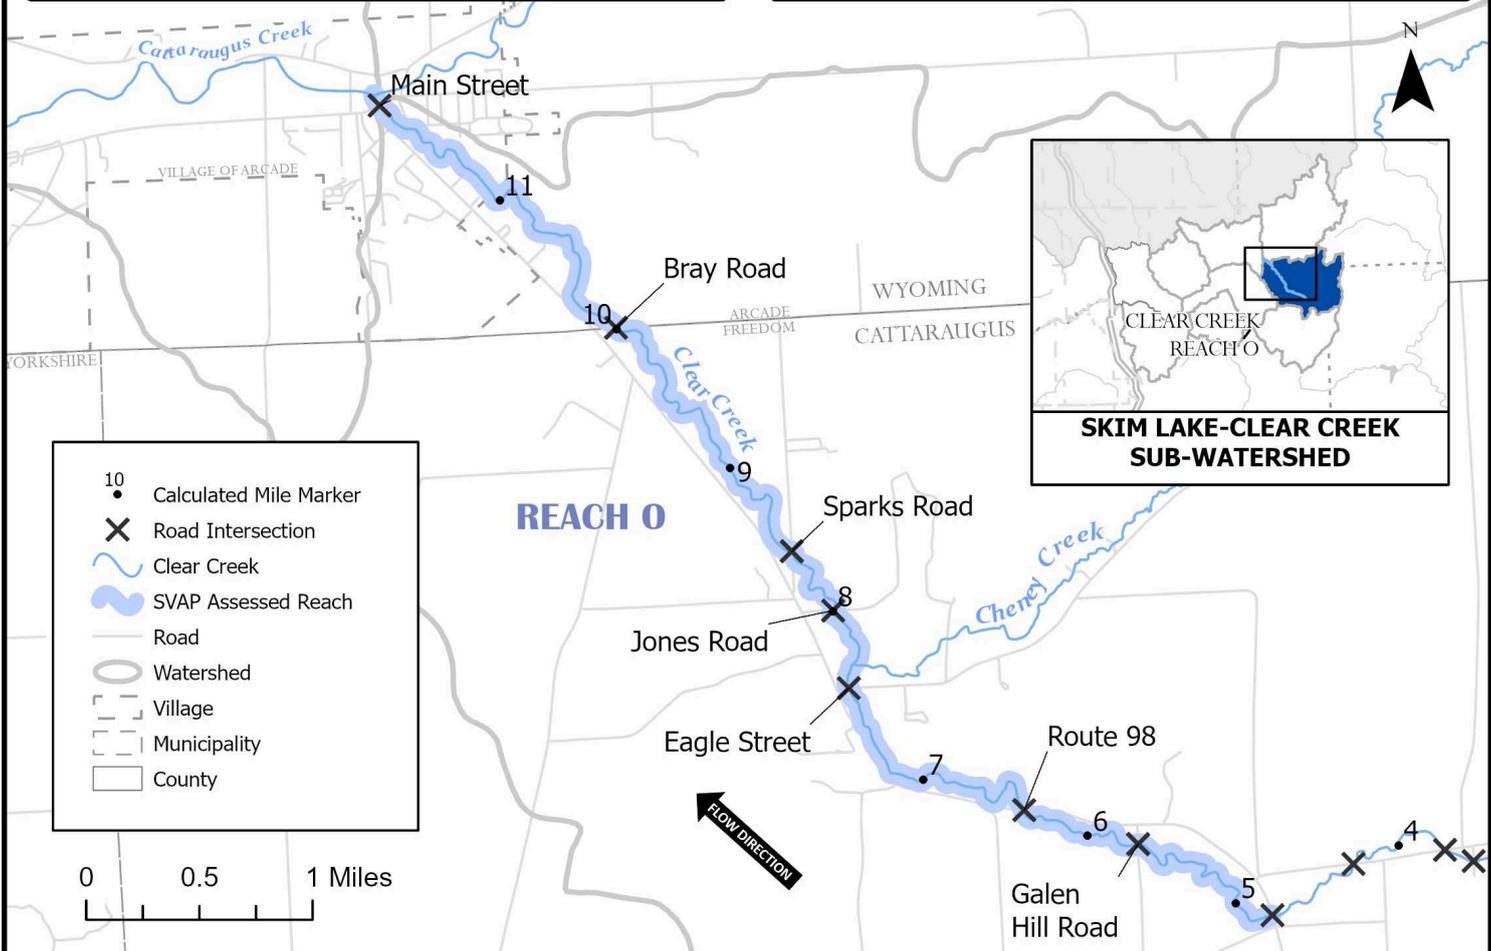
CLEAR CREEK
STREAM VISUAL ASSESSMENT PROTOCOL(SVAP) REACH 0

AVERAGE OVERALL SVAP RATING: **7.8**

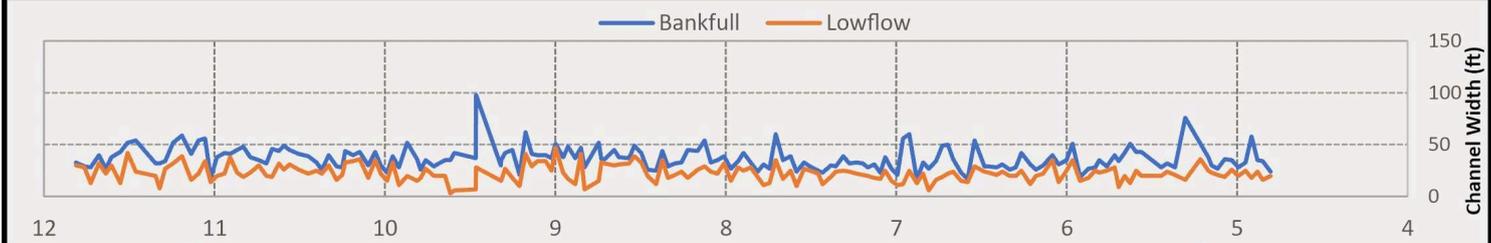
Channel Width

← FLOW DIRECTION **Creek Mile: Reach 0 (11.80 at Tailwater, 4.80 at Headwater)** → FLOW DIRECTION

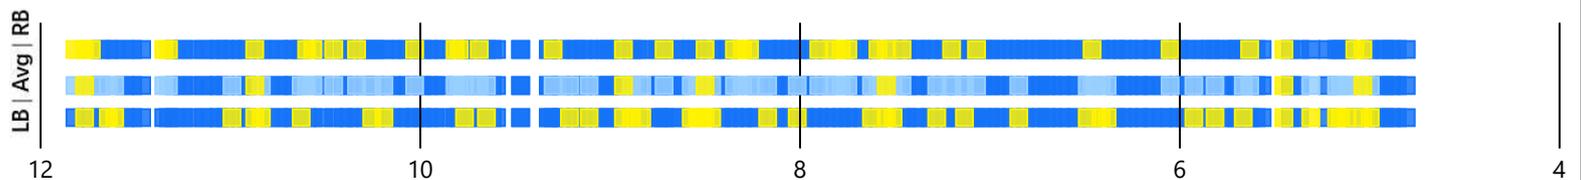
Riparian Zone

Score ■ Excellent ■ Good ■ Mediocre

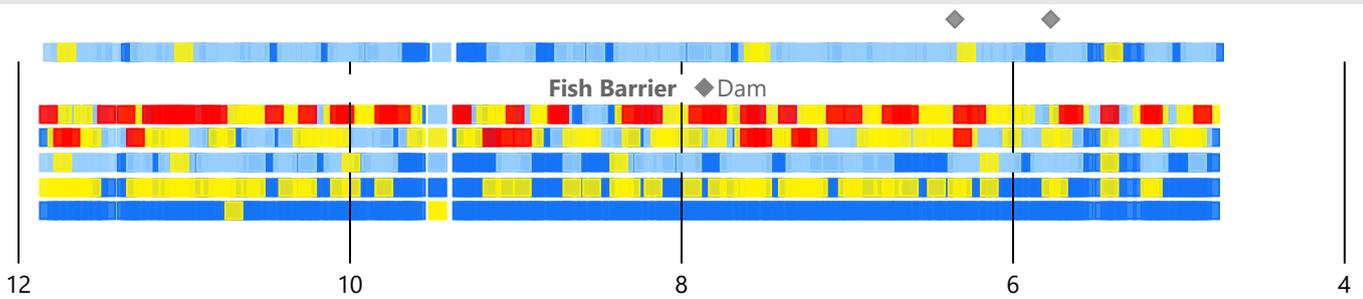
Score Excellent Good Mediocre Poor Note: Overall Score of Fish Habitat was calculated by averaging scores for the five variables shown below.

Canopy Cover Pools Invertebrate Habitat Instream Cover Riffle Embeddedness
