HEADWATERS CATTARAUGUS CREEK SUB-WATERSHED SVAP MILEAGE 2021

Stream Visual Assessment Protocol - SVAP

STREAM VISUAL ASSESSMENT PROTOCOL (SVAP) FOR REACH A & B

AVERAGE OVERALL SVAP RATING: **6.5**

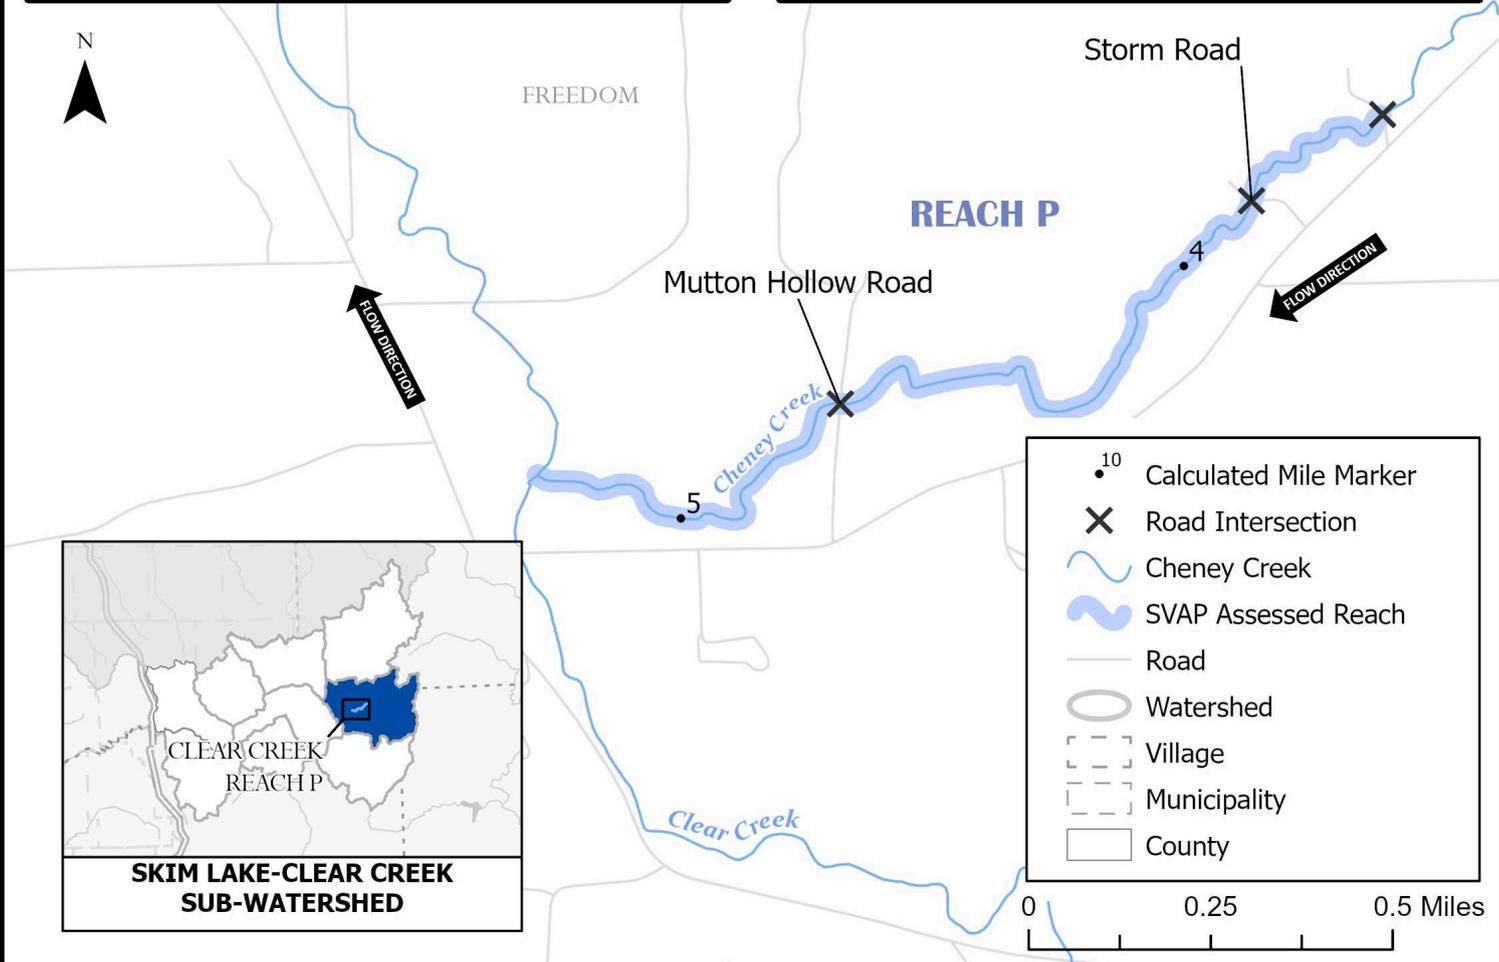
CHENEY CREEK
STREAM VISUAL ASSESSMENT PROTOCOL (SVAP) REACH P

AVERAGE OVERALL SVAP RATING: **9.1**

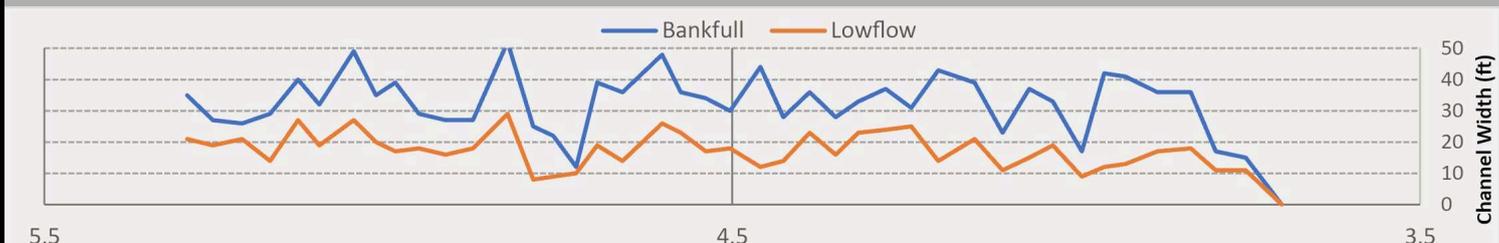
Channel Width

Creek Mile: Reach P (5.20 at Tailwater, 3.70 at Headwater)

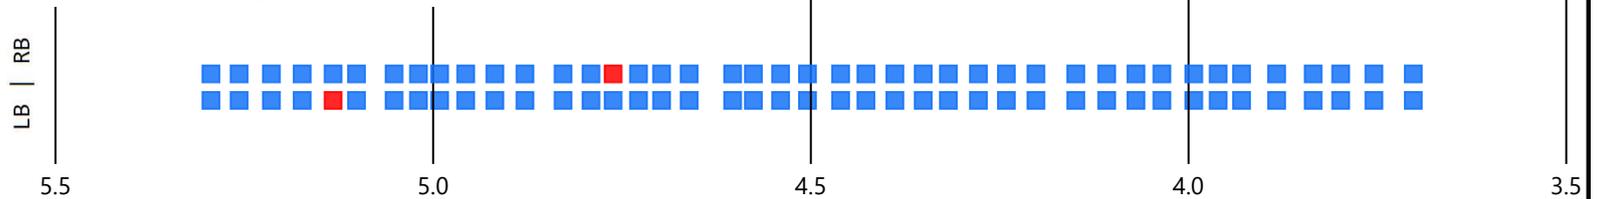
Bank Condition

■ Hardened Structure ■ Natural

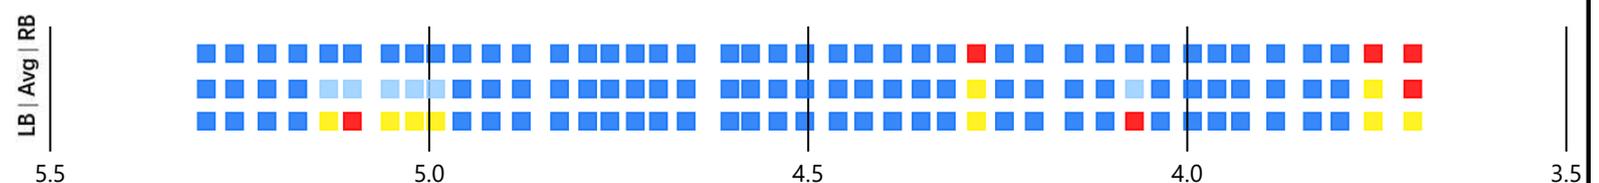
Riparian Zone

Score ■ Excellent ■ Good ■ Mediocre ■ Poor

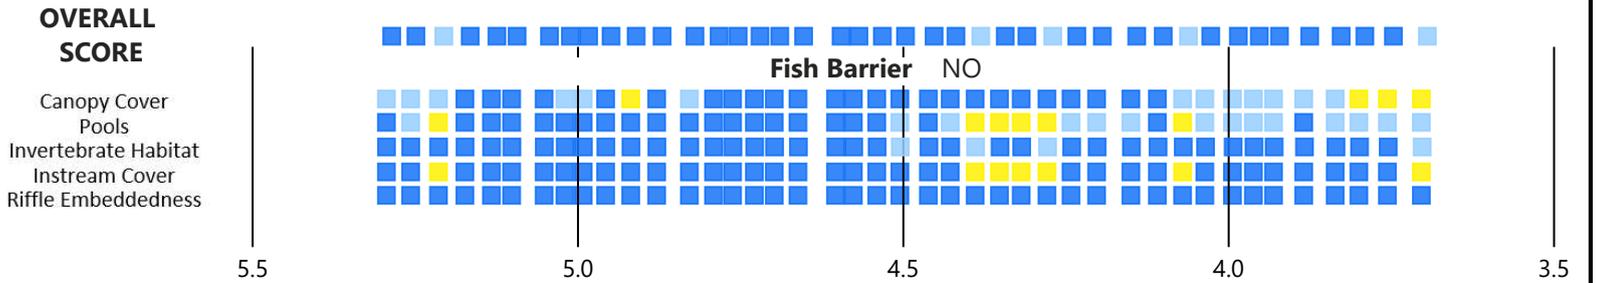
Score ■ Excellent ■ Good ■ Mediocre ■ Poor *Note: Overall Score of Fish Habitat was calculated by averaging scores for the five variables shown below.*
