# NIAGARA RIVER SUB-WATERSHED SVAP MILEAGE 2024

## Stream Visual Assessment Protocol - SVAP

NOTE: Waterway reaches were assessed using a modified SVAP procedure from the USDA Natural Resources Conservation Service. 11.67 miles of waterways were assessed out of a total of 218.56 miles of waterways.

STREAM VISUAL ASSESSMENT PROTOCOL (SVAP) RESULTS FOR REACH A

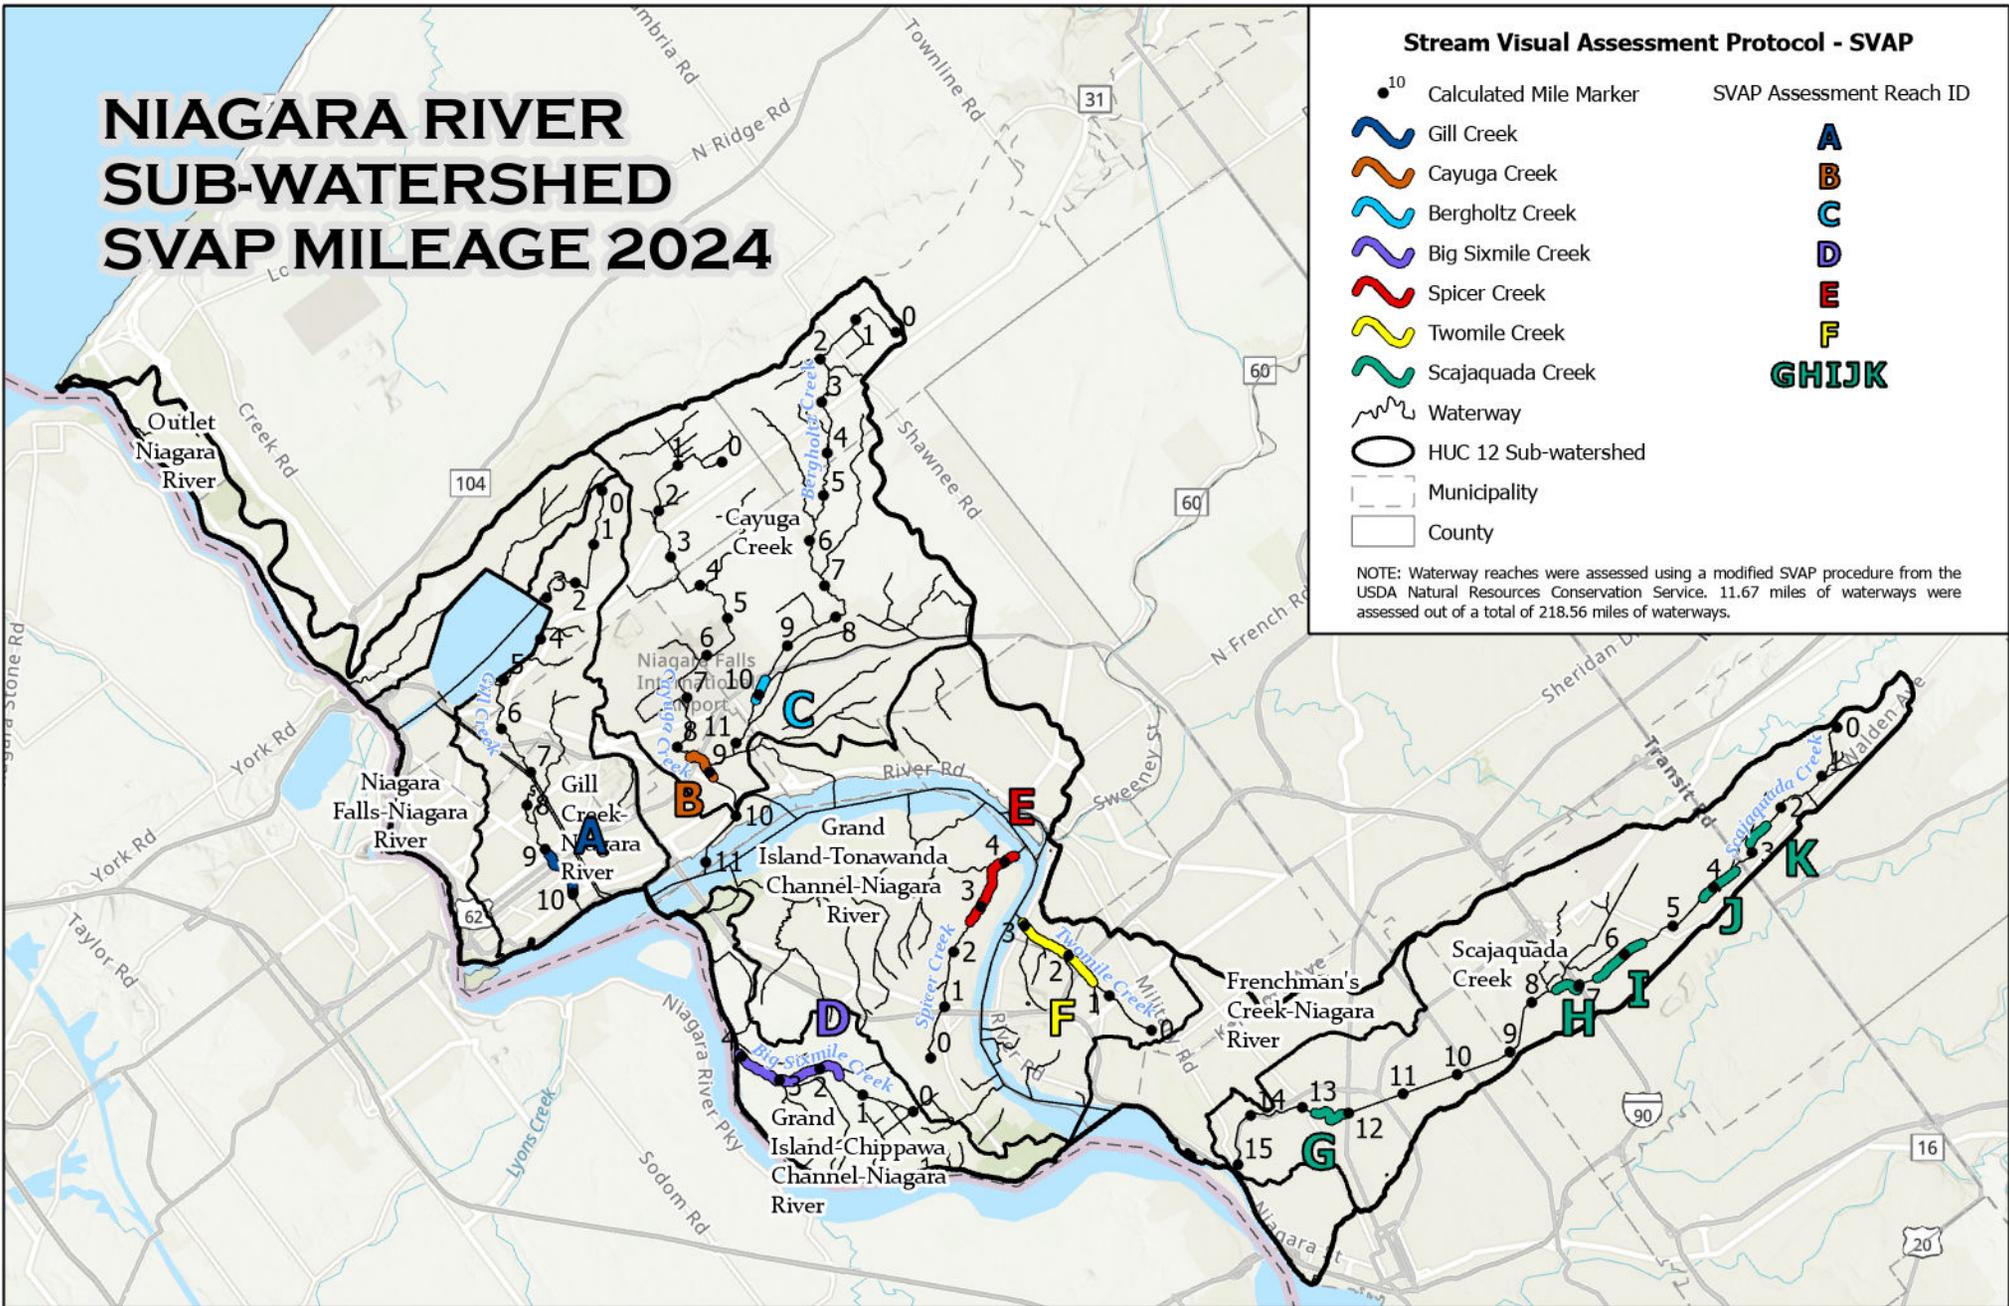
- <sup>10</sup> Calculated Mile Marker
- SVAP Assessment Reach ID
- Gill Creek
- Cayuga Creek
- Bergholtz Creek
- Big Sixmile Creek
- Spicer Creek
- Twomile Creek
- Scajaquada Creek
- Waterway
- HUC 12 Sub-watershed
- Municipality
- County

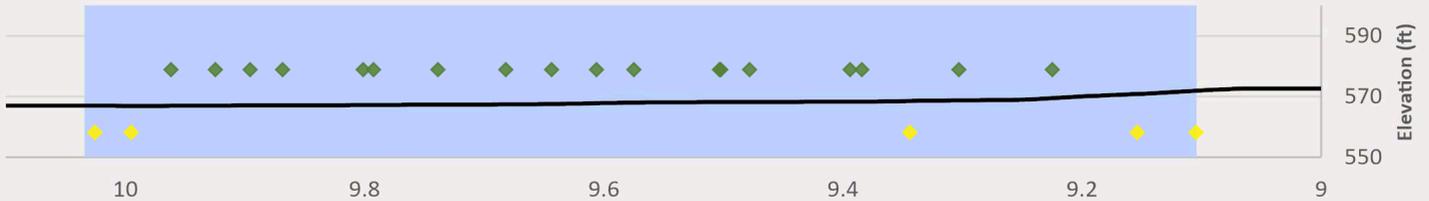
## Elevation Profile

Substrate: ◆ Cobble ◆ Silt/Clay

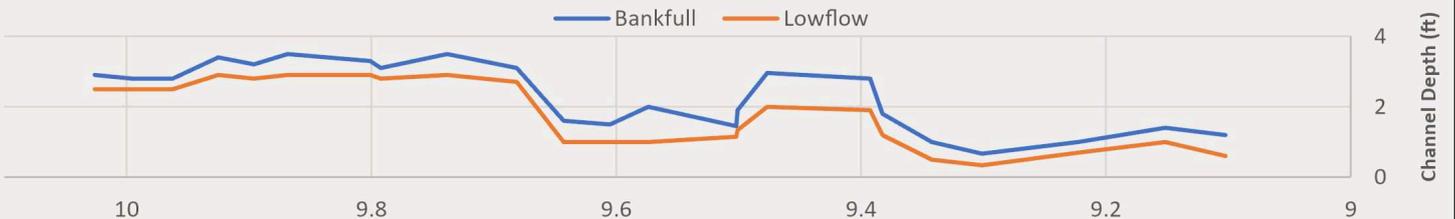
## Channel Depth

← FLOW DIRECTION Creek Mile (10.03 at Tailwater, 9.10 at Headwater) FLOW DIRECTION →

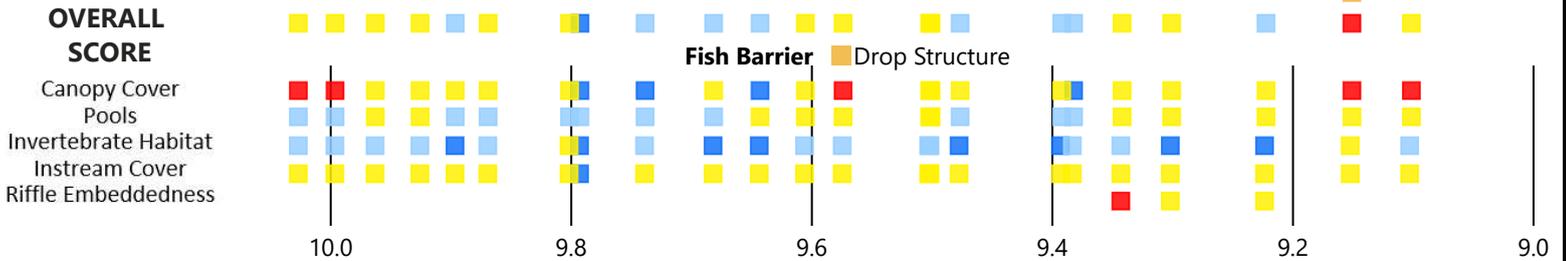
Score Excellent Good Mediocre Poor

Note: Overall Score of Fish Habitat was calculated by averaging scores for the five variables shown below.

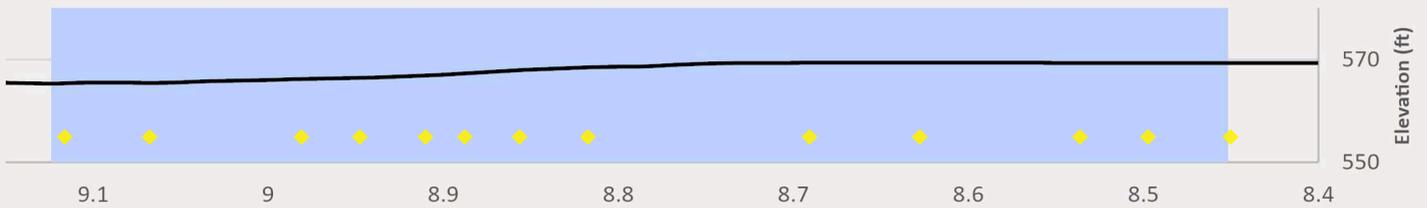
## Elevation Profile Substrate ◆ Silt/Clay

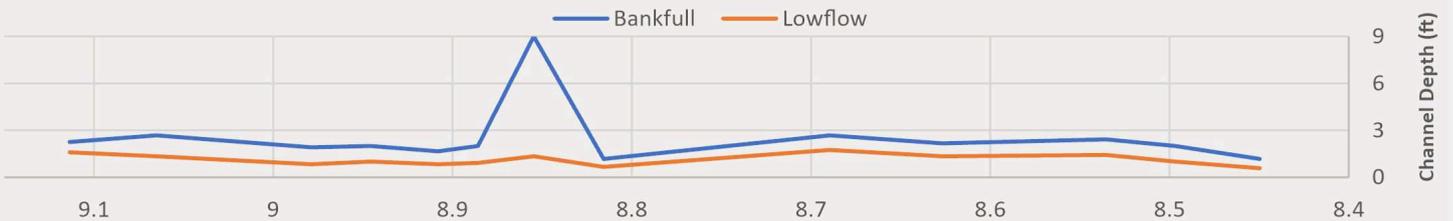
## Channel Depth

Creek Mile (9.11 at Tailwater, 8.45 at Headwater)

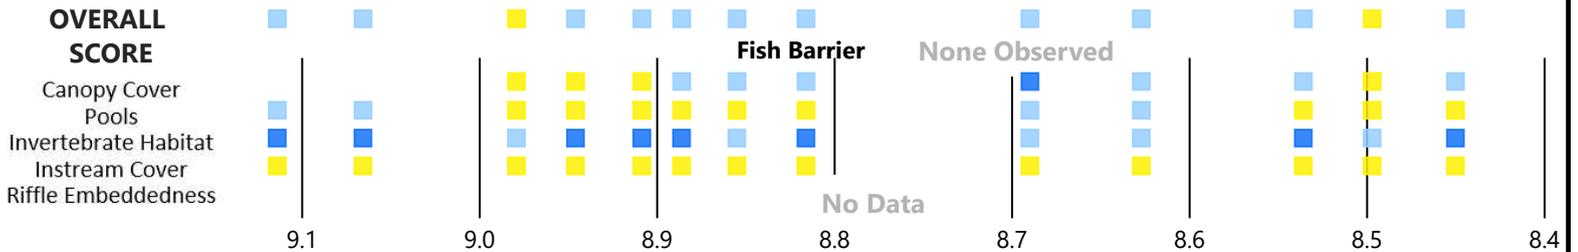
Score ■ Excellent ■ Good ■ Mediocre ■ Poor

Note: Overall Score of Fish Habitat was calculated by averaging scores for the five variables shown below.

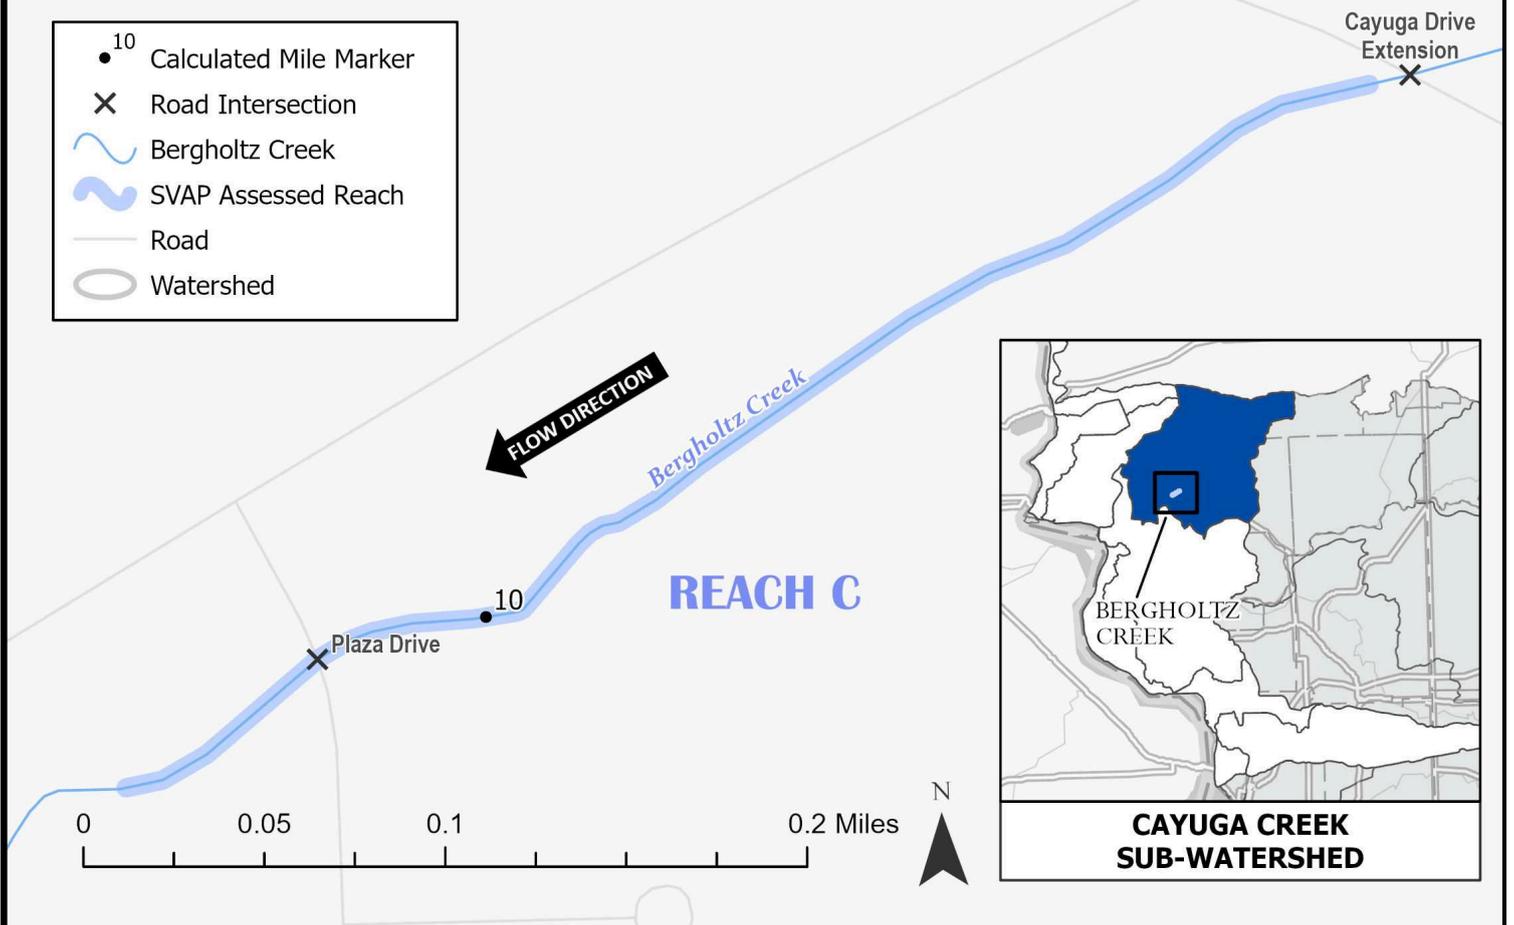
STREAM VISUAL ASSESSMENT PROTOCOL (SVAP) RESULTS FOR REACH C

- <sup>10</sup> Calculated Mile Marker
- ✕ Road Intersection
- ~ Bergholtz Creek
- ~ SVAP Assessed Reach
- Road
- Watershed

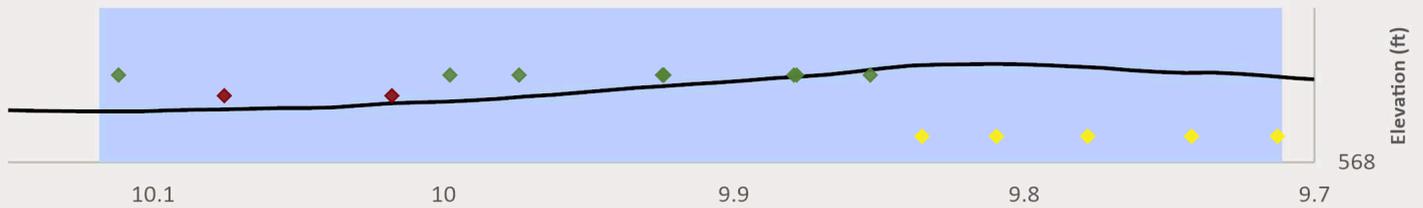
## Elevation Profile

Substrate ◆ Cobble ◆ Gravel ◆ Silt/Clay

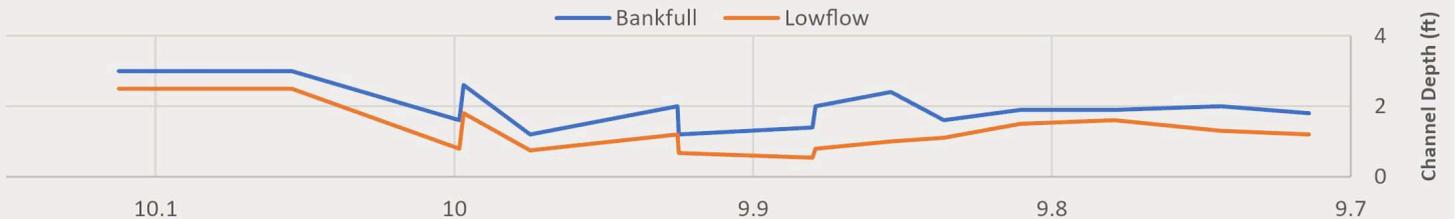
## Channel Depth

← FLOW DIRECTION Creek Mile (10.11 at Tailwater, 9.71 at Headwater) ← FLOW DIRECTION

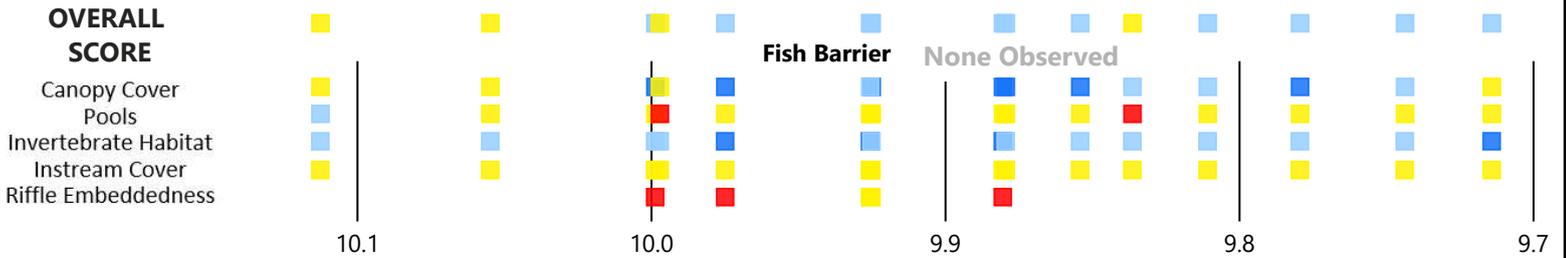
Score ■ Excellent ■ Good ■ Mediocre ■ Poor

Note: Overall Score of Fish Habitat was calculated by averaging scores for the five variables shown below.

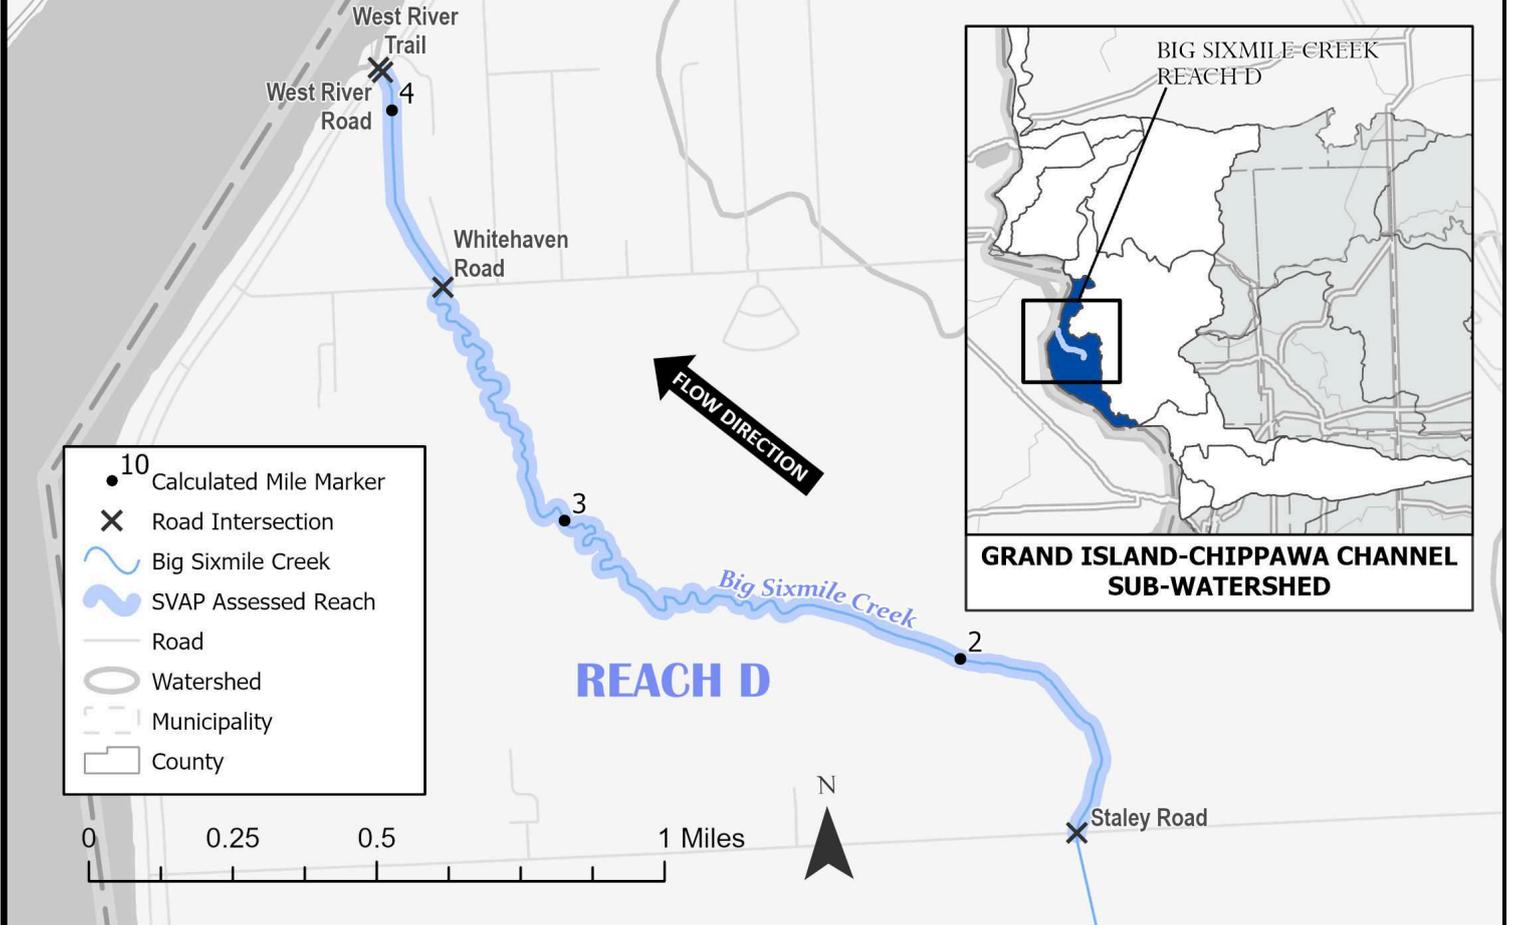
STREAM VISUAL ASSESSMENT PROTOCOL (SVAP) RESULTS FOR REACH D

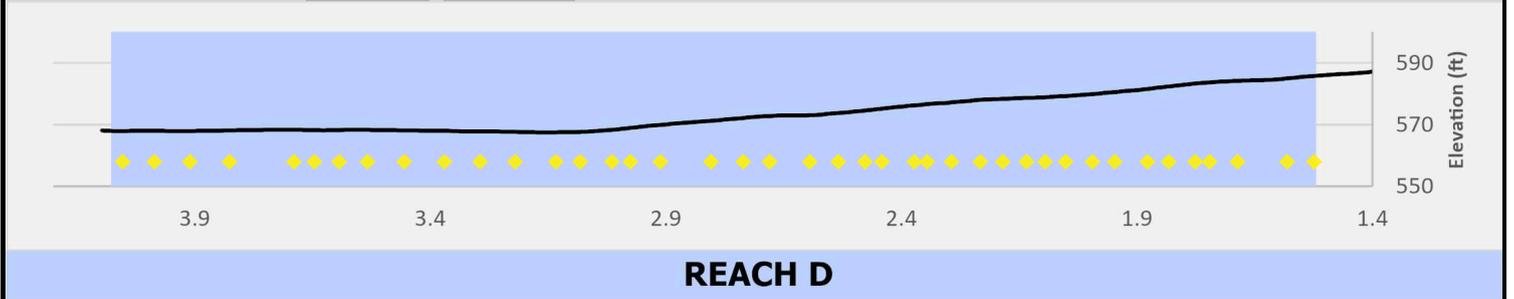
## Elevation Profile Substrate ◆ Silt/Clay

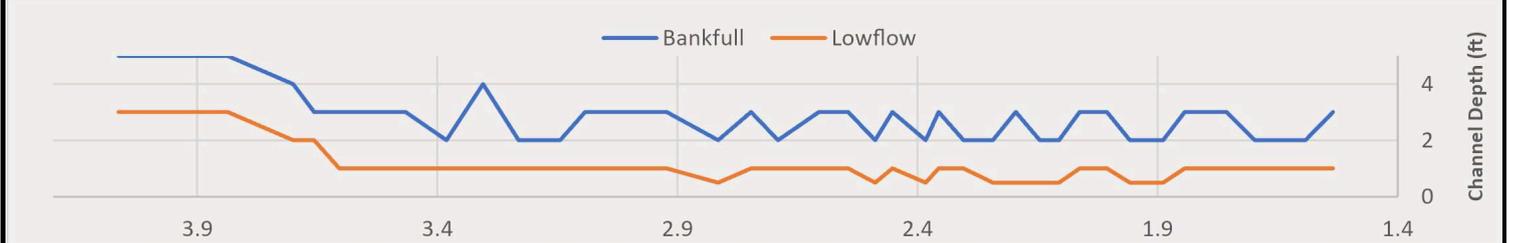
## Channel Depth

← FLOW DIRECTION
**Creek Mile (4.06 at Tailwater, 1.53 at Headwater)**
← FLOW DIRECTION

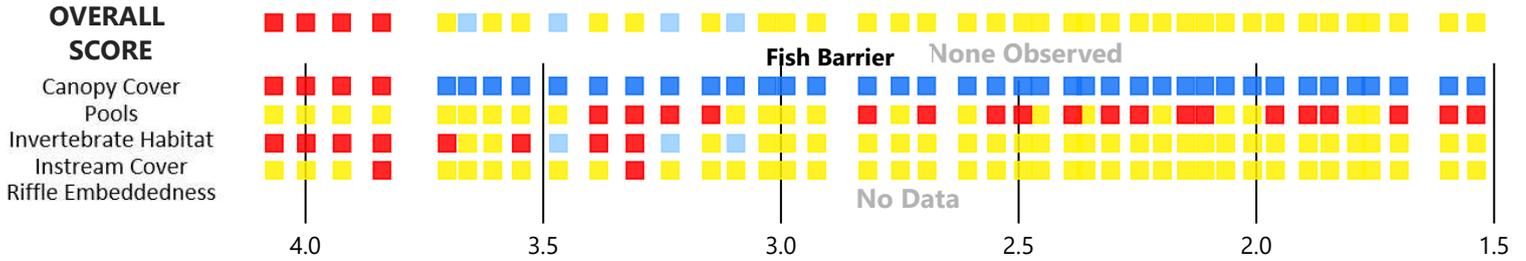
Score ■ Excellent ■ Good ■ Mediocre ■ Poor

Note: Overall Score of Fish Habitat was calculated by averaging scores for the five variables shown below.

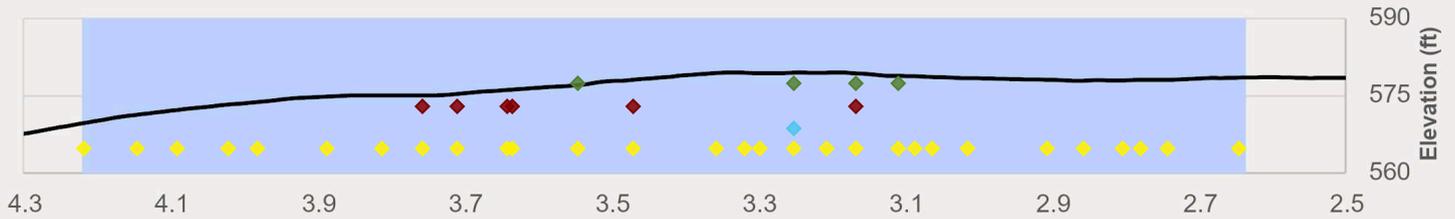
## Elevation Profile

Substrate: ◆ Cobble ◆ Gravel ◆ Sand ◆ Silt/Clay

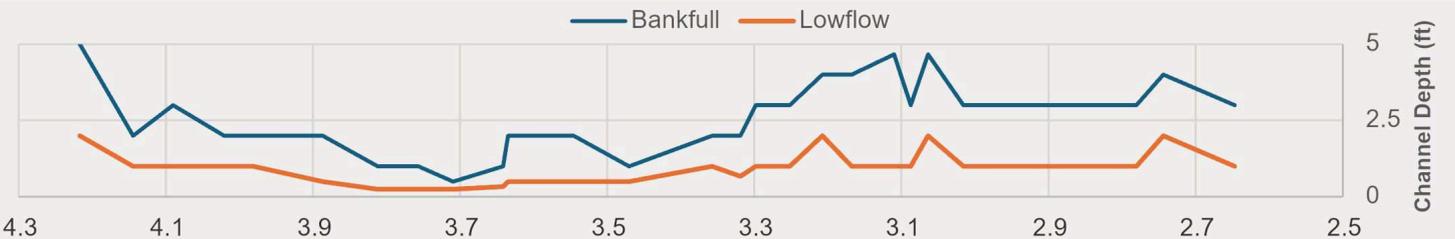
## Channel Depth

Creek Mile (4.22 at Tailwater, 2.65 at Headwater)

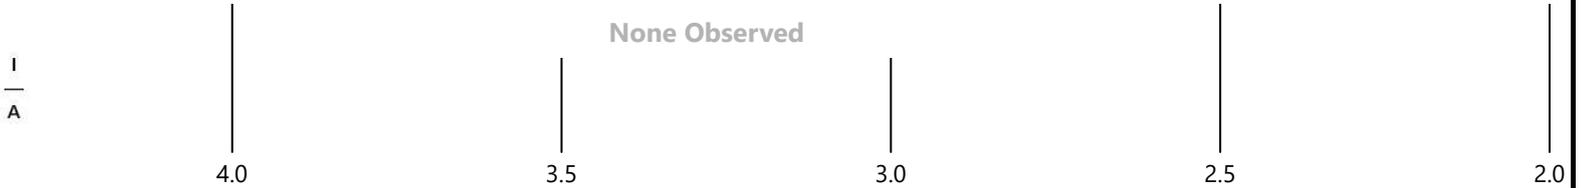
### Aggradation/Incision

■ Aggradation ▲ Incision

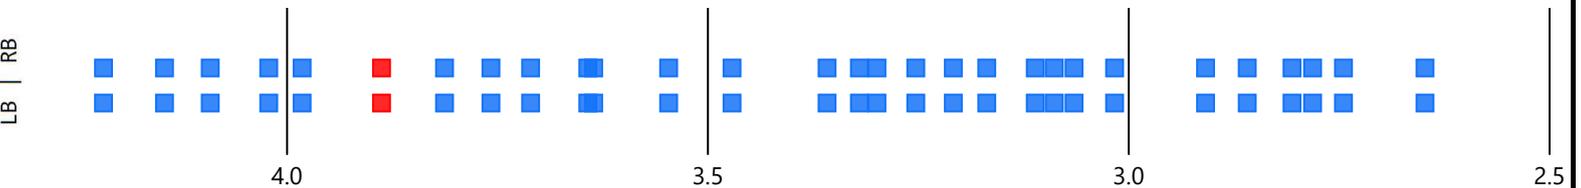
### Bank Condition

■ Hardened Structure ■ Natural

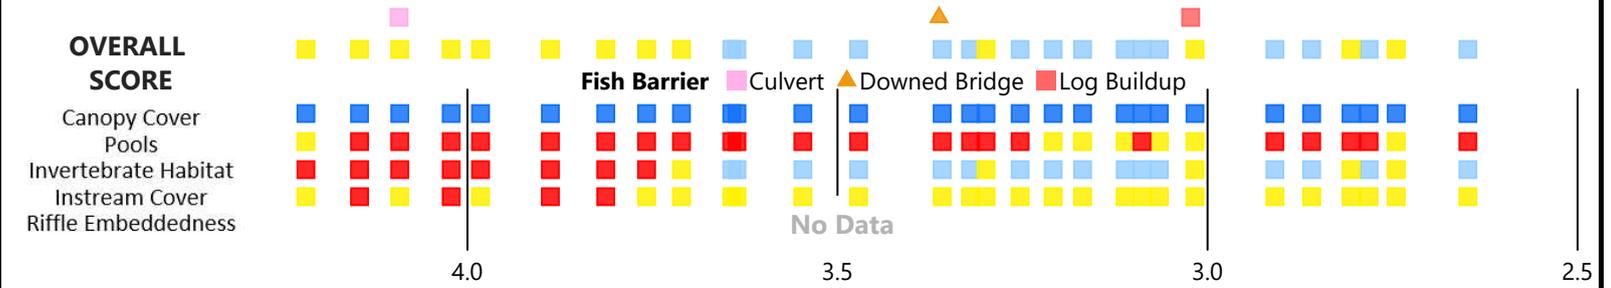
Score ■ Excellent ■ Good ■ Mediocre ■ Poor

Note: Overall Score of Fish Habitat was calculated by averaging scores for the five variables shown below.

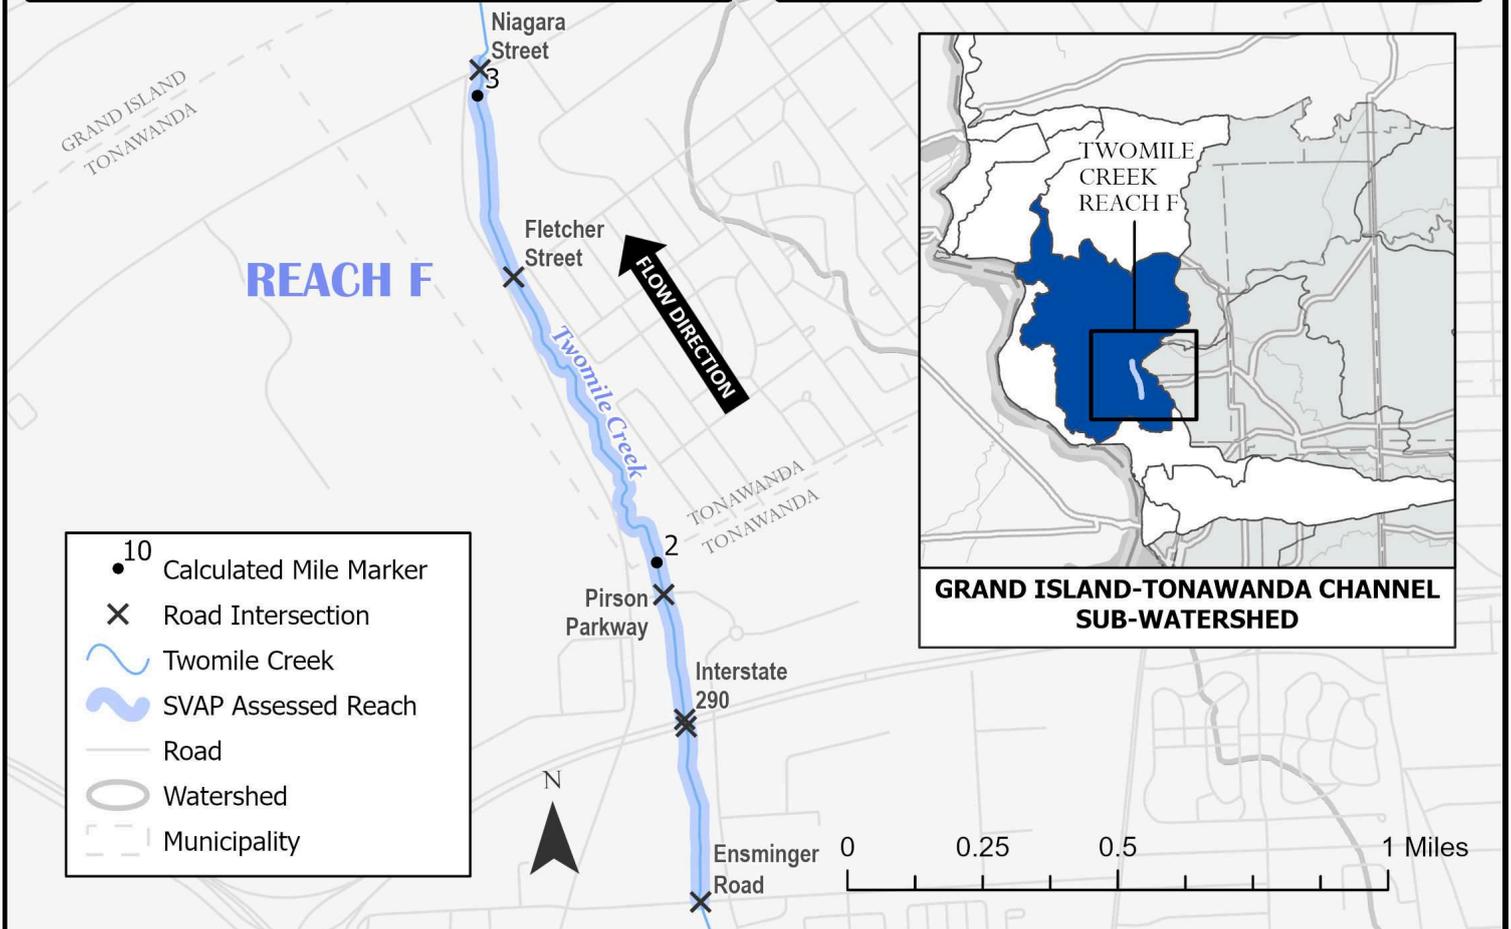
# TWOMILE CREEK

STREAM VISUAL ASSESSMENT PROTOCOL (SVAP) RESULTS FOR REACH F

AVERAGE OVERALL SVAP RATING: **4.6**

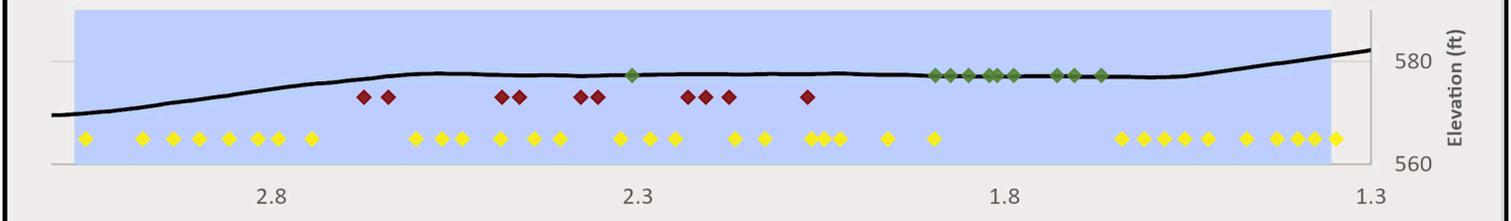
## Elevation Profile Substrate

◆ Cobble ◆ Gravel ◆ Silt/Clay

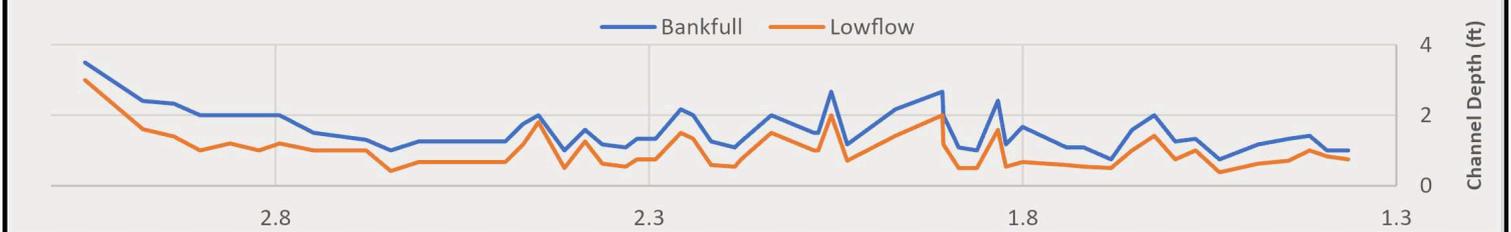
## Channel Depth

← FLOW DIRECTION Creek Mile (3.05 at Tailwater, 1.36 at Headwater) → FLOW DIRECTION

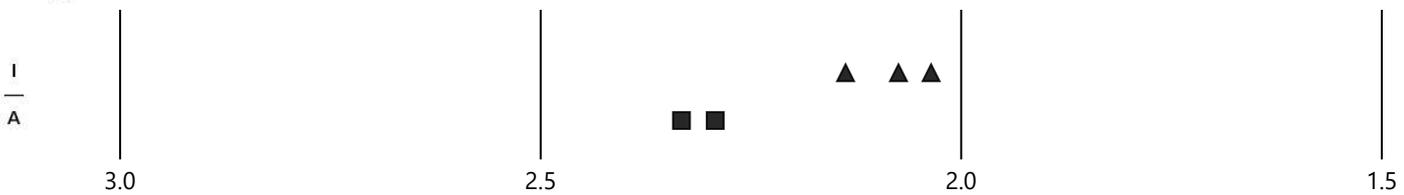
## Aggradation/Incision

■ Aggradation ▲ Incision

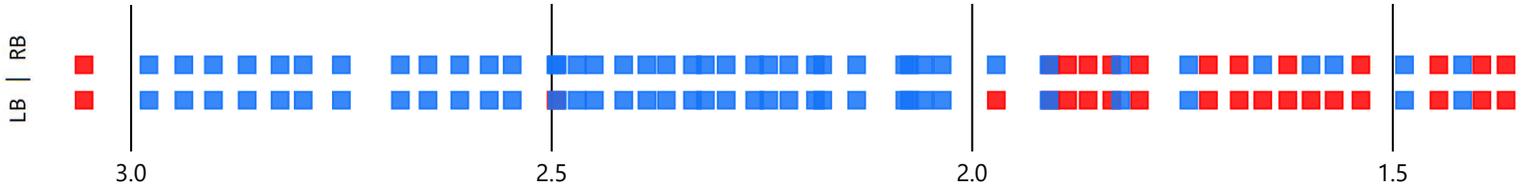
## Bank Condition

■ Hardened Structure ■ Natural

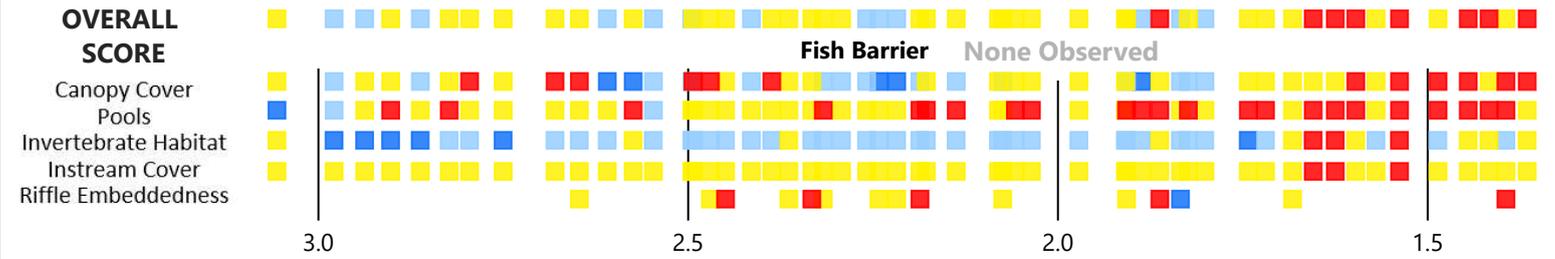
Score ■ Excellent ■ Good ■ Mediocre ■ Poor *Note: Overall Score of Fish Habitat was calculated by averaging scores for the five variables shown below.*

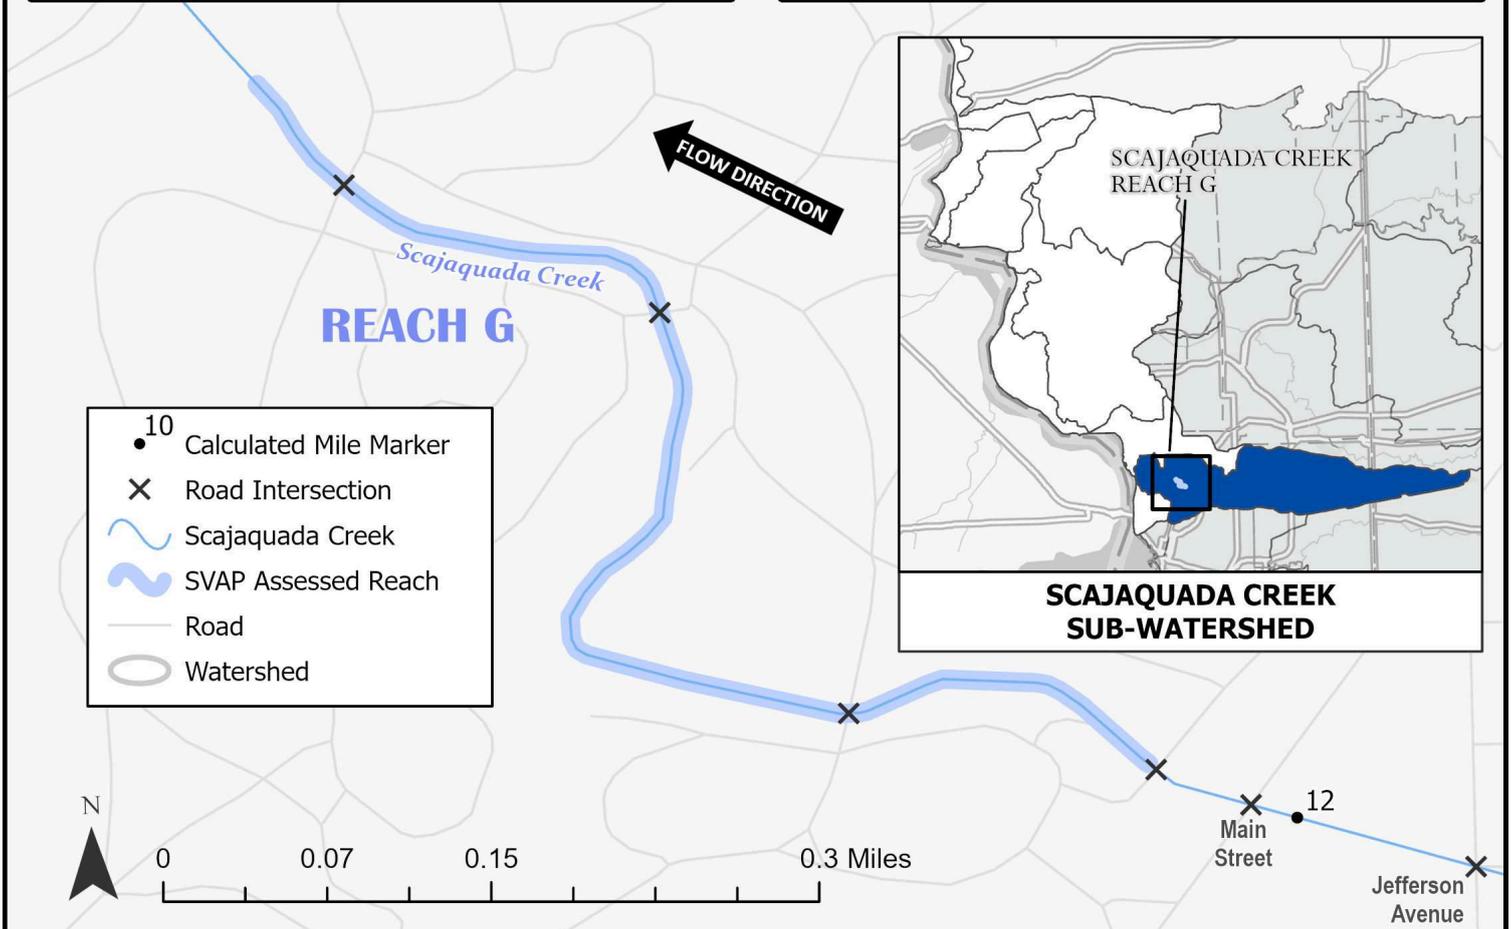
# SCAJAQUADA CREEK

STREAM VISUAL ASSESSMENT PROTOCOL (SVAP) RESULTS FOR REACH G

AVERAGE OVERALL SVAP RATING: **4.2**

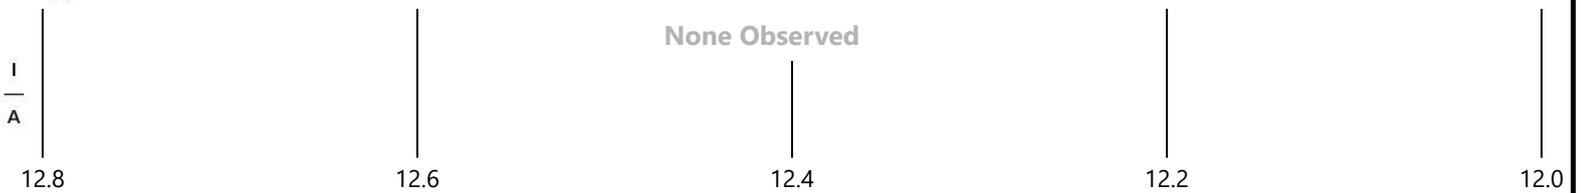
## Aggradation/Incision

■ Aggradation ▲ Incision

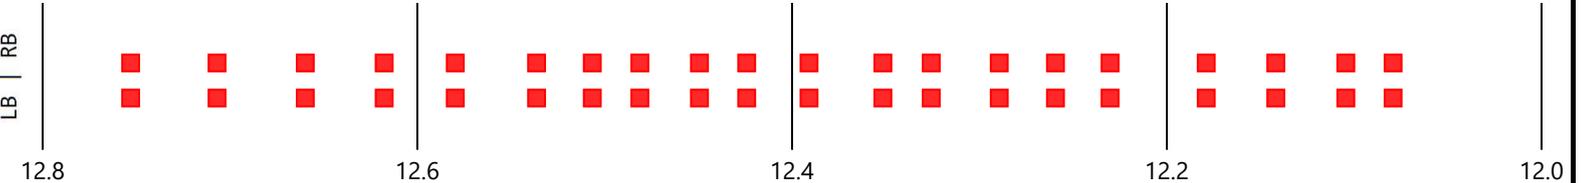
## Bank Condition

■ Hardened Structure ■ Natural

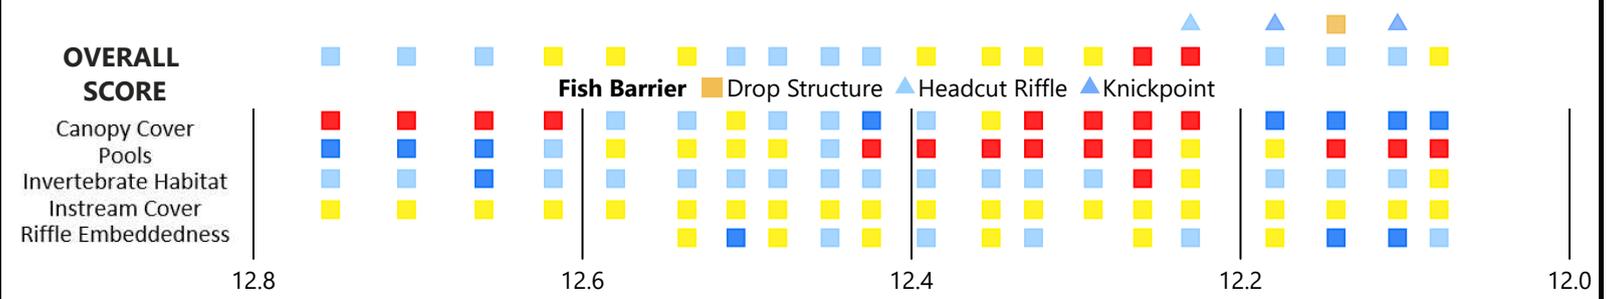
Score ■ Excellent ■ Good ■ Mediocre ■ Poor *Note: Overall Score of Fish Habitat was calculated by averaging scores for the five variables shown below.*

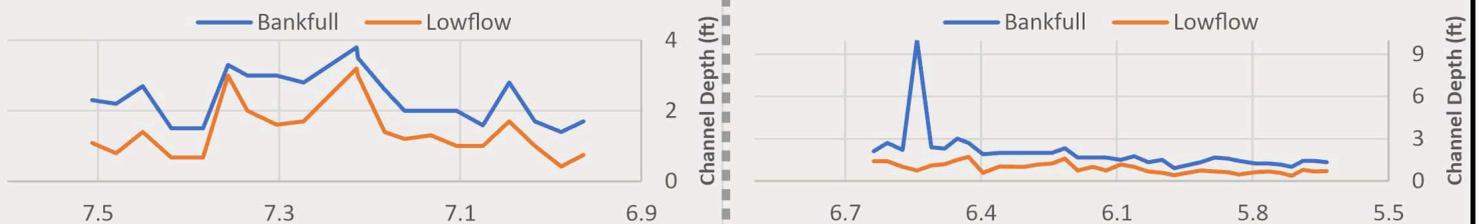
## Channel Depth

FLOW DIRECTION Creek Mile (Reach H: 7.51 at Tailwater, 6.96 at Headwater; Reach I: 6.64 at Tailwater, 5.64 at Headwater) FLOW DIRECTION

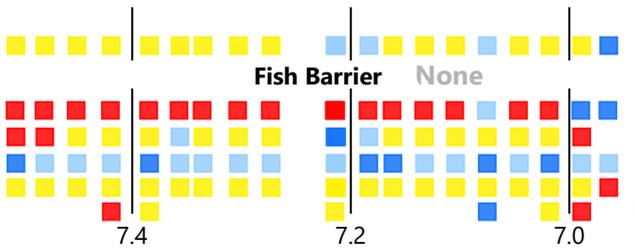
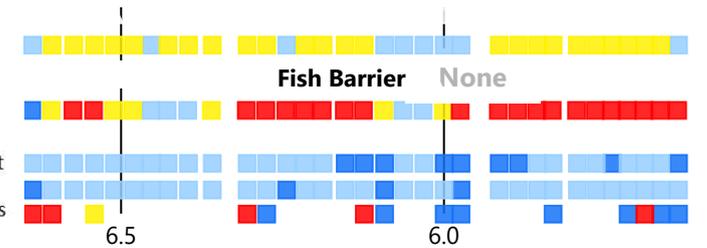
Score Excellent Good Mediocre Poor

Note: Overall Score of Fish Habitat was calculated by averaging scores for the five variables shown below.

Canopy Cover Pools Invertebrate Habitat Instream Cover Riffle Embeddedness

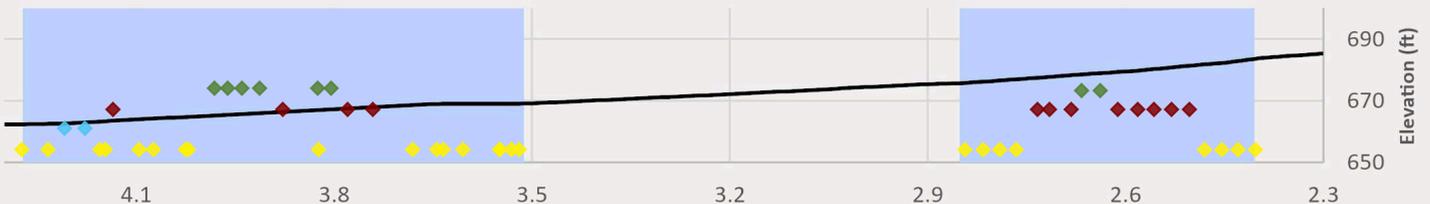
## Elevation Profile

Substrate: ◆ Cobble ◆ Gravel ◆ Sand ◆ Silt/Clay

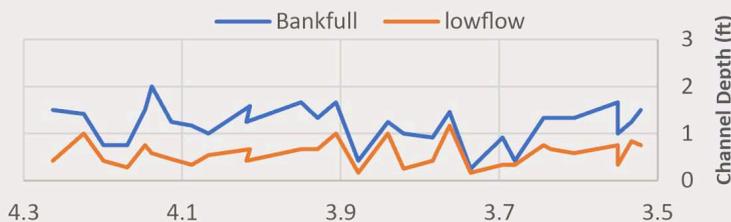
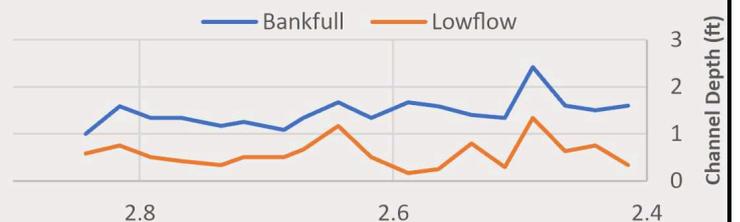
## Channel Depth

← FLOW DIRECTION Creek Mile (Reach J: 4.26 at Tailwater, 3.52 at Headwater; Reach K: 2.84 at Tailwater, 2.41 at Headwater) FLOW DIRECTION →
