ALTERNATIVES ANALYSIS

The Buffalo Bills Stadium Redevelopment Erie County, New York

Screening Level Phase I Environmental Site Assessment

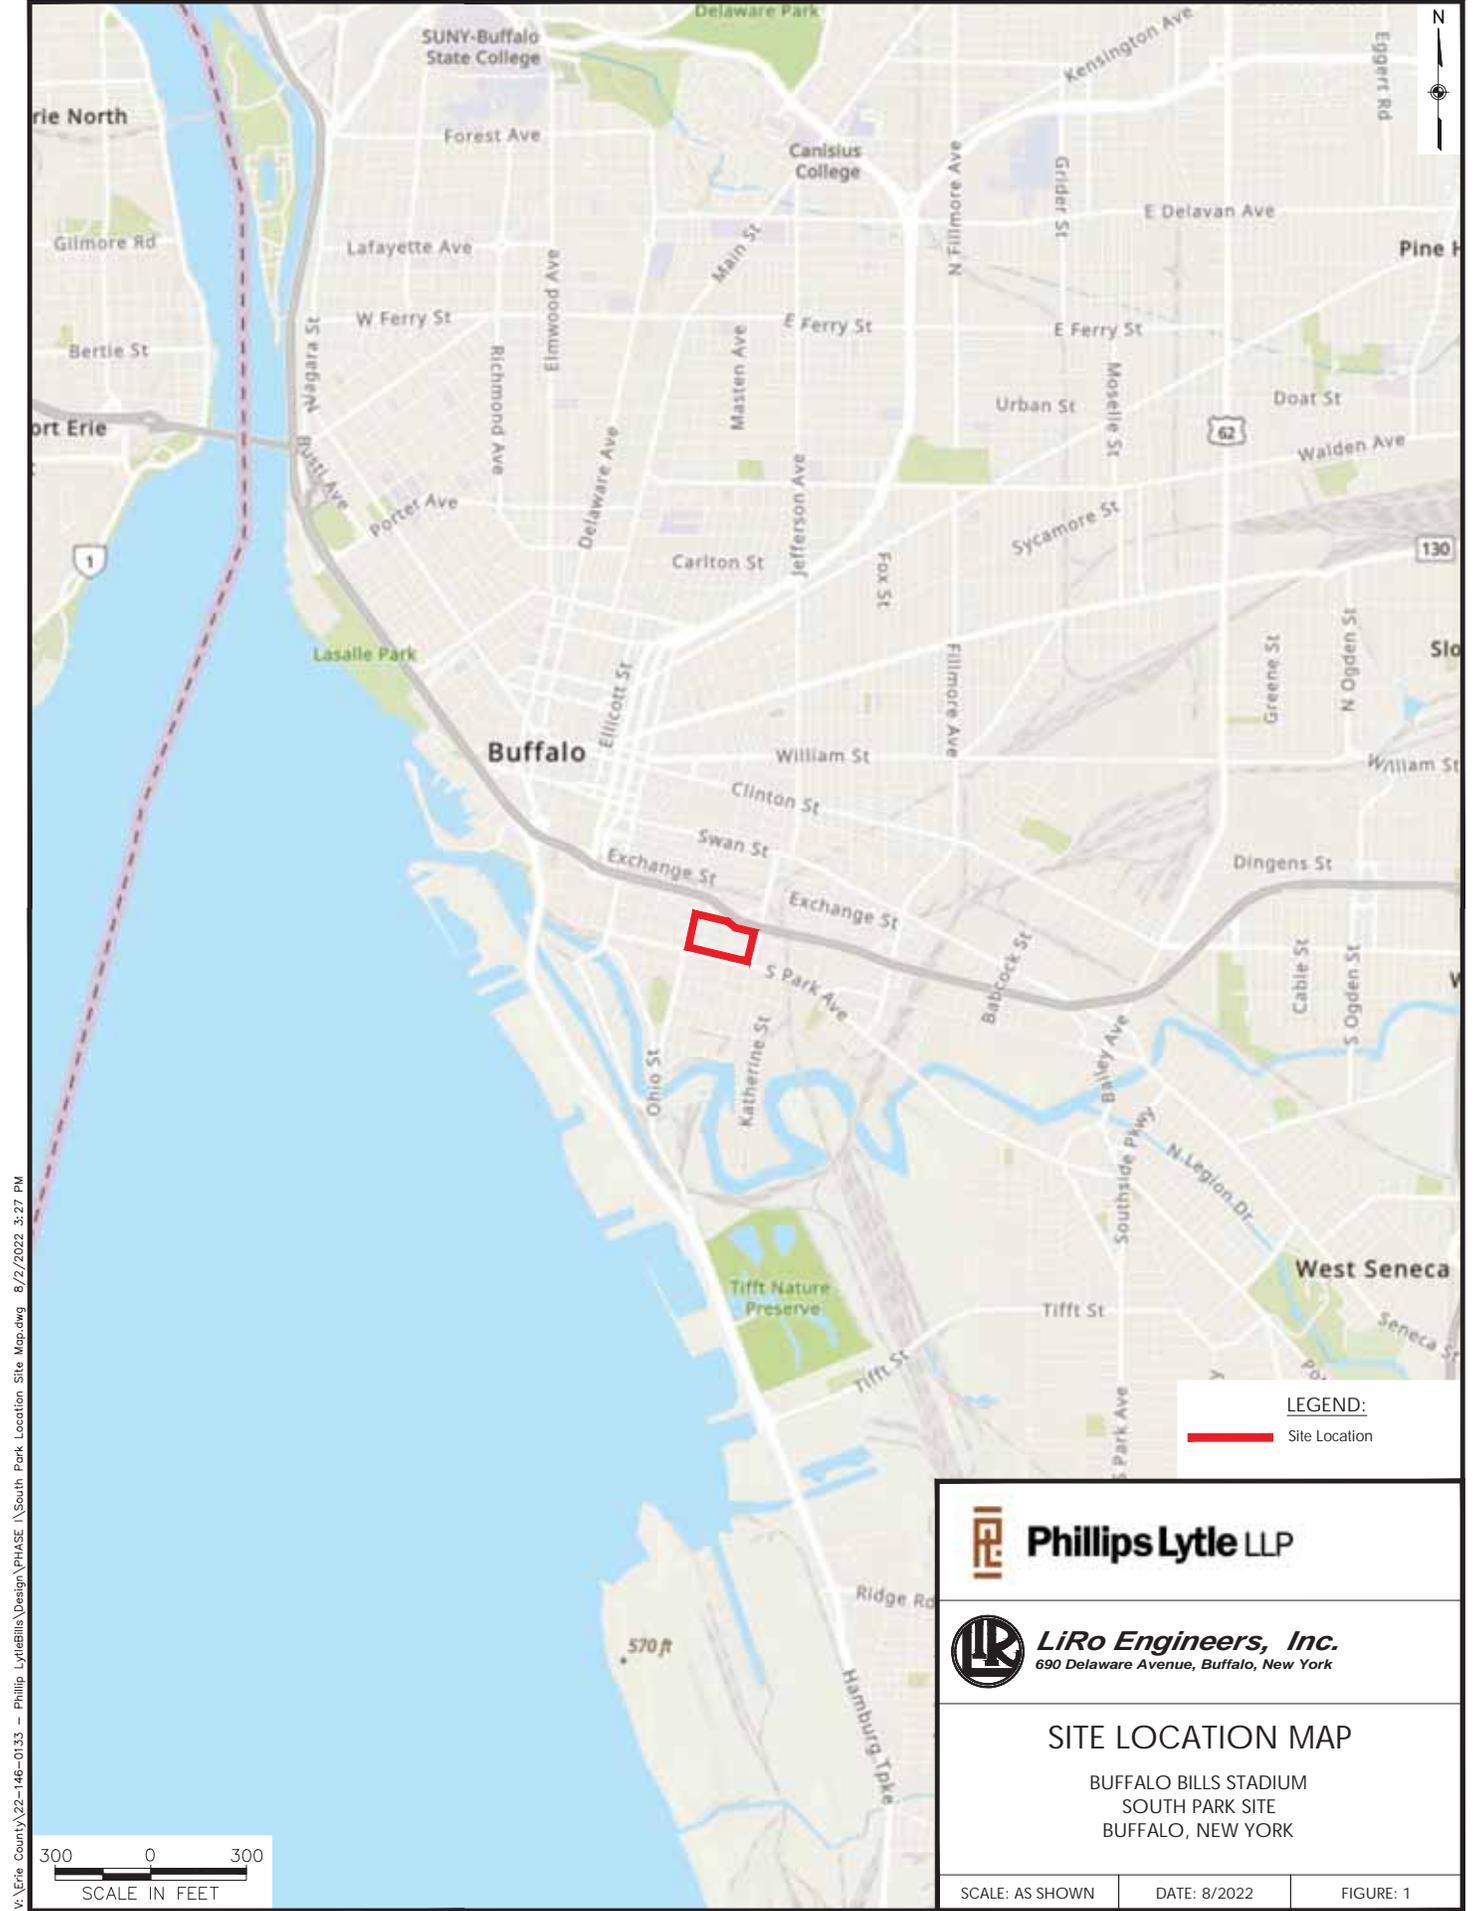
SCALE: AS SHOWN DATE: 8/2022 FIGURE: 1

The numerous subject properties that comprise the Site are located within the City of Buffalo, New York (Figure 1). The Site is bound by the I-190 to the north, South Park Avenue to the south, Hamburg Street to the east, and Louisiana Street to the west, as shown on Figures 1 and 2. The Site is generally rectangular-shaped with frontages along Hamburg Street, Louisiana Street, South Park Avenue, Otto Street, Perry Street, Hayward Street, Stannard Alley, Fulton Street, Coatsworth Alley, and Alabama Street. The Site is currently developed with multiple residential and commercial structures, many of which are vacant.

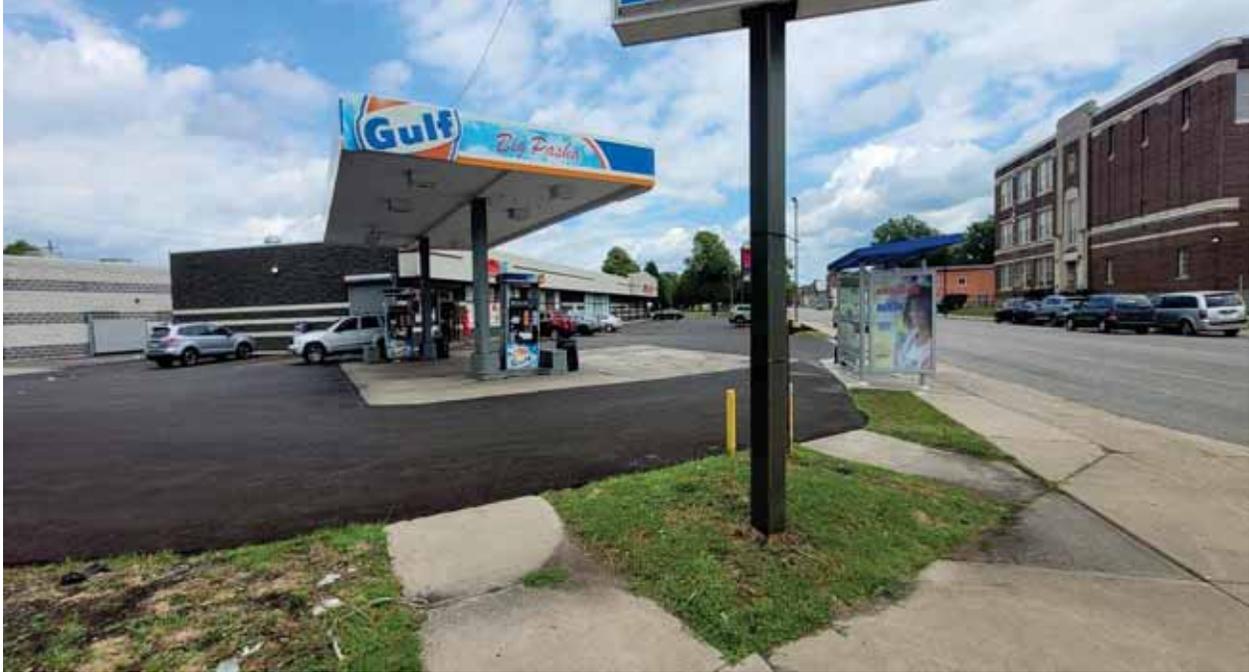
Photo No. 2: View of the former Buffalo Public Library and Catholic Church and School located along South Park Avenue.

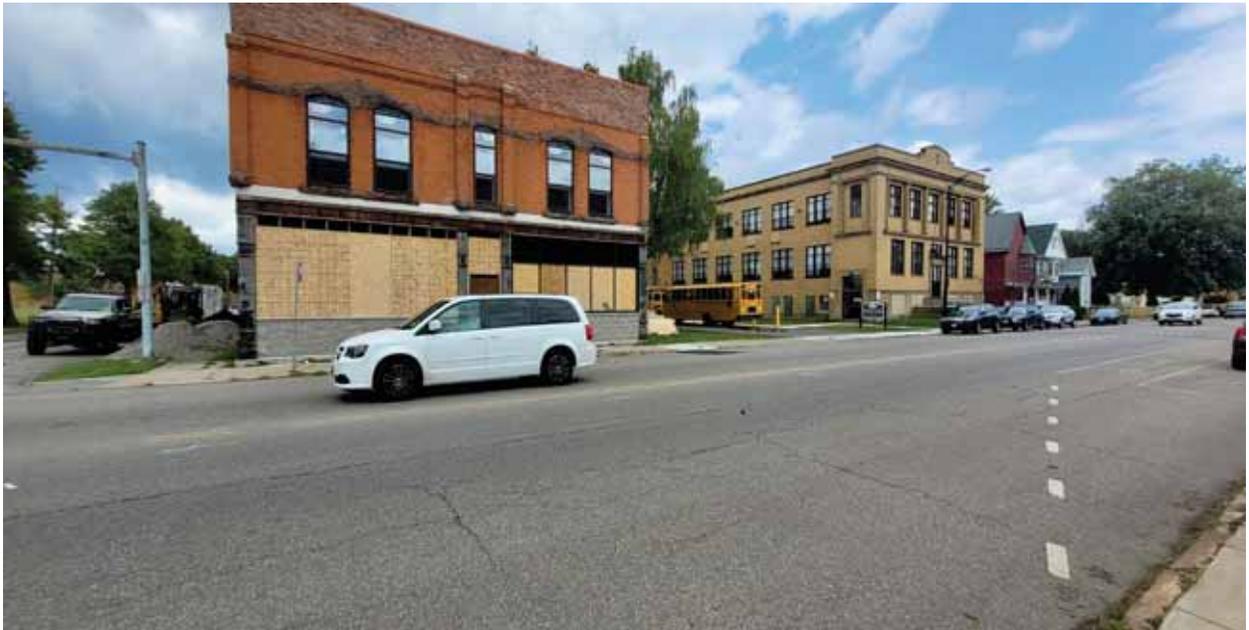
Photo No. 3: View of 568 South Park Ave. (southeast corner of the Site) looking north at the intersection of South Park Avenue and Hamburg Street.

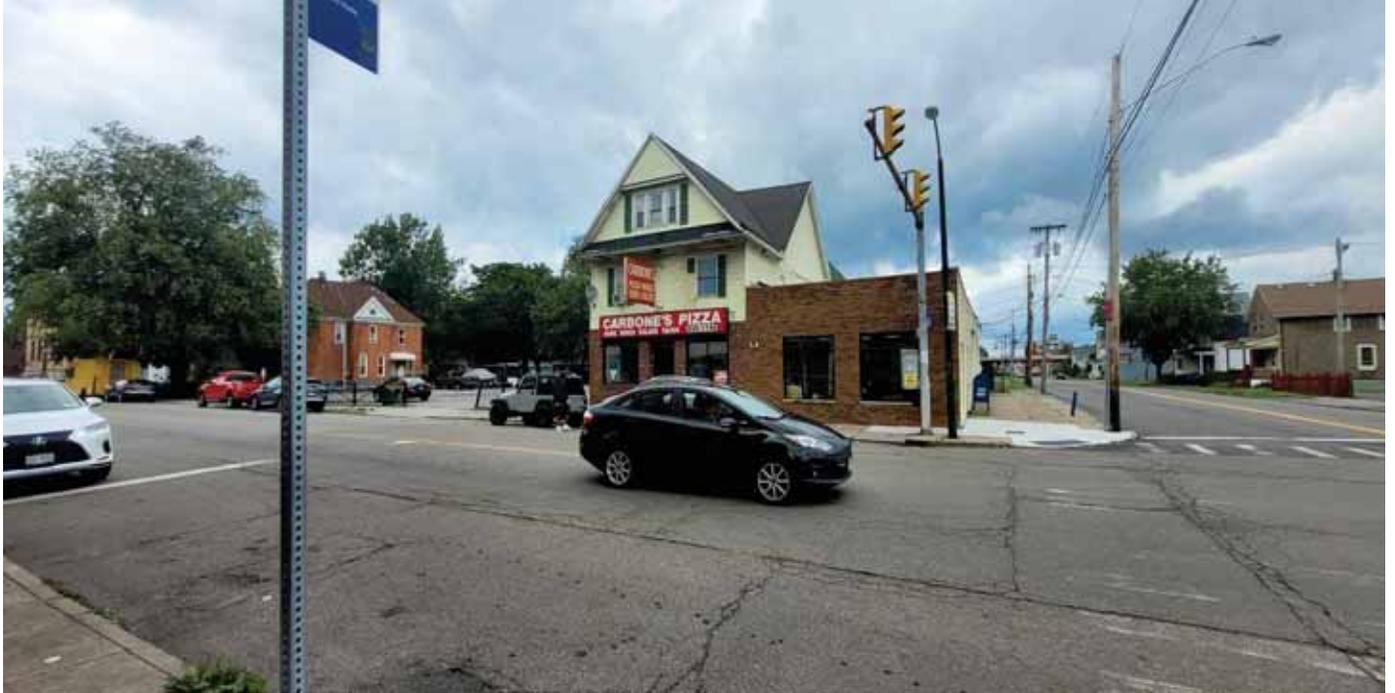
Photo No. 4: Another view of 568 South Park Ave. looking west along Hamburg Street. Note Grease trap behind the pizzeria.

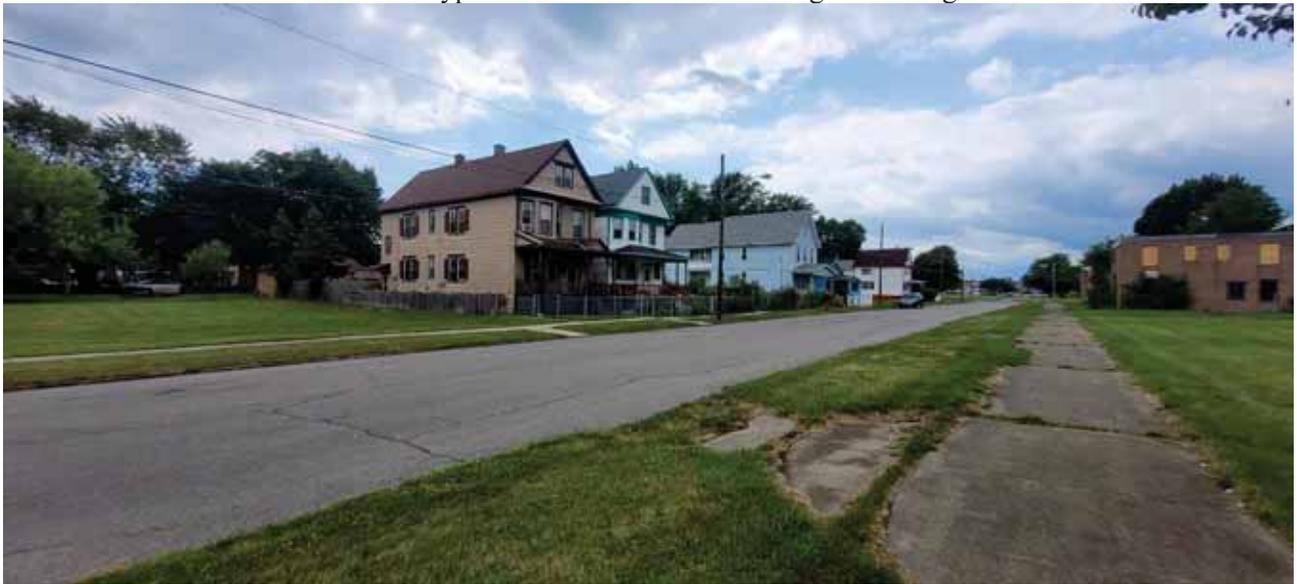
Photo No. 6: View of the former Commodore Perry Housing Projects looking north along Alabama Street.

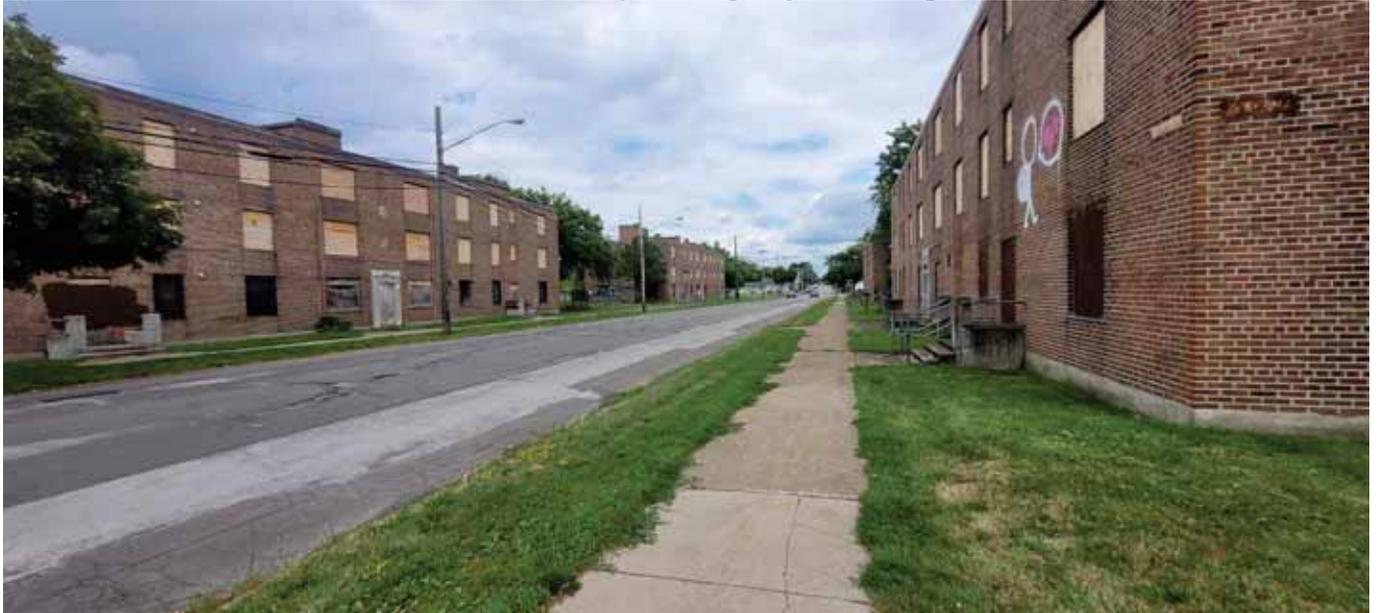
Photo No. 8: View of the former Commodore Perry Housing Projects looking south on Alabama Street.

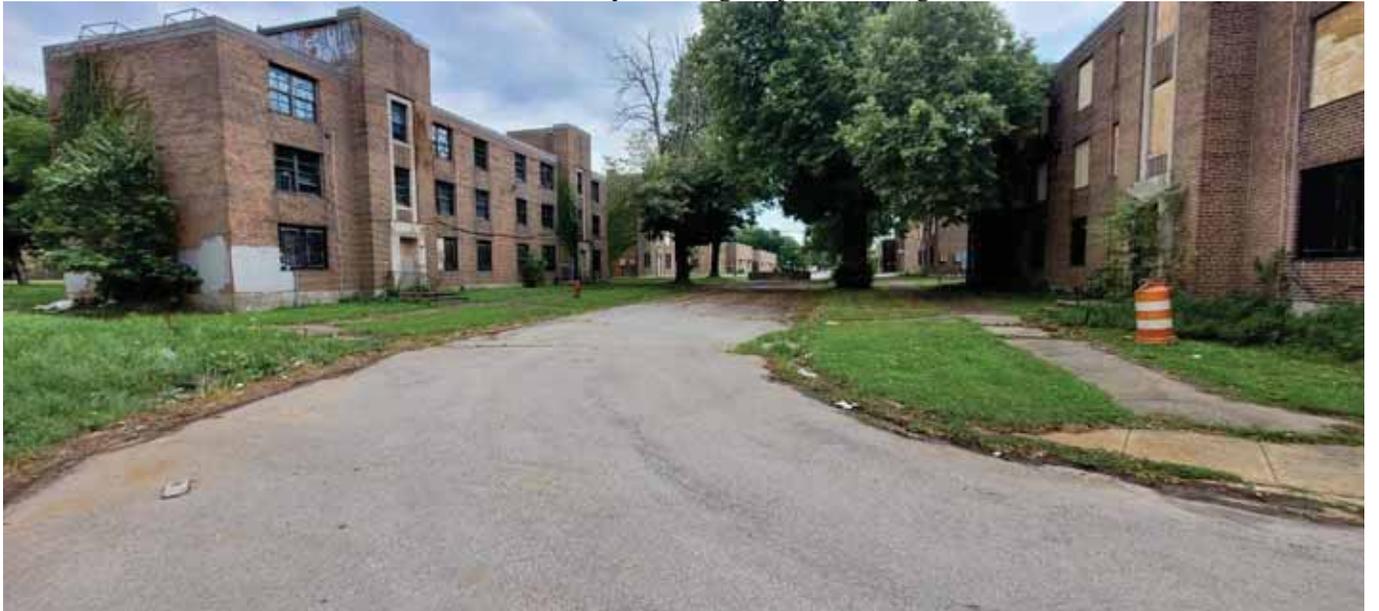
Photo No. 9: View of the former Commodore Perry Housing Projects looking south along Otto Street.
Note the large, tarp covered pile.

- If the entire Site area was to be re-developed, a Phase II Environmental Subsurface Investigation (ESI) would be warranted to assess the on-site environmental conditions. Due to the unknown nature of the stockpiled material located on-site, further research into the source of the material is warranted and/or sampling of the pile is warranted prior to transport and disposal of the material. The Phase II ESI should include an assessment of soil, groundwater, and soil vapor.
- Prior to conducting a Phase II ESI, additional evaluations should be conducted to develop the Phase II scope. These should include direct access inspections to properties, interviews with the property owners for properties with current or historical uses of environmental concern, and research of additional New York State and City of Buffalo records pertaining to the properties of environmental concern.

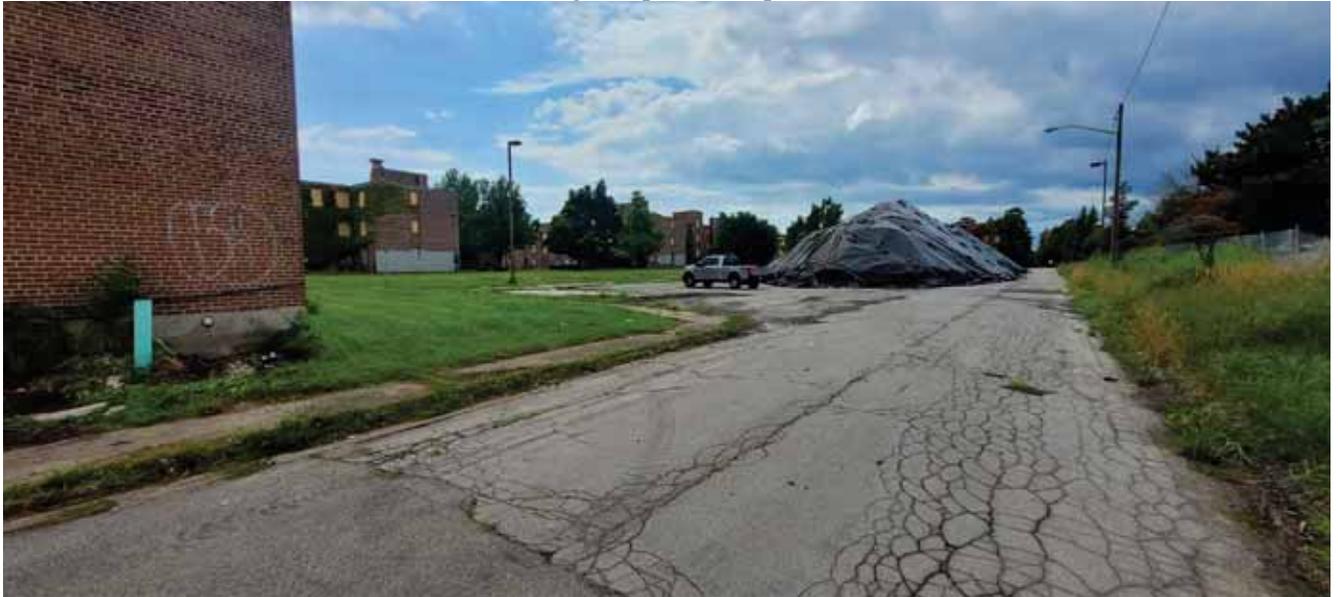
Photo No. 10: Another view of the large, tarp covered pile looking northeast.

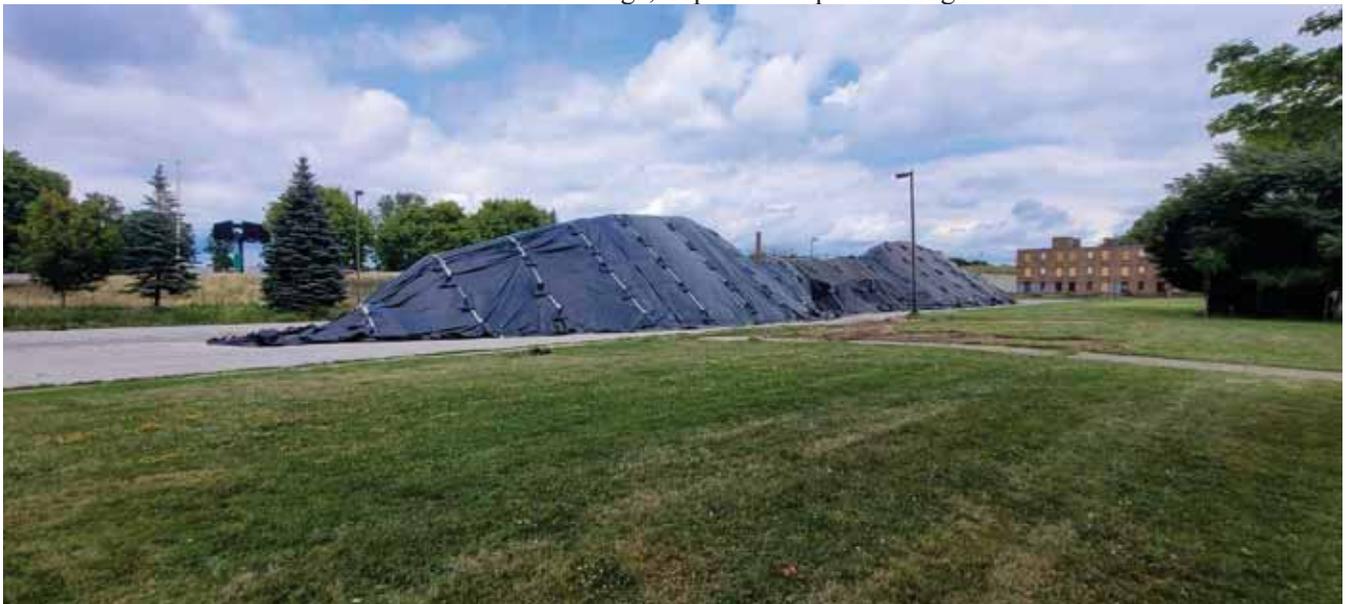
Photo No. 11: View of the former Commodore Perry Housing Projects looking east in a parking lot south of Otto Street. Note the small stockpile of soil.

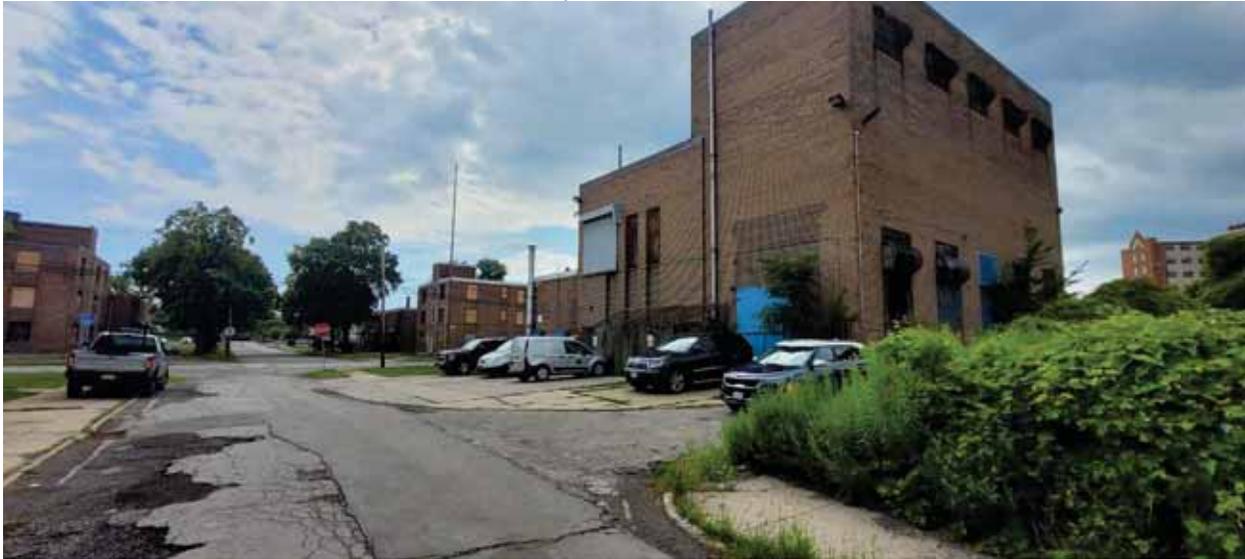
- Three flush-mount groundwater monitoring wells were noted in the area of 386 Perry Street. Three Leaking Tanks (LTANKs) and one NY Spill are recorded for the 386 Perry Street facility. All of which have been closed by the New York State Department of Environmental Conservation (NYSDEC).
- Due to the anticipated age of many of the on-site structures, asbestos-containing materials (ACMs) and lead-based paint are likely present.

Photo No. 14: View of the alleyway behind the possible incinerator/power plant located at 386 Perry Street looking east. Note the flush-mount monitoring well.

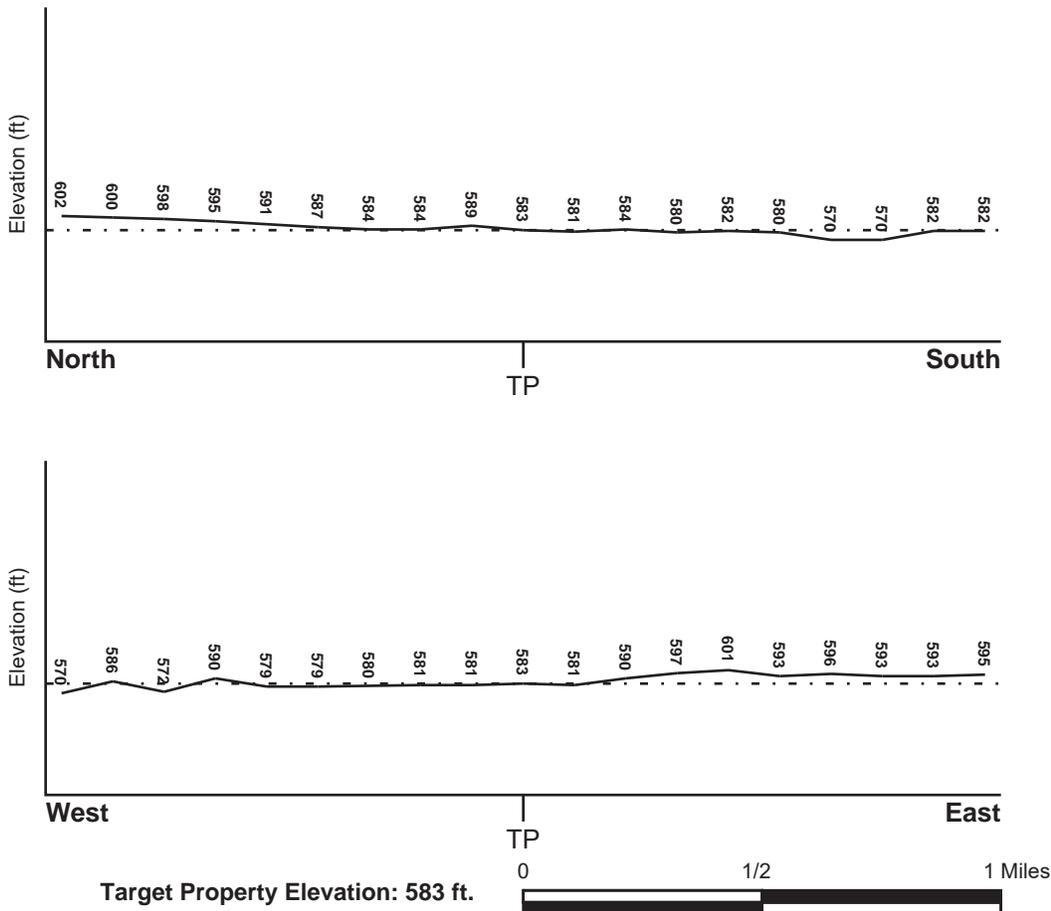
SURROUNDING TOPOGRAPHY: ELEVATION PROFILES

Source: Topography has been determined from the USGS 7.5' Digital Elevation Model and should be evaluated on a relative (not an absolute) basis. Relative elevation information between sites of close proximity should be field verified.
