Phase I

Environmental Site Assessment

Bills Stadium Project
1 Bills Drive, 4196 Abbott Road, 4041 Southwestern Boulevard, and Unaddressed Parcel on Southwestern Boulevard
Orchard Park, New York 14127

LaBella Project No. 2221770.02
Award/Client Project No. N/A

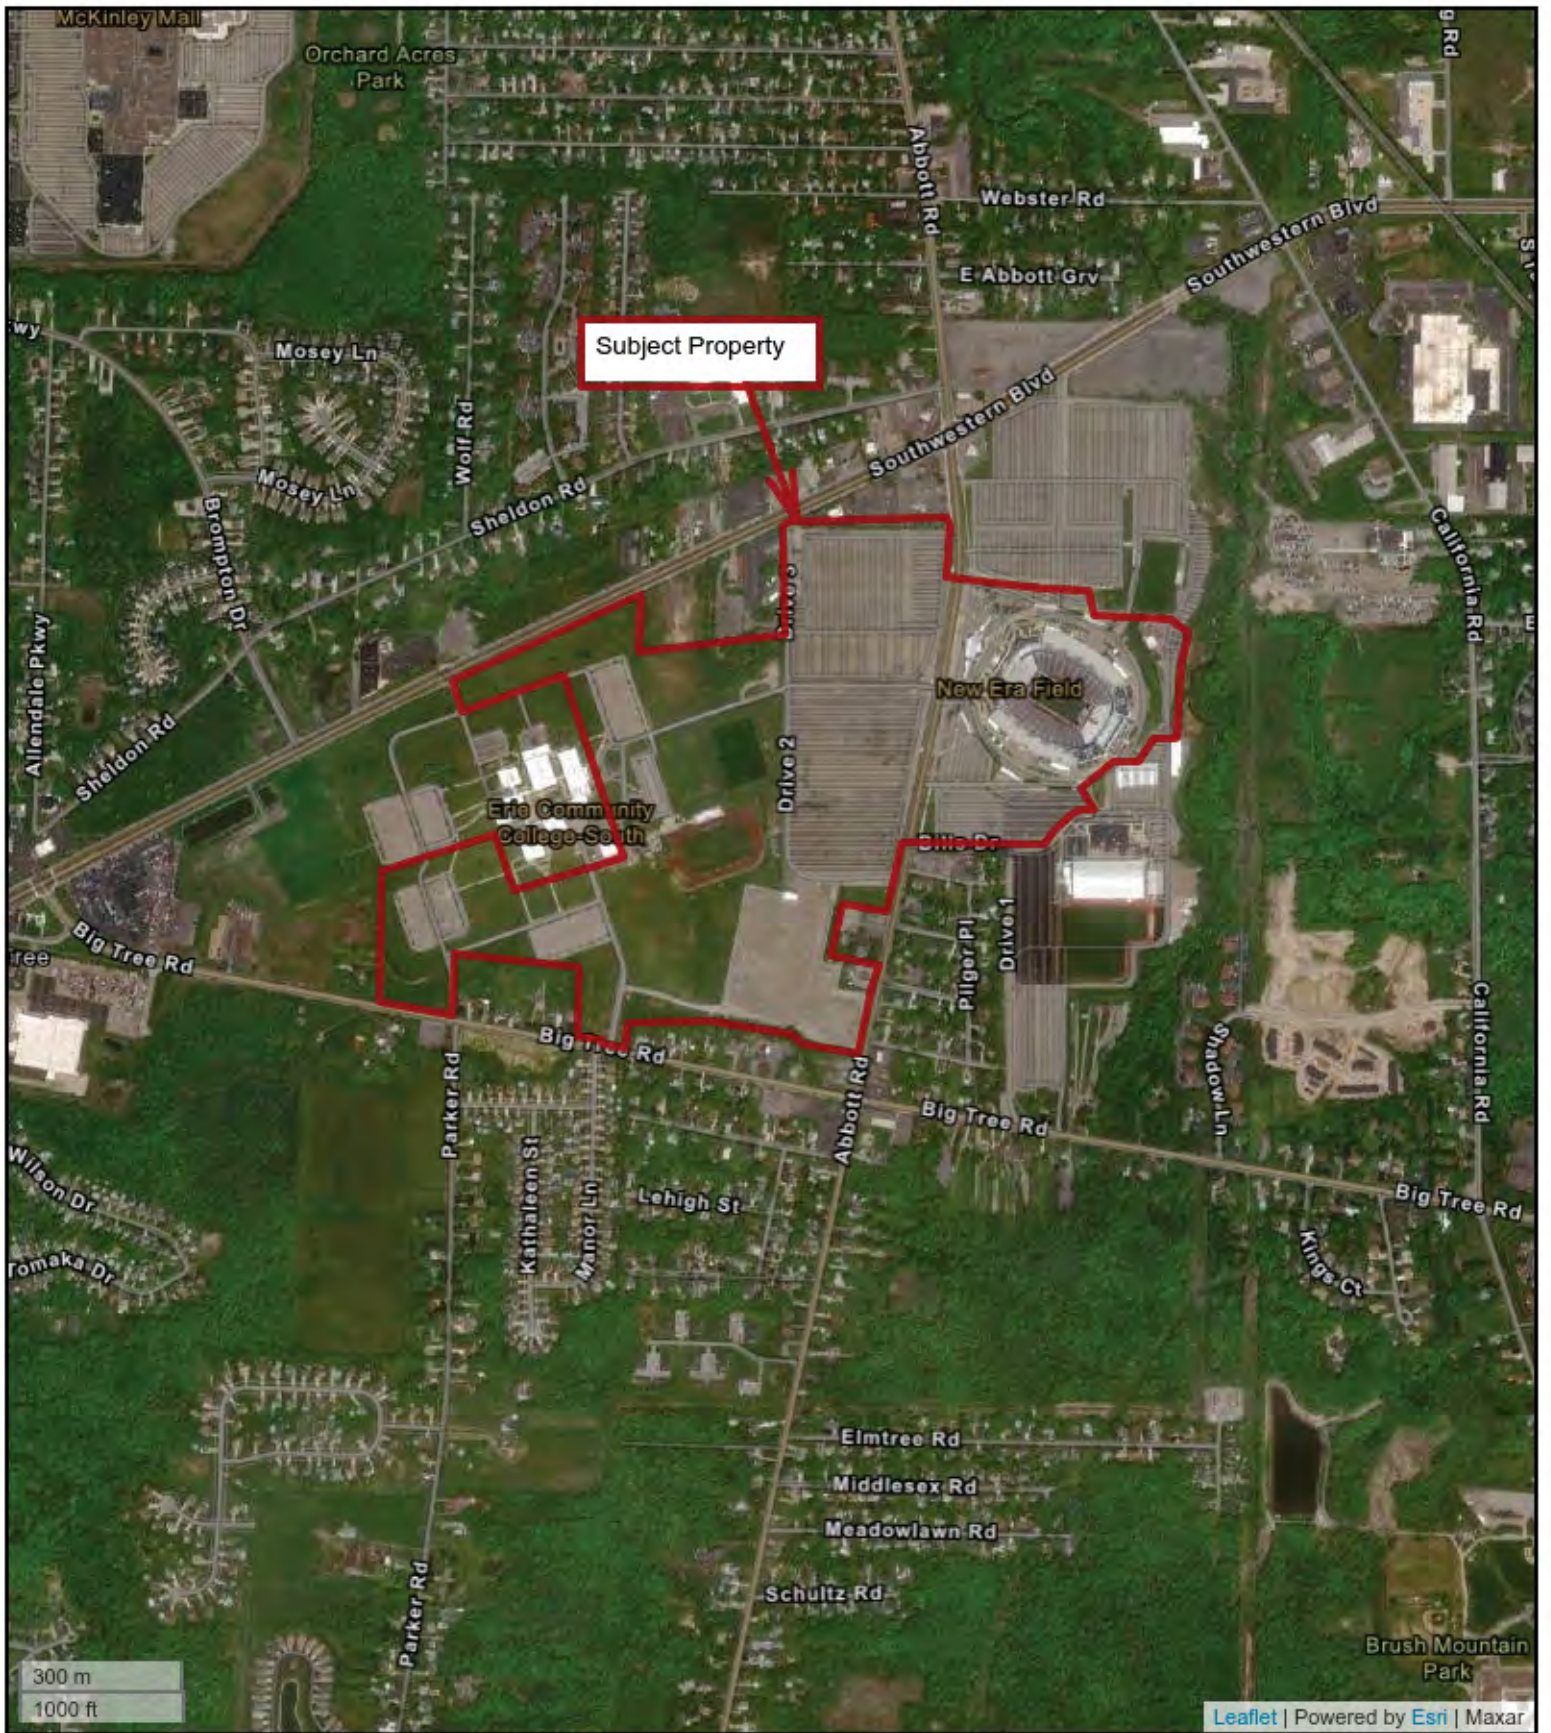
Figure 3 Site Plan

Observations discussed in this Section are noted on [Figure 3](#). Copies of the field notes taken during the site visit are included in the [Site Reconnaissance Worksheet](#) Appendix. Representative photographs of the Subject Property at the time of the site reconnaissance are included in the [Site Photographs](#) Appendix.

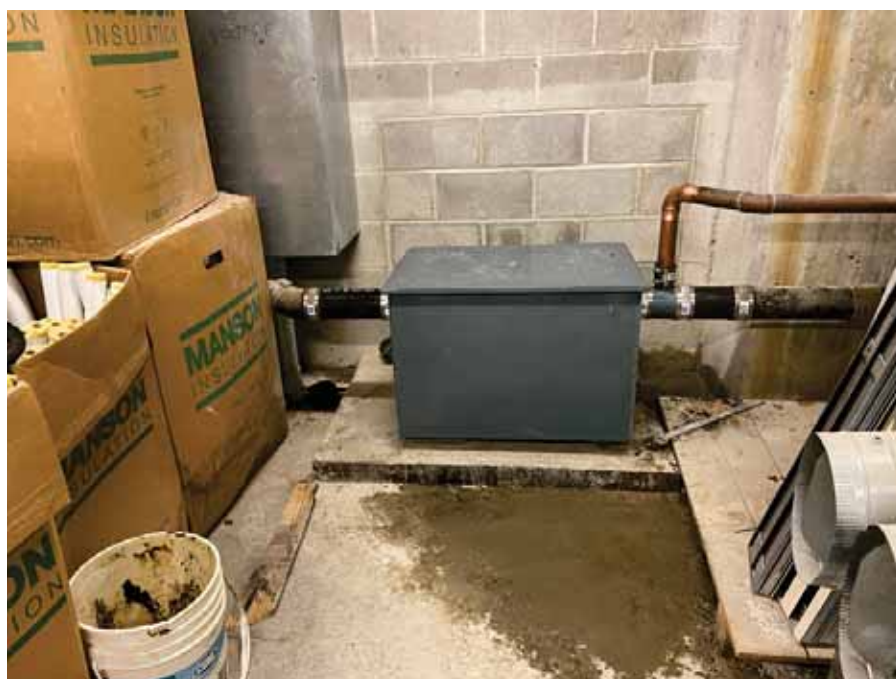
Photo 30 : Typical grease trap in Building One in Concession Area

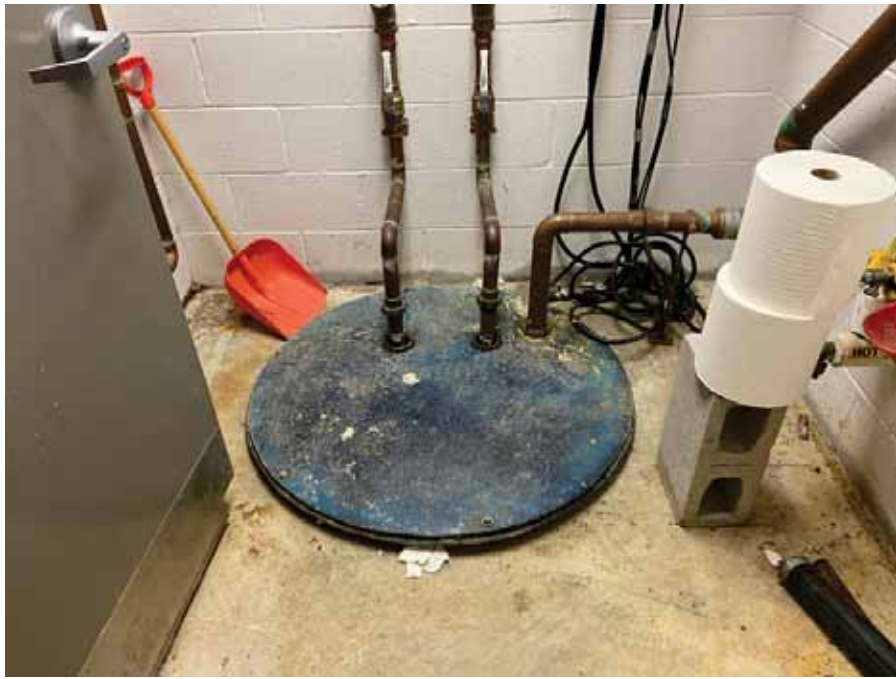
Photo 39 : Collection and pump located within Building Six

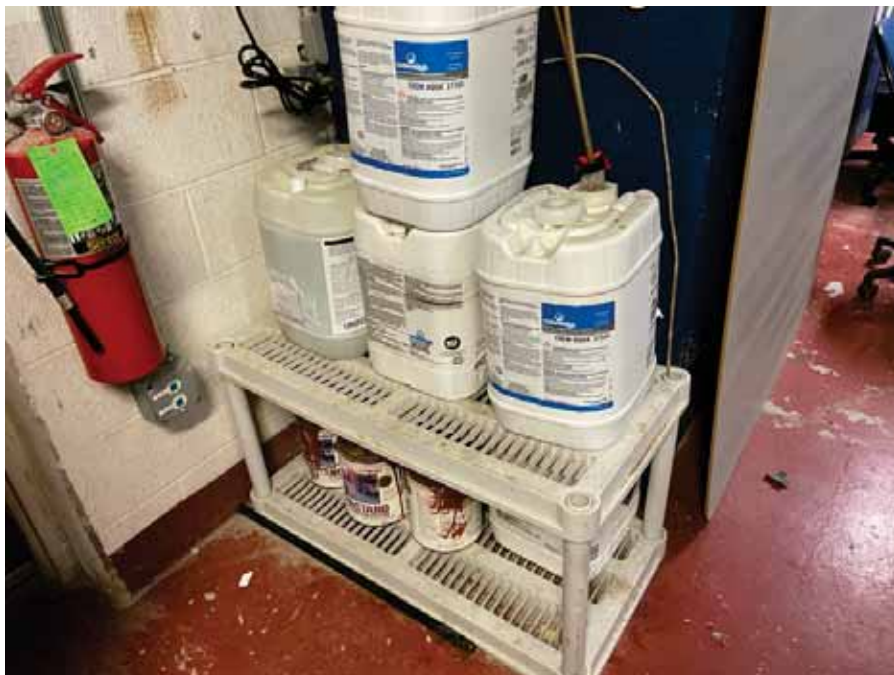
Amount/Capacity/Contents	Location	Use	Staining/Evidence of Release?
Various cleaning materials/ Various sizes	Janitor Rooms in Building One	Maintenance	No
Hydraulic Oil/25-gallon drums	Building One	Maintenance of boiler room and elevator equipment	No
Pink Glycol/various 55-gallon containers	Building One	Maintenance of boiler room equipment	No
Feedwater Treatment/various 55-gallon containers	Building One	Maintenance of boiler room equipment	No
Water softeners/25 gallon containers	Building One	Maintenance of boiler room equipment	No
Laundry Detergents/ 150-gallon containers	Building One	Laundry	No
Propane/compressed gas containers	Eastern exterior of Building One	Maintenance Operations	No
Argon and Nitrogen/ compressed gas containers	Eastern exterior of Building One	Maintenance Operations	No
Paint/5-gallon containers	Northern exterior of Building Four	Paint Fields	No

Photo 48 : Typical Hazardous materials within Building One

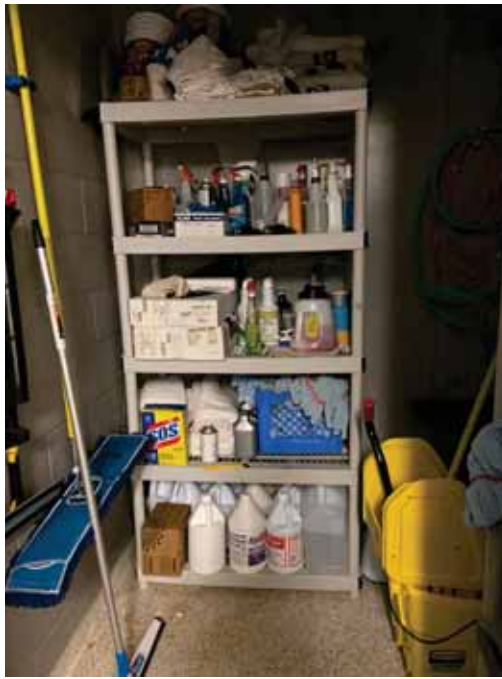
Photo 49 : Typical cleaning supplies in Building One

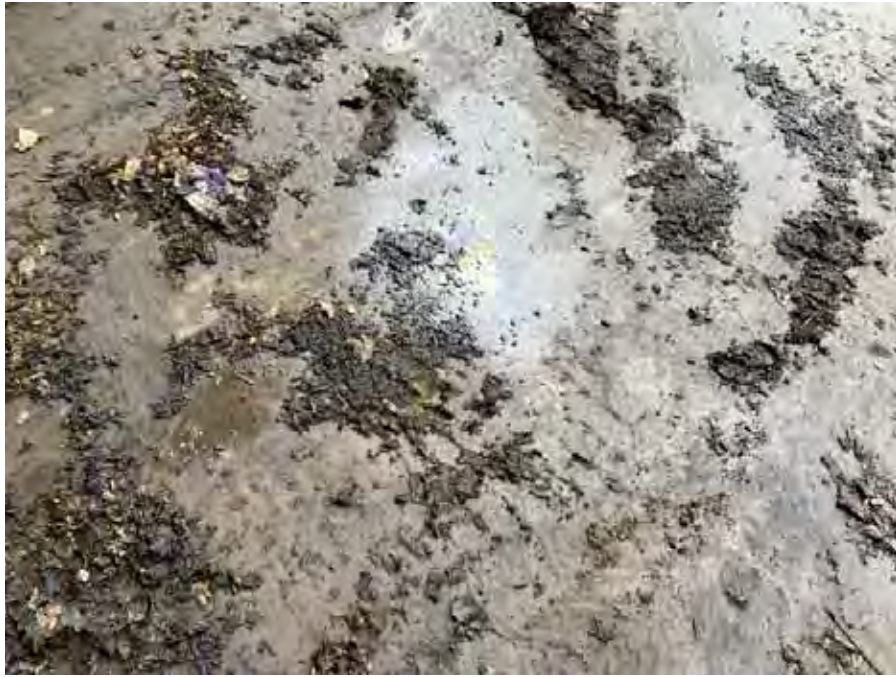
- Minor staining observed near lawn equipment on the concrete floor in the shed underneath the bleachers in Area Two
- Minor staining observed to concrete floors in Building Eight

Photo 115 : Minor oil staining observed in Building Eight

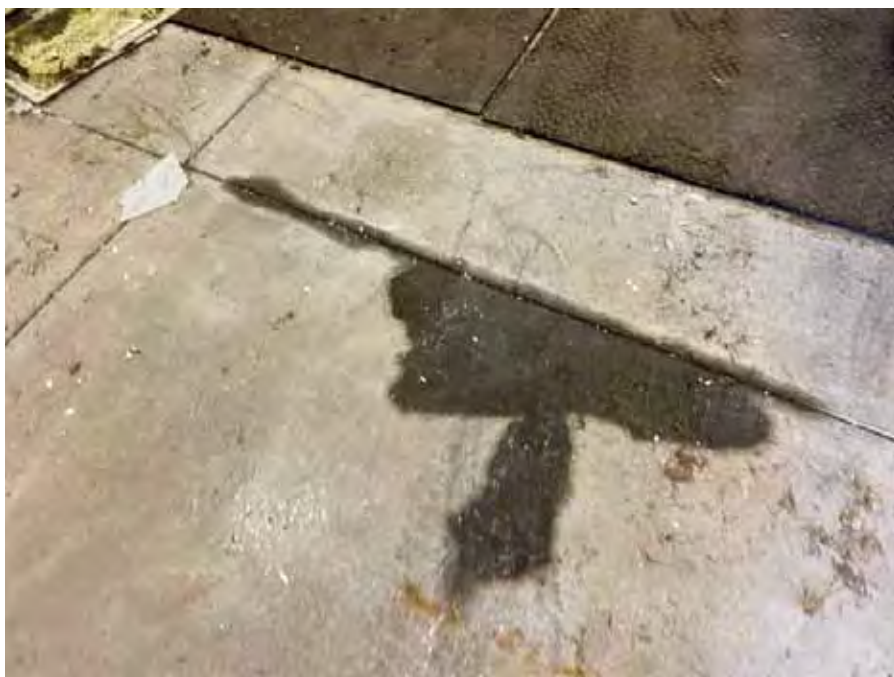
Photo 134 : Staining observed in shed underneath the bleachers in Area Two

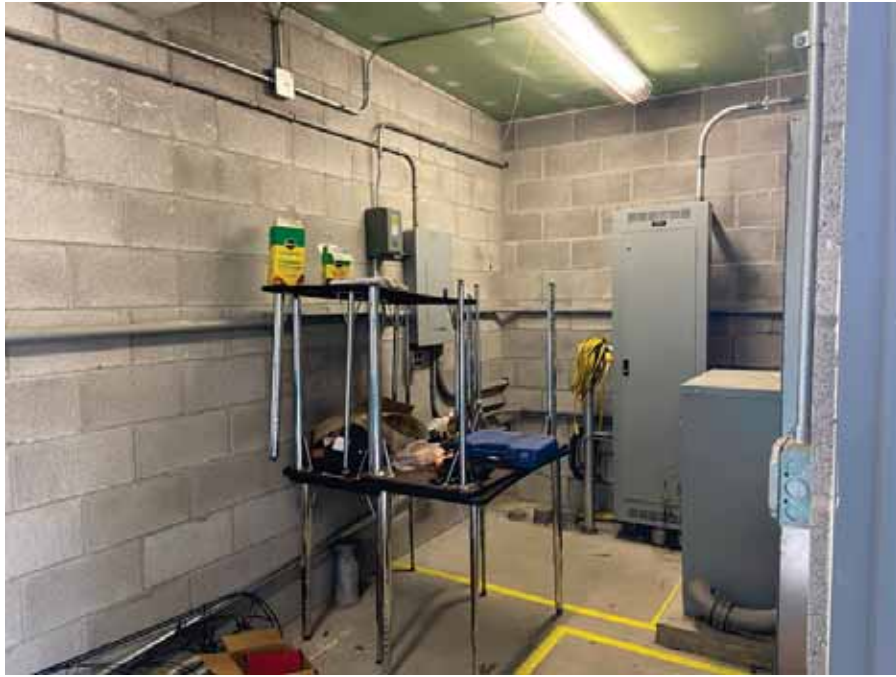
Potential PCB-Containing Equipment	Location	Evidence of Leaks
Pole-Mounted Transformers	Located east/southeast of Building Three	No
Pad-Mounted Transformers	Located in boiler rooms of Club Areas in Building One, southwest exterior of Building One, west of electrical Building in Area Two, in storage building underneath bleachers in Area Two, north of bleachers in Area Two	No
Elevators	Located throughout Building One and in Building Two	The reservoir associated with the elevator appeared to be in good condition

Photo 135 : Pad-mounted transformer in storage building underneath bleachers in Area Two
